Transit Asset Management Plan

October 1, 2022 – September 30, 2026

RHODE ISLAND PUBLIC TRANSIT AUTHORITY

FINAL ASSESSMENT REPORT
August, 2022

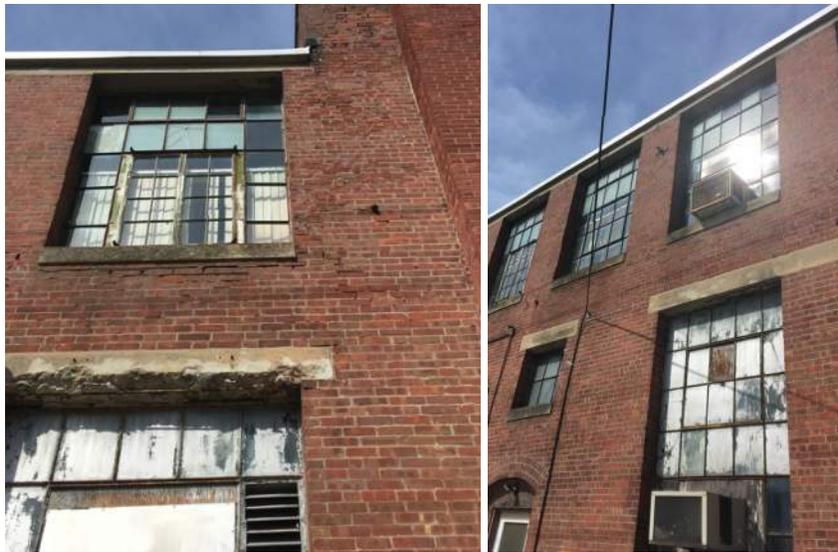
Coding / Field Name	Asset Description
System Name	Exterior office windows
Condition	1
Quantity	~50
Unit Cost	Total: \$489,600
Year in Service	1975
Expected Useful Life	30 years
Remaining Useful Life	0 years, Estimated, Based on Date of Observation
Location	Building interior
Basis of Costing	Square Foot Costs with RSMeans Data 2022 – 43 rd Edition

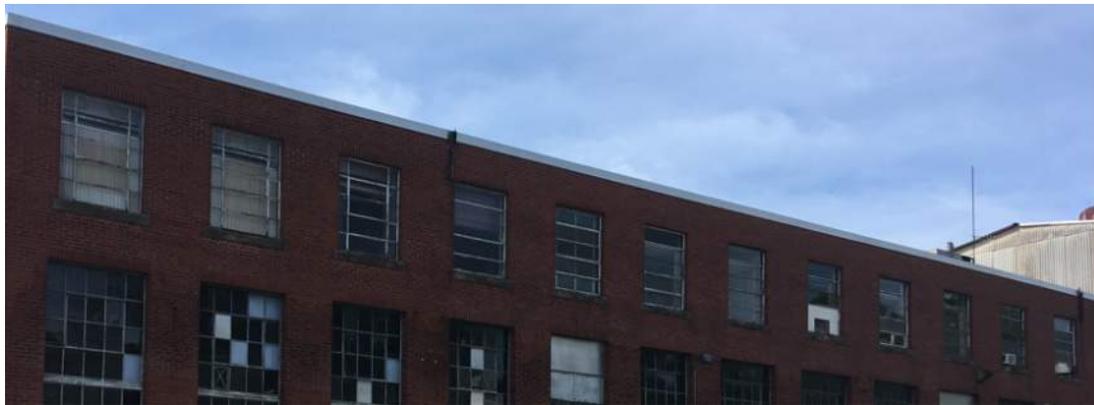
Coding / Field Name	Asset Description
System Name	Exterior steel windows
Condition	1
Quantity	~29
Unit Cost	Total: \$350,096
Year in Service	1975
Expected Useful Life	30 years
Remaining Useful Life	0 years, Estimated, Based on Date of Observation
Location	Building exterior
Basis of Costing	Square Foot Costs with RSMeans Data 2022 – 43 rd Edition

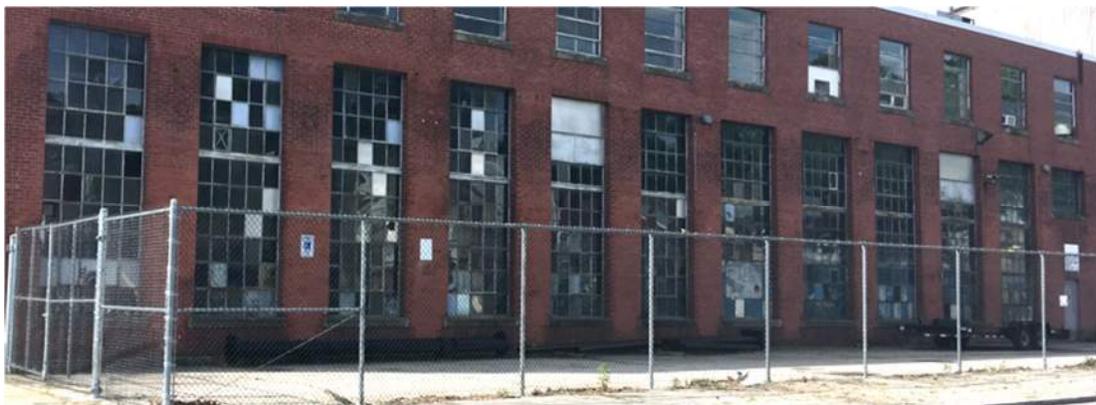
Coding / Field Name	Asset Description
System Name	Storefront, Metal-framed with Glazing
Condition	1
Quantity	~500 sq. ft.
Unit Cost	Total: \$14,090
Year in Service	1985
Expected Useful Life	30 years
Remaining Useful Life	0 years, Estimated, Based on Date of Observation
Location	Building exterior
Basis of Costing	Square Foot Costs with RSMeans Data 2022 – 43 rd Edition

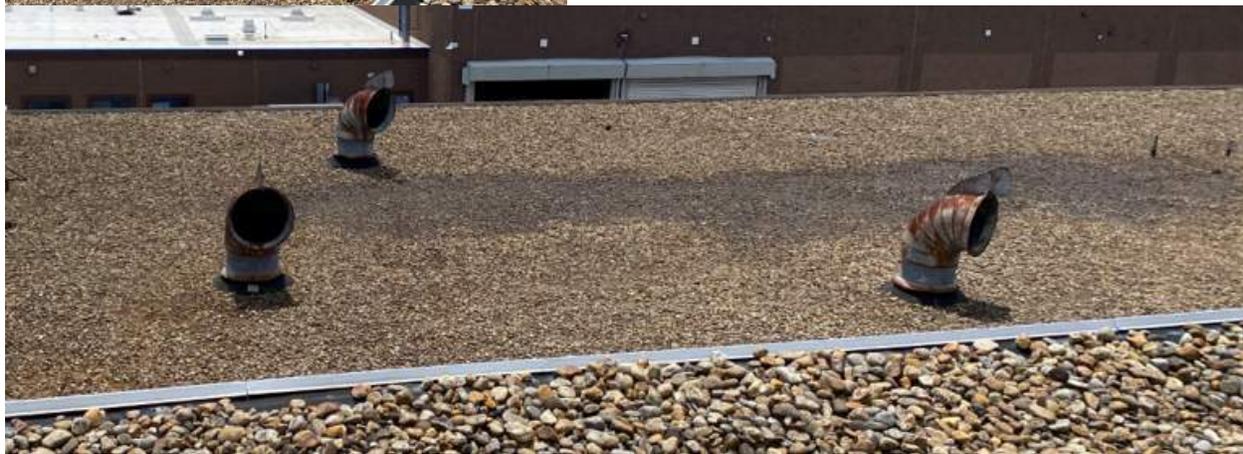
Coding / Field Name	Asset Description
System Name	Roof head houses
Condition	1
Quantity	~600 sq. ft.
Unit Cost	\$25,248
Year in Service	N/A
Expected Useful Life	N/A
Remaining Useful Life	0 years, Estimated, Based on Date of Observation
Location	Roof
Basis of Costing	Square Foot Costs with RSMeans Data 2022 – 43 rd Edition

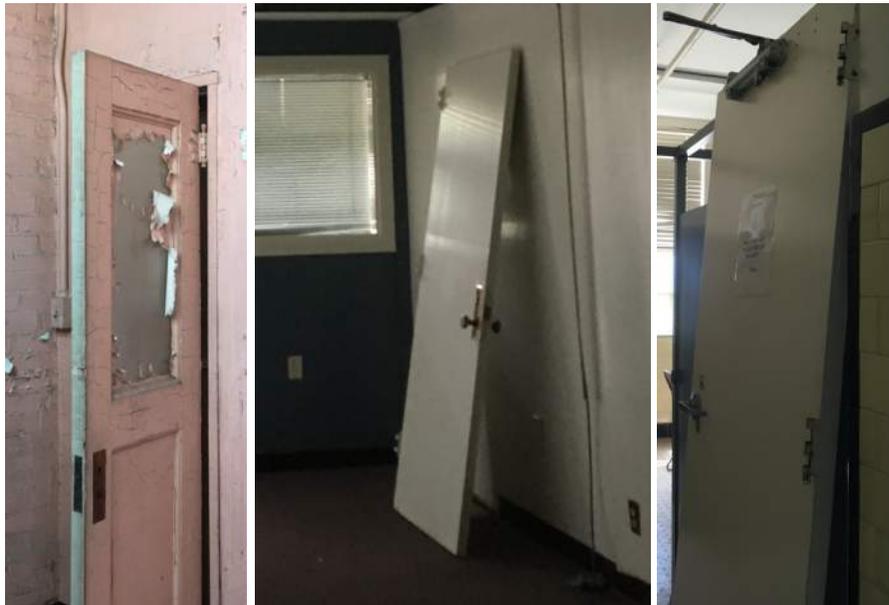
Coding / Field Name	Asset Description
System Name	Interior fire rated doors
Condition	2
Quantity	6
Unit Cost	\$12,662.40
Year in Service	1985
Expected Useful Life	25 years
Remaining Useful Life	2 years, Estimated, Based on Date of Observation
Location	Building interior
Basis of Costing	Square Foot Costs with RSMeans Data 2022 – 43 rd Edition

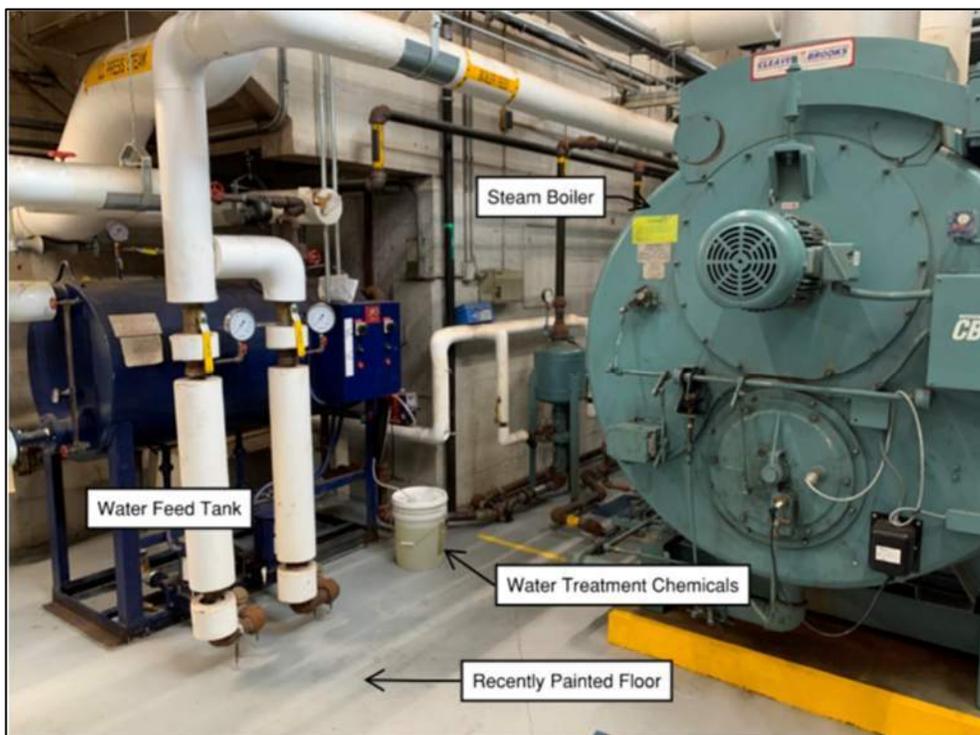
Figure 23: Boiler Room

The Cleaverbrooks boiler was manufactured in 2010. This system replaced the existing oil-fired steam boiler that was abandoned in place in the basement. The boiler room is clean and appears to be well maintained. The floor was recently painted. However, building maintenance mentioned that only recently has the boiler feed water been treated. There is a 5 gallon-bucket of treatment chemicals being dosed into the Shipco Water Feed Tank. There isn't a contract with a water treatment company. Building maintenance mentioned the steam system is very loud and condensate traps fail often. This is most likely due to the lack of water treatment. Air purge valves and condensate traps become stuck due to the corrosion effects of the inadequately treated water. Trapped air and cold condensate flash with the steam and knock pipes.

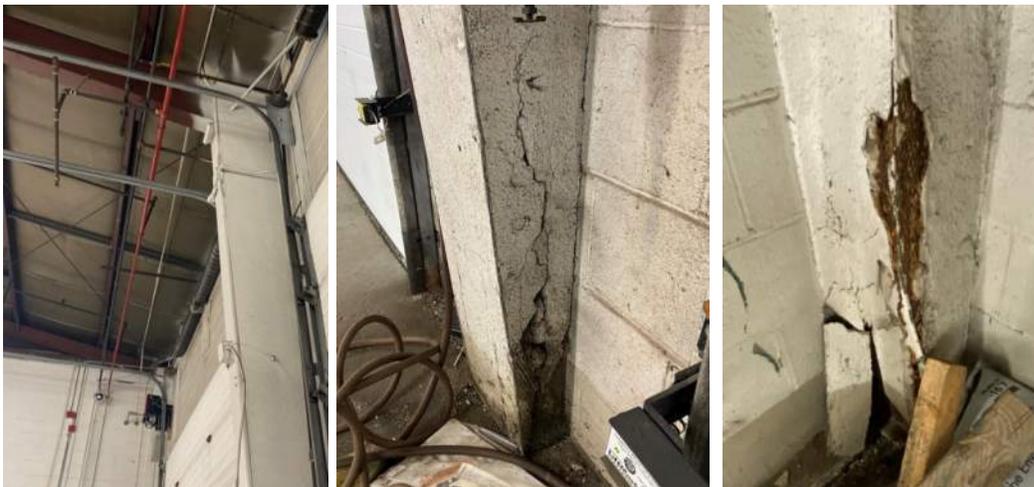
Coding \$ Field Name	Asset Description
System Name	CMU walls
Condition	3
Quantity	~8,200 sq. ft.
Unit Cost	Total: \$200,694.42
Year in Service	~1960s with Sporadic Modifications
Expected Useful Life	100 years
Remaining Useful Life	35 years, Estimated, Based on Date of Observation
Location	Exterior and interior bearing walls.
Basis of Costing	Square Foot Costs with RSMeans Data 2022 – 43 rd Edition

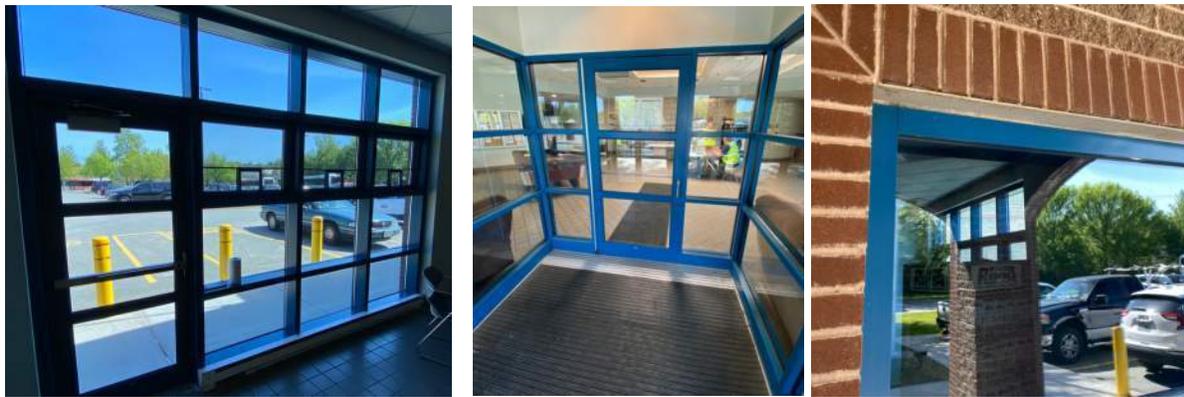
Coding / Field Name	Asset Description
System Name	Exterior linear metal ceilings
Condition	4
Quantity	~342 sq. ft.
Unit Cost	Total: \$4,258
Year in Service	1993
Expected Useful Life	50 years
Remaining Useful Life	35 years, Estimated, Based on Date of Observation
Location	Building exterior and vestibule
Basis of Costing	Square Foot Costs with RSMeans Data 2022 – 43 rd Edition

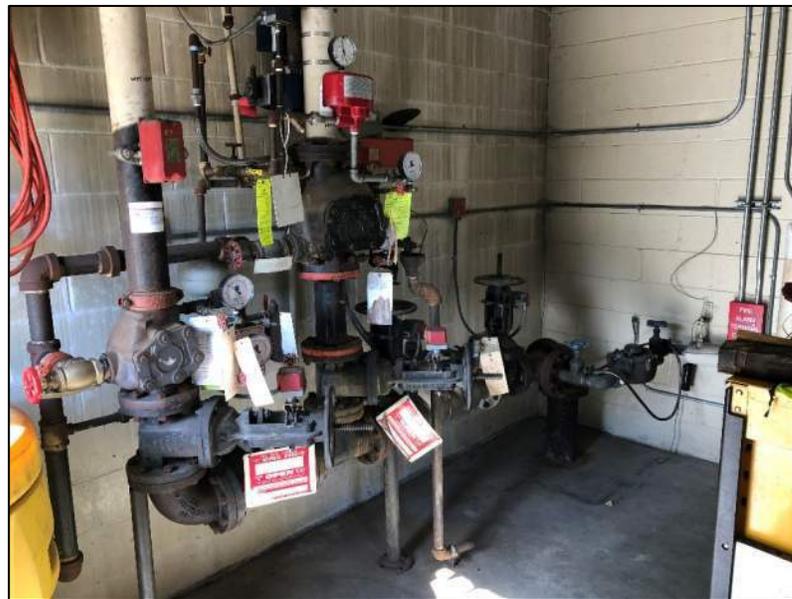
Figure 23: Fire and Water Services

The fire protection and domestic water systems connect to a common 6”-service lateral from the street. The fire sprinkler system has Qty (2) risers: (1) is a wet-system riser and (1) is a dry-system riser. The office is protected with the wet-system riser and the sprinkler heads appear original to the building. The maintenance bay is supplied with the dry-system with upright heads that also appear original.

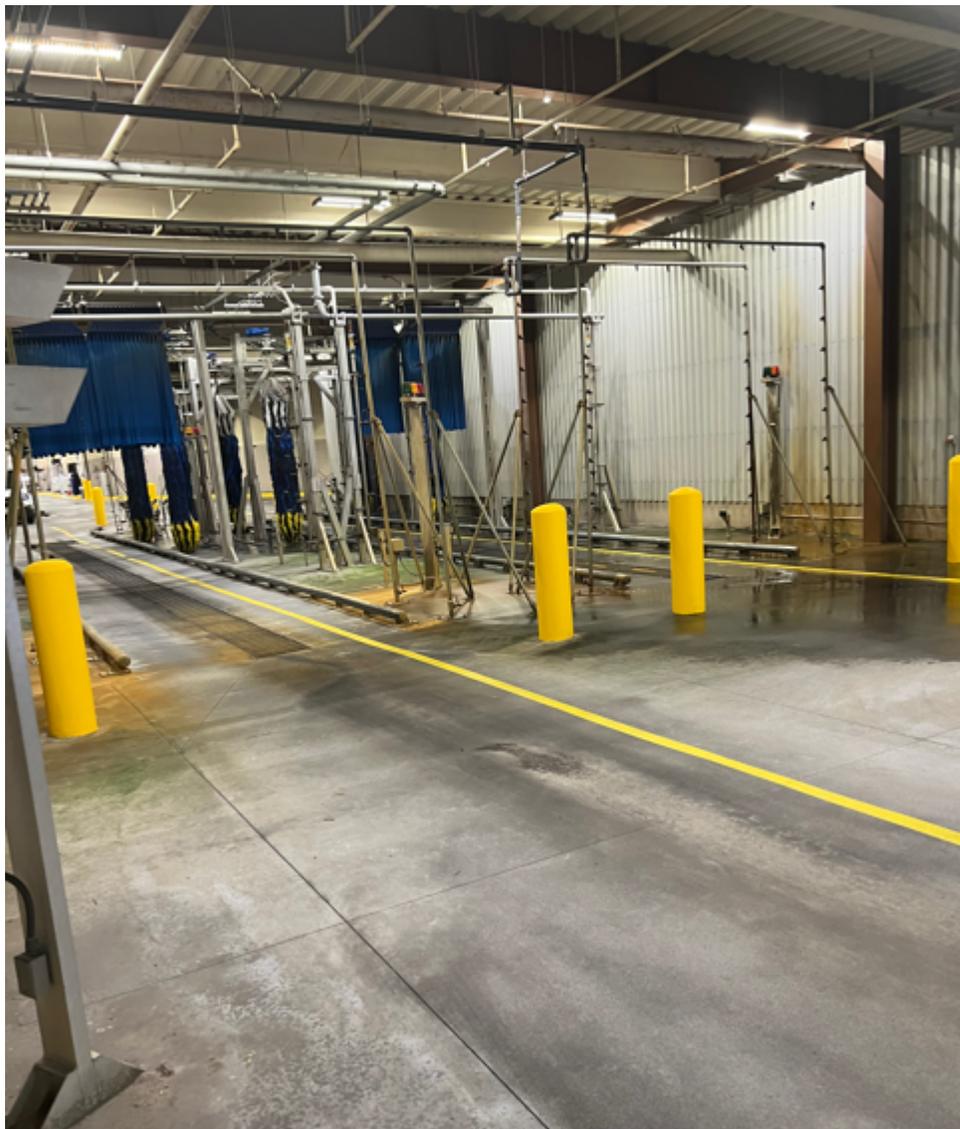
Coding / Field Name	Asset Description
System Name	Bus wash
Condition	3
Quantity	2
Unit Cost	\$99,172
Year in Service	2009
Expected Useful Life	25 years
Remaining Useful Life	15 years, Estimated, Based on Date of Observation
Location	Building interior
Basis of Costing	Square Foot Costs with RSMMeans Data 2022 – 43 rd Edition
