Transit Asset Management Plan

October 1, 2022 – September 30, 2026

RHODE ISLAND PUBLIC TRANSIT AUTHORITY

FINAL ASSESSMENT REPORT
August, 2022

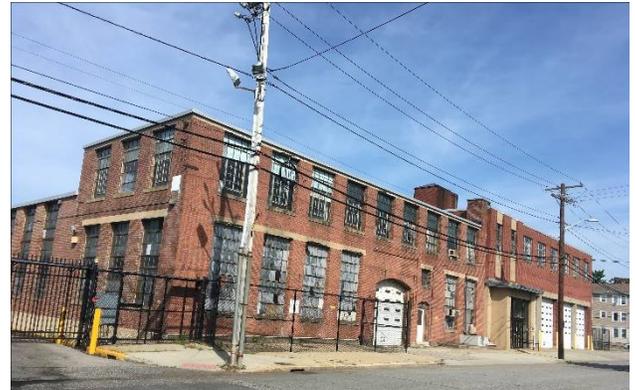
There is a partial second floor and two small partial basement areas, which were previously used for mechanical equipment. 267 Melrose Street houses vehicle storage and repair on the first level. The second level features an office area that has been vacant for more than 10 years. Both second floor levels previously housed RIPTA administrative offices and have now been abandoned due to disrepair, hazardous materials building components, leaking roofs, and inefficient and obsolete building systems.

The building is the lowest rated in RIPTA’s facility portfolio. Photos showing the current condition of the exterior and interior of the building are enclosed in Appendix B. Based on our team’s assessment, the building is in a poor condition. There is approximately \$8.8M of improvements that fall within the 20-year forecast for 265 Melrose. Because of the existing condition of the building, there is a concentrated effort to get it into a state of good repair. Proposed projects span across the category of assets.

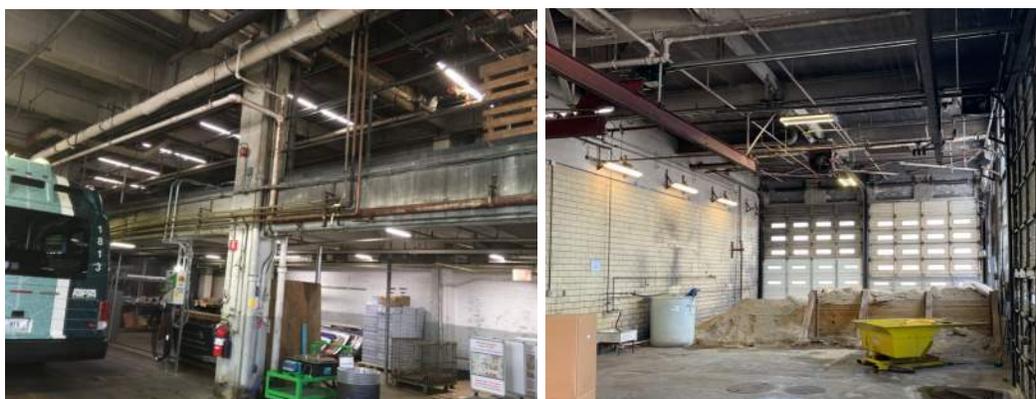
Coding / Field Name	Asset Description
System Name	Superstructure, concrete/steel.
Condition	3
Quantity	72,000 sq. ft.
Unit Cost	Total: \$972,000
Year in Service	1922
Expected Useful Life	100 years
Remaining Useful Life	25 years, Estimated, Based on Date of Observation
Location	Structure
Basis of Costing	Square Foot Costs with RSMeans Data 2022 – 43 rd Edition

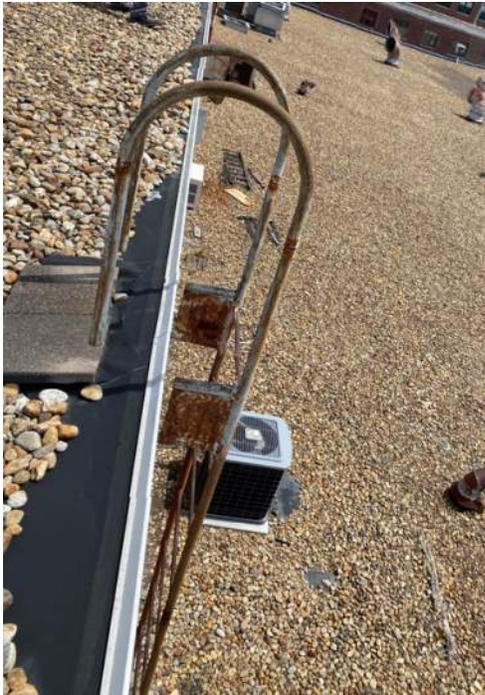
Coding / Field Name	Asset Description
System Name	Roof access ladder, steel
Condition	1
Quantity	1
Unit Cost	\$2,296.85
Year in Service	N/A
Expected Useful Life	N/A
Remaining Useful Life	0 years, Estimated, Based on Date of Observation
Location	Roof
Basis of Costing	Square Foot Costs with RSMeans Data 2022 – 43 rd Edition

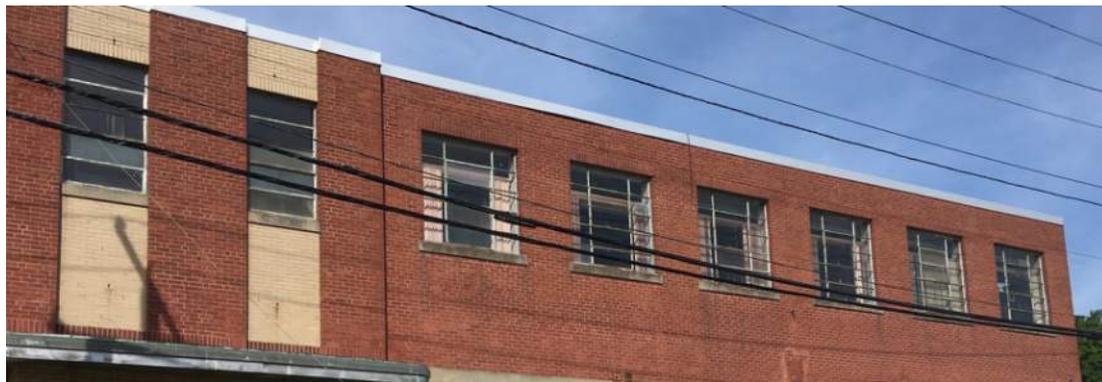
Coding / Field Name	Asset Description
System Name	Exterior office windows
Condition	1
Quantity	~50
Unit Cost	Total: \$489,600
Year in Service	1975
Expected Useful Life	30 years
Remaining Useful Life	0 years, Estimated, Based on Date of Observation
Location	Building interior
Basis of Costing	Square Foot Costs with RSMeans Data 2022 – 43 rd Edition

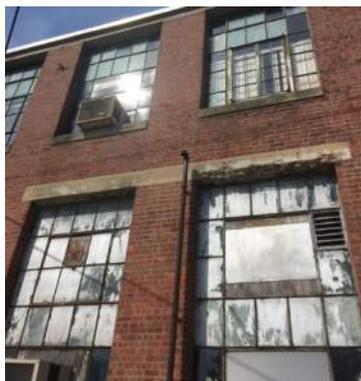
Coding / Field Name	Asset Description
System Name	Exterior steel windows
Condition	1
Quantity	~29
Unit Cost	Total: \$350,096
Year in Service	1975
Expected Useful Life	30 years
Remaining Useful Life	0 years, Estimated, Based on Date of Observation
Location	Building exterior
Basis of Costing	Square Foot Costs with RSMeans Data 2022 – 43 rd Edition

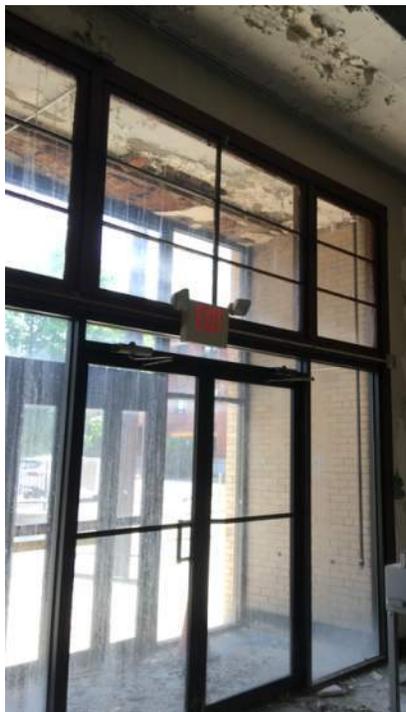
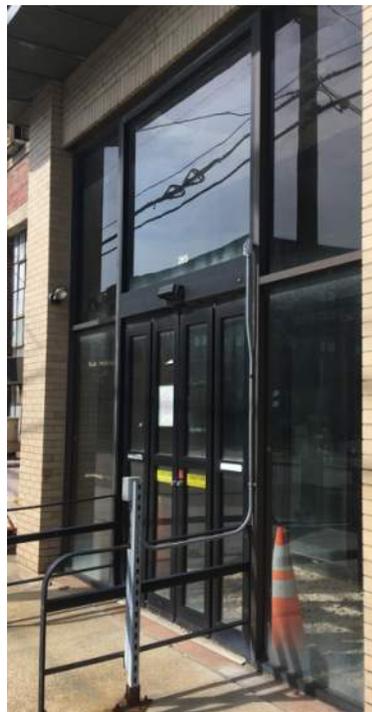
Coding / Field Name	Asset Description
System Name	Storefront, Metal-framed with Glazing
Condition	1
Quantity	~500 sq. ft.
Unit Cost	Total: \$14,090
Year in Service	1985
Expected Useful Life	30 years
Remaining Useful Life	0 years, Estimated, Based on Date of Observation
Location	Building exterior
Basis of Costing	Square Foot Costs with RSMeans Data 2022 – 43 rd Edition

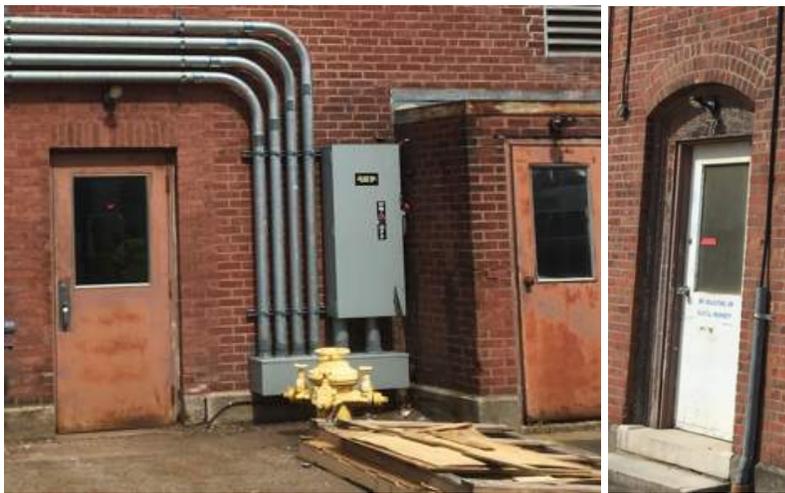
Coding / Field Name	Asset Description
System Name	Steel exterior doors, frames, and hardware
Condition	1
Quantity	8
Unit Cost	Total: \$16,931
Year in Service	1997
Expected Useful Life	25 years
Remaining Useful Life	1 year, Estimated, Based on Date of Observation
Location	Building exterior
Basis of Costing	Square Foot Costs with RSMeans Data 2022 – 43 rd Edition

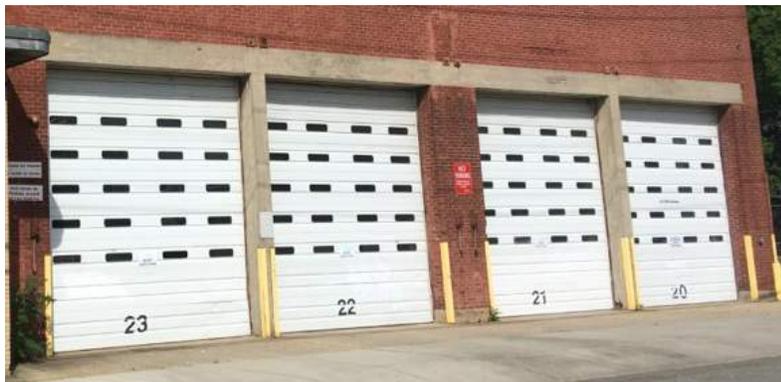
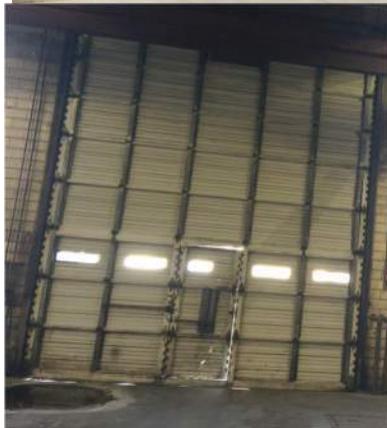
Coding / Field Name	Asset Description
System Name	Overhead steel garage doors
Condition	2
Quantity	22
Unit Cost	Total: \$153,063
Year in Service	1995
Expected Useful Life	30 years
Remaining Useful Life	5 years, Estimated, Based on Date of Observation
Location	Building exterior
Basis of Costing	Square Foot Costs with RSMeans Data 2022 – 43 rd Edition

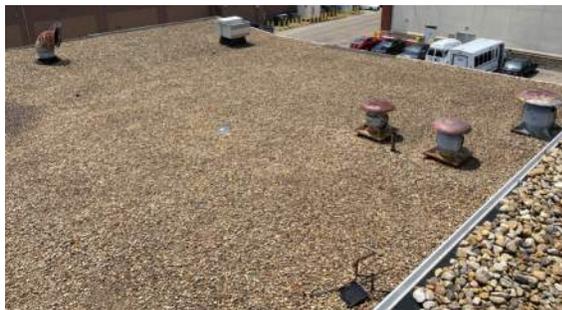
The ballasted roof is in very poor condition. Evidence of extreme ponding, damage to the membrane layer, and leaking can be observed. On the roof is a headhouse which includes cladding and glazing in disrepair.

Coding / Field Name	Asset Description
System Name	Roofing – ballasted
Condition	1
Quantity	~43,500 sq. ft.
Unit Cost	Total: \$1,344,194
Year in Service	1995
Expected Useful Life	20 years
Remaining Useful Life	0 years, Estimated, Based on Date of Observation
Location	Roof
Basis of Costing	Square Foot Costs with RSMeans Data 2022 – 43 rd Edition

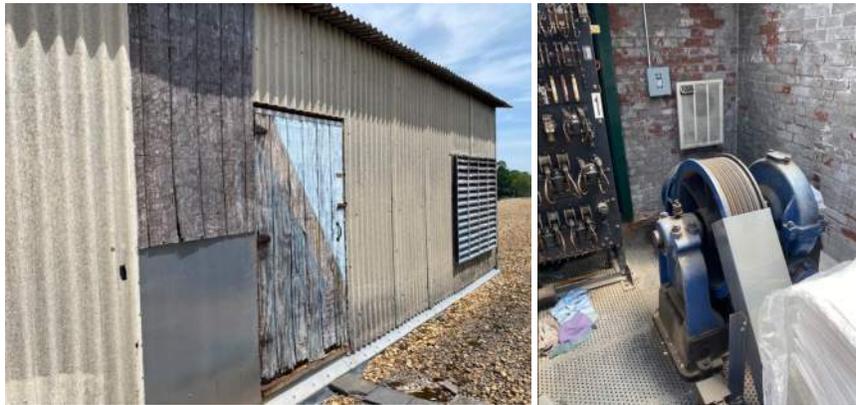
Coding / Field Name	Asset Description
System Name	Roof head houses
Condition	1
Quantity	~600 sq. ft.
Unit Cost	\$25,248
Year in Service	N/A
Expected Useful Life	N/A
Remaining Useful Life	0 years, Estimated, Based on Date of Observation
Location	Roof
Basis of Costing	Square Foot Costs with RSMeans Data 2022 – 43 rd Edition

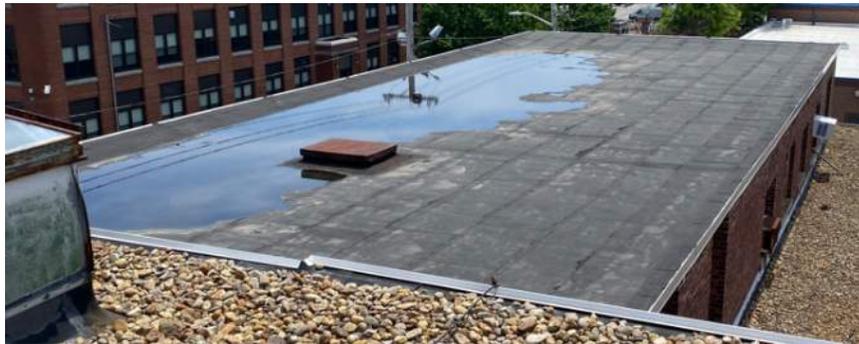
Coding / Field Name	Asset Description
System Name	Roof – Membrane
Condition	2
Quantity	~3,000 sq. ft.
Unit Cost	Total: \$22,872
Year in Service	2005
Expected Useful Life	20
Remaining Useful Life	5 years, Estimated, Based on Date of Observation
Location	Building structure
Basis of Costing	Square Foot Costs with RSMeans Data 2022 – 43 rd Edition

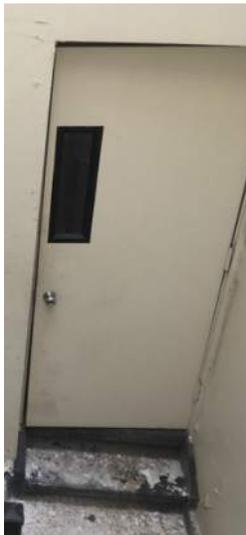
Coding / Field Name	Asset Description
System Name	Interior steel doors
Condition	1
Quantity	23
Unit Cost	Total: \$37,039.20
Year in Service	2010
Expected Useful Life	20
Remaining Useful Life	2 years, Estimated, Based on Date of Observation
Location	Building interior
Basis of Costing	Square Foot Costs with RSMeans Data 2022 – 43 rd Edition

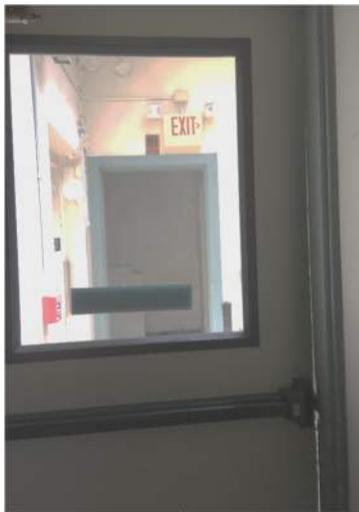
Coding / Field Name	Asset Description
System Name	Interior fire rated doors
Condition	2
Quantity	6
Unit Cost	\$12,662.40
Year in Service	1985
Expected Useful Life	25 years
Remaining Useful Life	2 years, Estimated, Based on Date of Observation
Location	Building interior
Basis of Costing	Square Foot Costs with RSMeans Data 2022 – 43 rd Edition

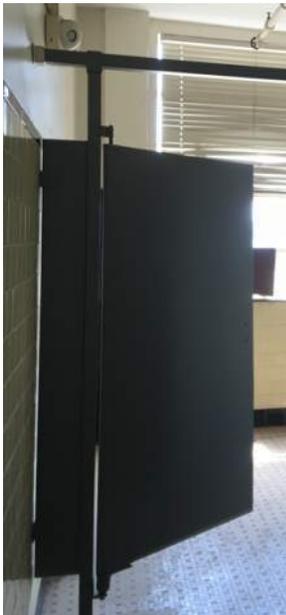
Coding / Field Name	Asset Description
System Name	Toilet partitions - metal
Condition	3
Quantity	5
Unit Cost	\$5289.84
Year in Service	2010
Expected Useful Life	15 years
Remaining Useful Life	5 years, Estimated, Based on Date of Observation
Location	Building interior
Basis of Costing	Square Foot Costs with RSMeans Data 2022 – 43 rd Edition

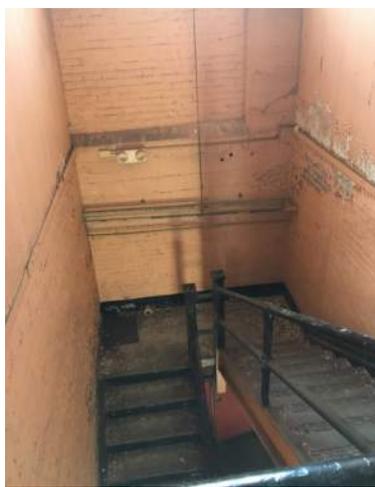
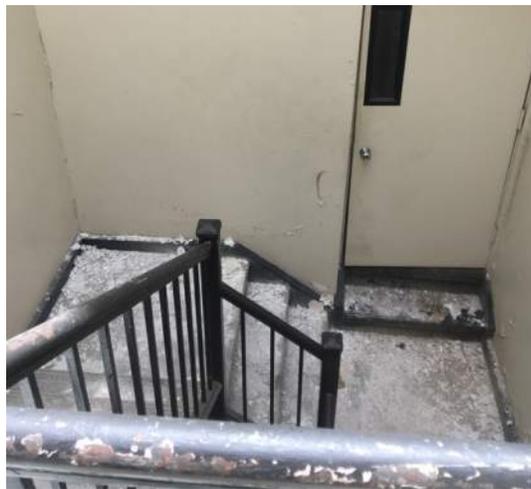
Coding / Field Name	Asset Description
System Name	Interior stairs, Fire Exit
Condition	1
Quantity	~2,000 sq. ft.
Unit Cost	\$33,825
Year in Service	1927
Expected Useful Life	50 years
Remaining Useful Life	0 years, Estimated, Based on Date of Observation
Location	Building interior
Basis of Costing	Square Foot Costs with RSMeans Data 2022 – 43 rd Edition

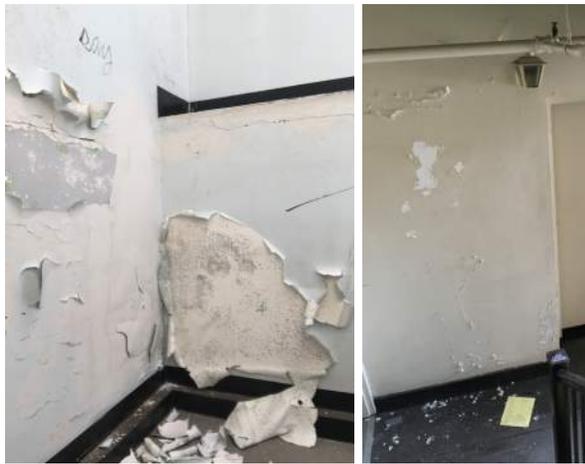
Coding / Field Name	Asset Description
System Name	Interior gypsum partitions/walls
Condition	1
Quantity	~25,000 sq. ft.
Unit Cost	\$221,087.50
Year in Service	N/A
Expected Useful Life	75 years
Remaining Useful Life	0 years, Estimated, Based on Date of Observation
Location	Building interior
Basis of Costing	Square Foot Costs with RSMeans Data 2022 – 43 rd Edition

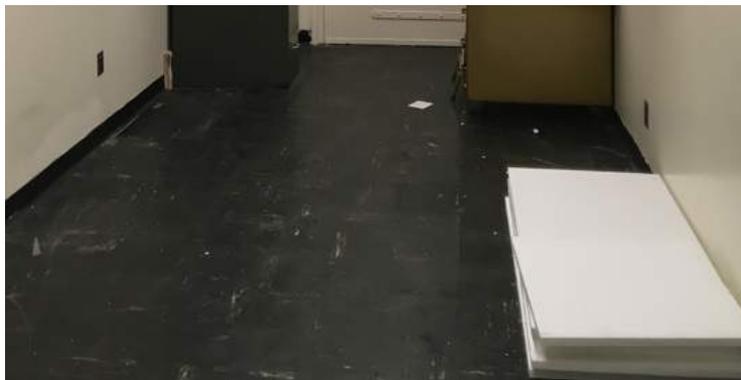
Coding / Field Name	Asset Description
System Name	Vinyl tile flooring
Condition	1
Quantity	~12,000 sq. ft.
Unit Cost	\$81,000
Year in Service	1975
Expected Useful Life	50 years
Remaining Useful Life	0 years, Estimated, Based on Date of Observation
Location	Building interior
Basis of Costing	Square Foot Costs with RSMeans Data 2022 – 43 rd Edition

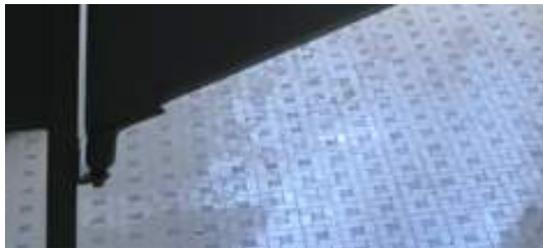
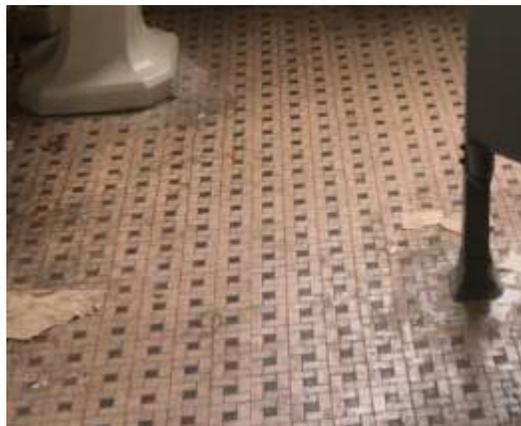
Coding / Field Name	Asset Description
System Name	Ceramic tile flooring
Condition	1
Quantity	2,000 sq. ft.
Unit Cost	\$27,226.41
Year in Service	1975
Expected Useful Life	75 years
Remaining Useful Life	10 years, Estimated, Based on Date of Observation
Location	Building interior
Basis of Costing	Square Foot Costs with RSMeans Data 2022 – 43 rd Edition

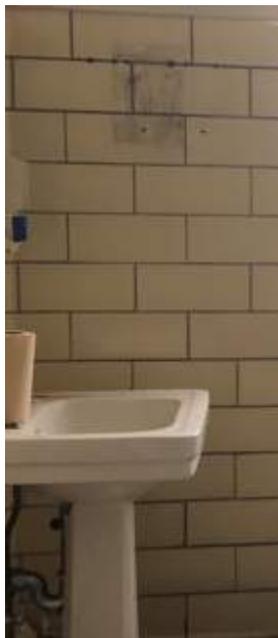
Coding / Field Name	Asset Description
System Name	Ceramic wall tile
Condition	1
Quantity	~2,000
Unit Cost	\$18,000
Year in Service	1975
Expected Useful Life	50 years
Remaining Useful Life	0 years, Estimated, Based on Date of Observation
Location	Building interior
Basis of Costing	Square Foot Costs with RSMeans Data 2022 – 43 rd Edition

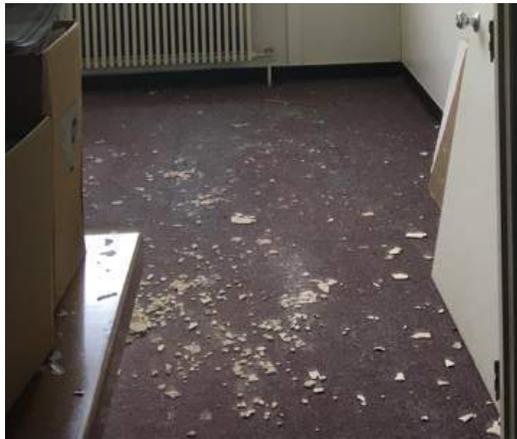
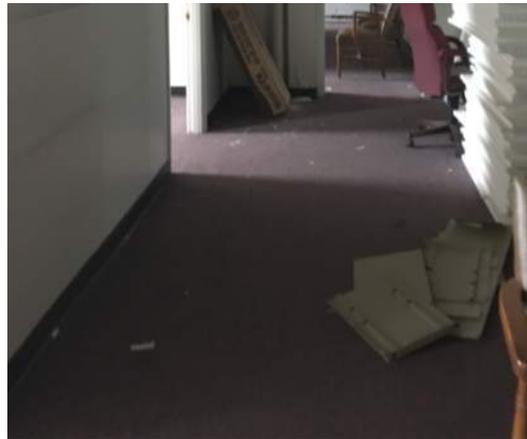
Coding / Field Name	Asset Description
System Name	Carpet flooring
Condition	1
Quantity	14,000 sq. ft.
Unit Cost	\$95,634
Year in Service	1975
Expected Useful Life	10 years
Remaining Useful Life	0 years, Estimated, Based on Date of Observation
Location	Building interior
Basis of Costing	Square Foot Costs with RSMeans Data 2022 – 43 rd Edition

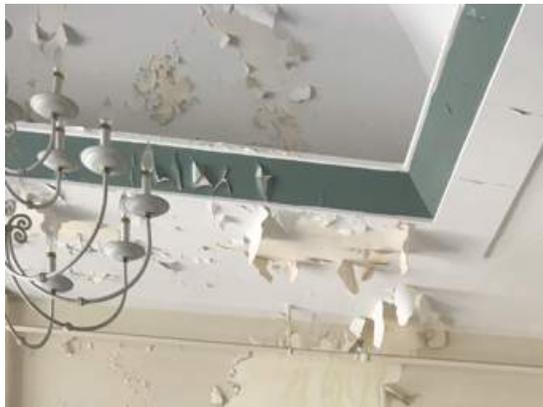
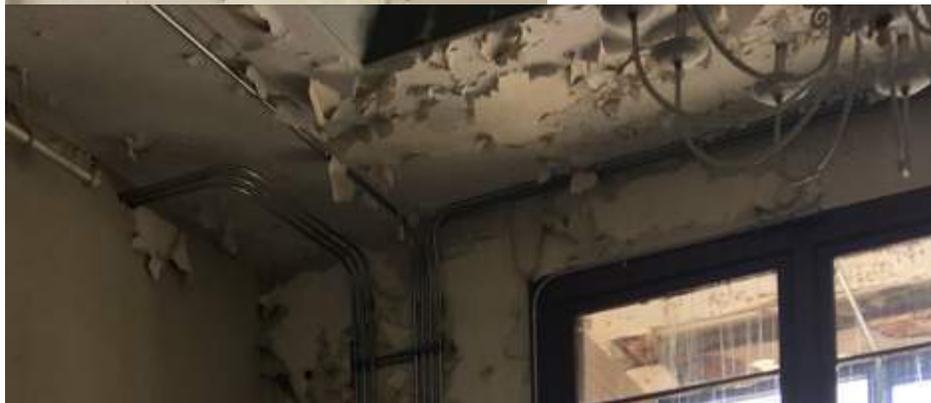
Coding / Field Name	Asset Description
System Name	Interior gypsum board ceilings
Condition	1
Quantity	~2,000 sq. ft.
Unit Cost	\$20,262
Year in Service	1927
Expected Useful Life	75 years
Remaining Useful Life	0 years, Estimated, Based on Date of Observation
Location	Building interior
Basis of Costing	Square Foot Costs with RSMMeans Data 2022 – 43 rd Edition

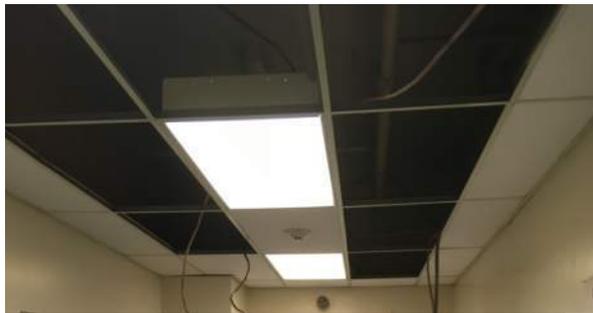
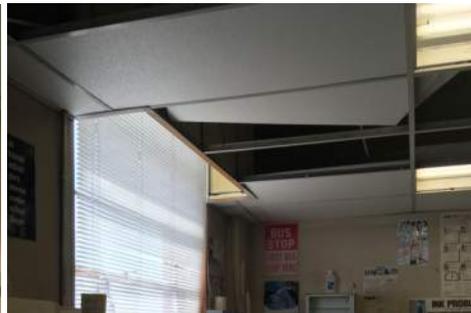
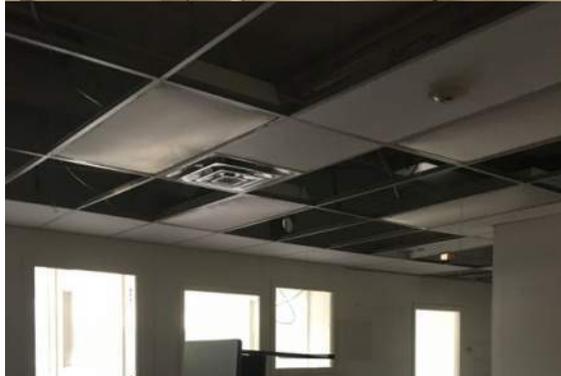
Coding / Field Name	Asset Description
System Name	Acoustic ceiling tile and grid systems.
Condition	1
Quantity	22,000 sq. ft.
Unit Cost	\$237,160.02
Year in Service	1975
Expected Useful Life	40 years
Remaining Useful Life	0 years, Estimated, Based on Date of Observation
Location	Building interior
Basis of Costing	Square Foot Costs with RSMeans Data 2022 – 43 rd Edition

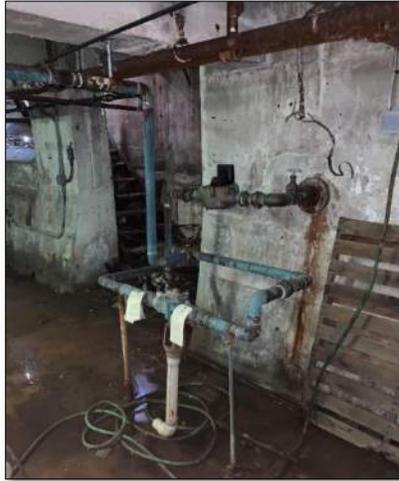
Figure 1: Water Service Entrance

The domestic water service is in a basement level. The service has a 2” copper line. There is a 2” water meter and a 2” reduced-pressure zone backflow preventer. The copper is slightly corroded but appears to be in fair condition. A pressure gauge at the service reads 78 psi. No pressure boosting pumps are present. The domestic water is

pipework with copper throughout the building. Maintenance was performed in a few sections. The older fittings were soldered, and the newer fittings are press-fit fittings. No insulation is present on hot or cold water piping.

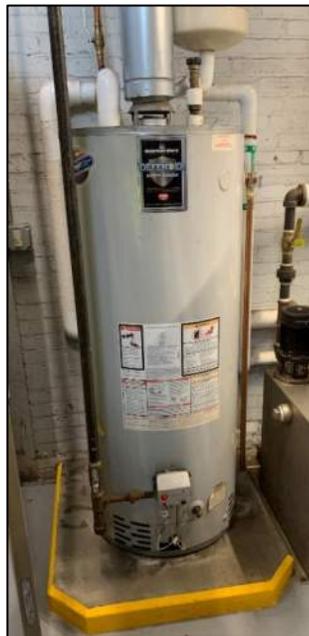
Figure 2: Gas-Fired Water Heater in Boiler Room

A 65-gallon, 65,000 Btu/hr gas-fired water heater located in the boiler room provides hot water to a wash sink and several interior hose bibbs. A small, tank electric water heater provides hot water to the restroom. In the office area, a small tank electric water heater is abandoned in place under the vanity of a lavatory.

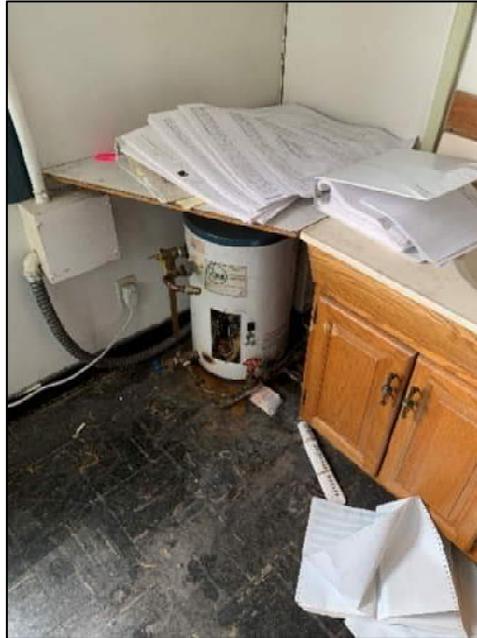
Figure 4: Electric Water Heater in Office Area

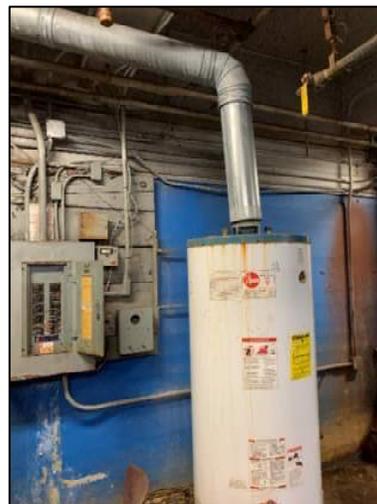
An abandoned, gas-fired water heater is in the abandoned boiler room. This water heater might have supplied hot water to the restrooms in the office area when the office portion of the building was operational.

Figure 5: Abandoned Gas-Fired Water Heater in Abandoned Boiler Room

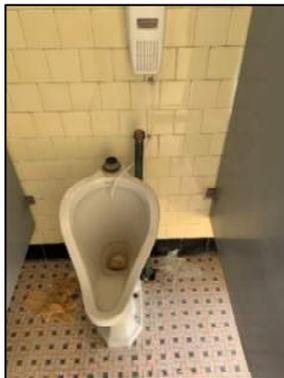
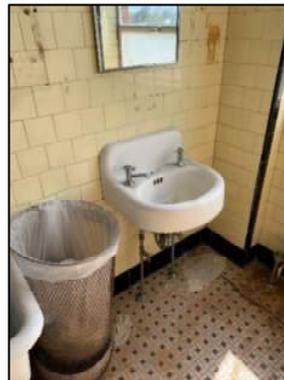
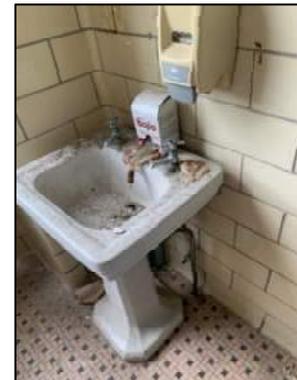
The observed abandoned plumbing fixtures are non-ADA compliant, are manually operated, and are not of the water-saving variety. There appeared to be no master mixing valve and no point-of-use mixing valves to provide scald protection.

Figure 6: Abandoned Urinal

Figure 7: Abandoned Lavatory

Figure 8: Abandoned Lavatory

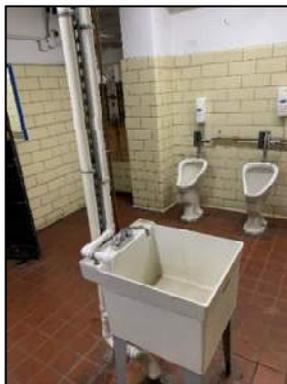
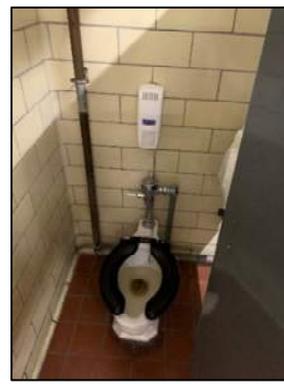
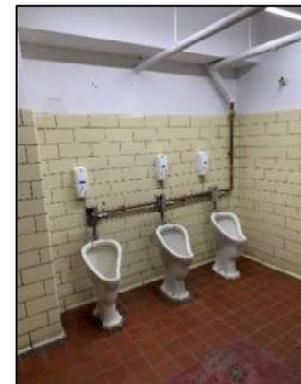
Coding / Field Name	Asset Description
Plumbing Fixtures	Water closets, lavatories, sinks, etc.
Condition	1-Poor
Quantity	~21,000 SF, ~20 Fixtures
Unit Cost	~\$4,000/Fixture and \$2.50/SF. Total: \$132,500
Year in Service	~1960s with sporadic modifications
Expected Useful Life (EUL)	~20 Years
Remaining Useful Life (RUL)	~0 Years
Location	Office Area
Basis of Costing	RMS Means Data with Contingencies Added

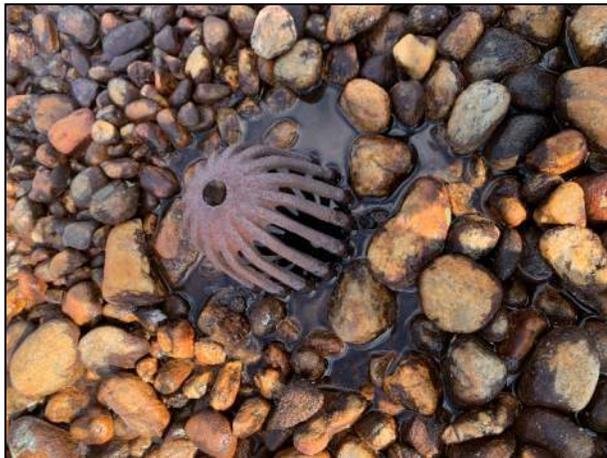
The storm drainage piping appeared to be original to the building. Most piping was bell and spigot cast iron, and some recent patching was done with PVC. The drains on the roof are original and some appear clogged. No secondary drainage was present.

Figure 12: Clogged Roof Drain

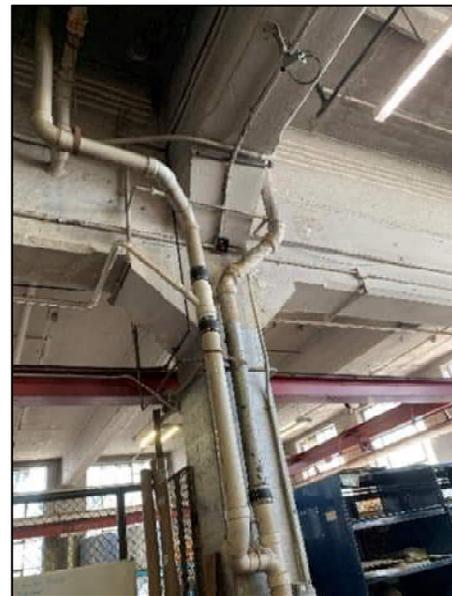
Figure 13: Storm Leaders - PVC and Cast Iron

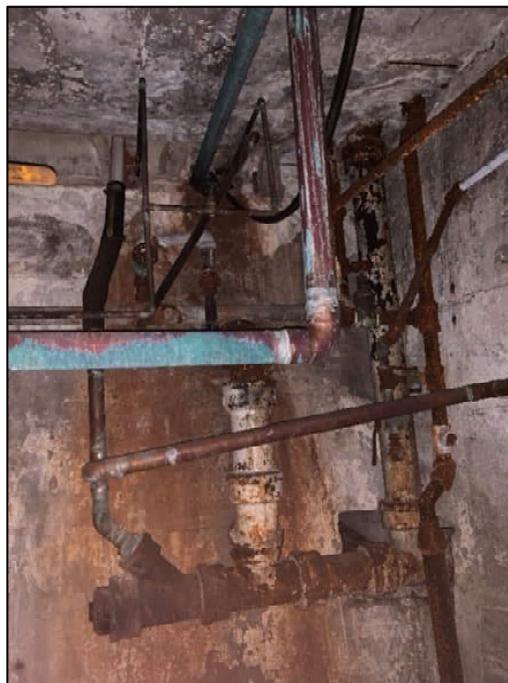
The sanitary piping is bell and spigot cast iron. The piping appeared to be original and is deteriorating in the basement, where one street lateral is observed.

Figure 14: Pipe Chase in Water Service Area. Sanitary Lateral

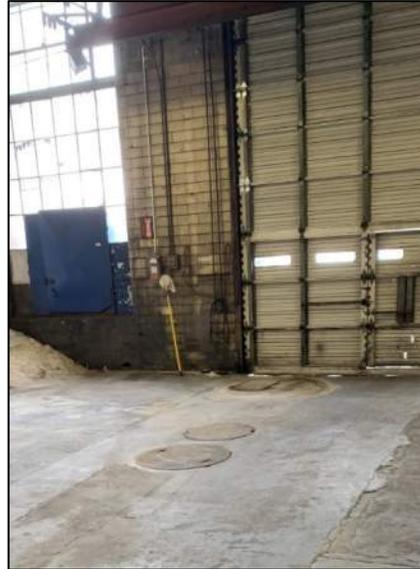
In the washroom, what appears to be a sand-oil separator is filled with concrete. No other oil separation system appears present in the building.

Figure 15: Filled Sand-Oil Separator

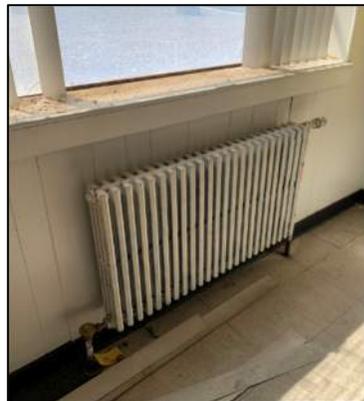
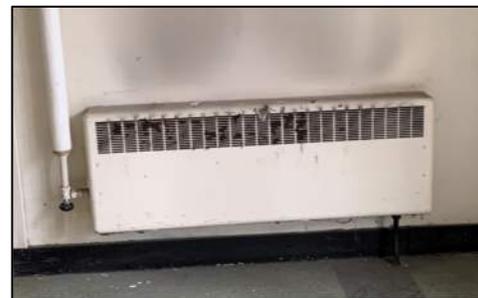
Coding / Field Name	Asset Description
Steam System	Steam boiler, piping, ancillary equipment, and terminal devices (radiators and fan coils).
Condition	Steam Boiler: 4-Good, Rest of System: 2-Marginal
Quantity	~71,000 square feet
Unit Cost	\$14/square foot for ~\$994,000
Year in Service	Boiler (2010), Other System Components ~1960s and 1997
Expected Useful Life (EUL)	Boiler ~30 Years, Other System Components ~30 Years
Remaining Useful Life (RUL)	Boiler ~20 years, Other System Components ~0 Years
Location	Boiler Room. See comments for further details.
Basis of Costing	RMS Means Data with Contingencies Added

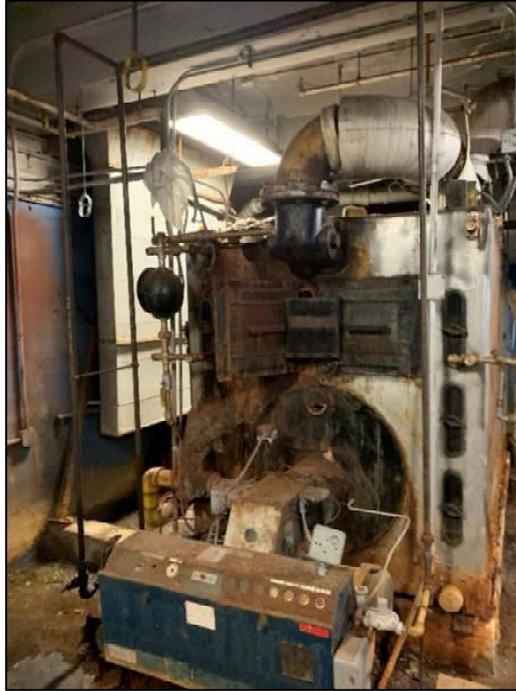
Figure 24: Abandoned Boiler in Abandoned Boiler Room

The Cleaverbrooks boiler was manufactured in 2010. This system replaced the existing oil-fired steam boiler that was abandoned in place in the basement. The boiler room is clean and appears to be well maintained. The floor was recently painted. However, building maintenance mentioned that only recently has the boiler feed water been treated. There is a 5 gallon-bucket of treatment chemicals being dosed into the Shipco Water Feed Tank. There isn't a contract with a water treatment company. Building maintenance mentioned the steam system is very loud and condensate traps fail often. This is most likely due to the lack of water treatment. Air purge valves and condensate traps become stuck due to the corrosion effects of the inadequately treated water. Trapped air and cold condensate flash with the steam and knock pipes.

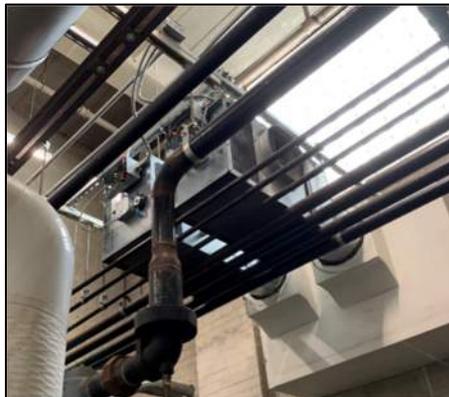
Figure 25: Combustion Air Fans

The maintenance staff mentioned the unit heaters work well, but it is unclear how many are operational or how many are not being triggered due to condensate traps failing or bad thermostats. Also, in the boiler room, the maintenance staff mentioned the need to open the boiler room doors to provide enough combustion air for the boiler. There are fans to provide combustion air, but the staff feels these are insufficiently sized. The control boxes are open exposing wiring.

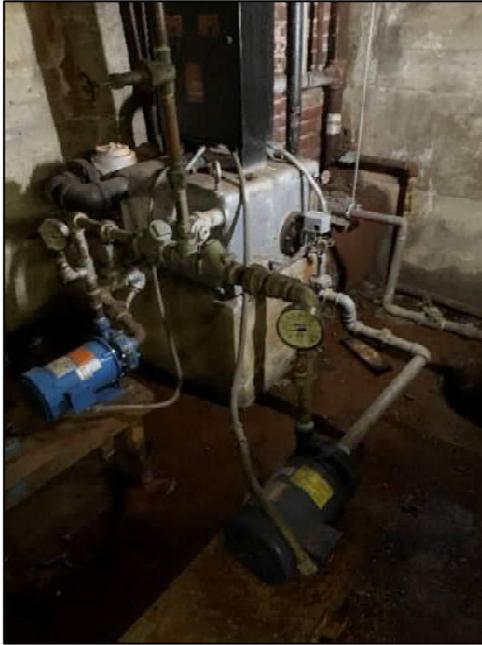
Figure 26: Condensate Receiver in the Basement

Condensate receivers are placed in various portions of the building. Some maintenance was observed, such as new pumps and motors.

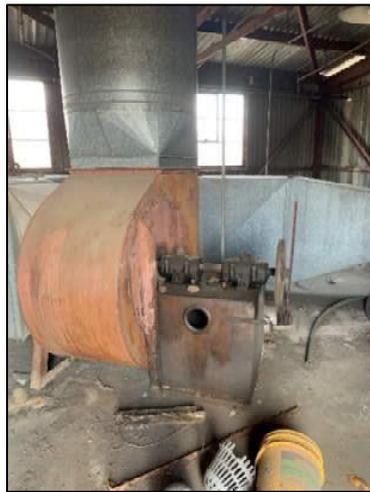
Figure 28: Abandoned Air Handler for Spray Booth, Located on Roof

There is an abandoned paint booth on the North side of the building. The duct work in place feeds a large Air Handler that was abandoned in place on the roof. The sprinkler system was also disconnected for the penthouse where the air handler is housed (mentioned later in this report). Another large Air Handler was abandoned in place on the roof, and this air handler served the sheet metal shop and the glass shop.

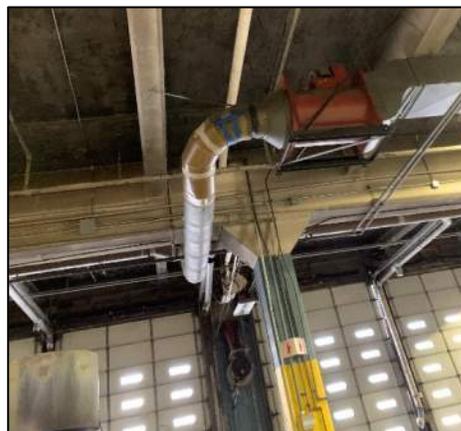
Figure 30: Garage Exhaust Fan

The garage has motor-driven exhaust fans that have some branch ducting. It appears the branch ducting was intended for localized exhaust, but the flexible ducting used for this purpose is not in place. It is unclear how the exhaust fans are controlled as there are no visible CO or NO2 controls that are typically in place and are mandated by current building codes. It is unclear how many exhaust fans are operational.

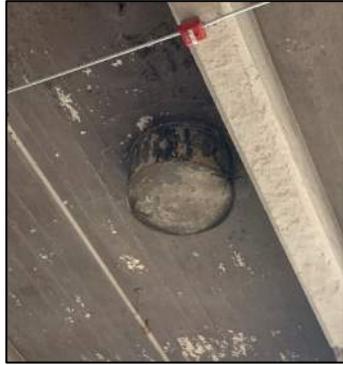
Figure 31: Garage Exhaust Duct Closed

The garage also has exhaust ducts with dampers that lead to the roof. Some dampers are open, and some aren't. Some have strings tied to the damper levers. The mechanical exhaust fans were fitted to several of these ducts.

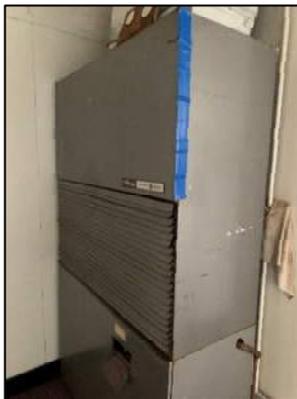
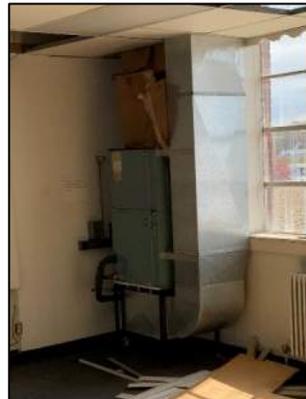
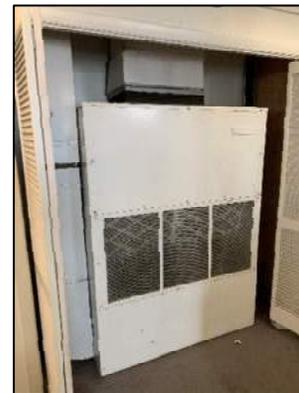
abandoned indoor unit as well, but it's difficult to determine which indoor unit is abandoned as none of the units appeared operational. Variable air volume boxes were not observed, though most of the drop ceiling was in place, obscuring views. The systems are most likely constant air-volume systems controlled by a single thermostat. Ventilation air was provided through mechanical means, but the windows are operable, meaning natural ventilation could be possible through this.

Figure 37: Indoor Evaporator

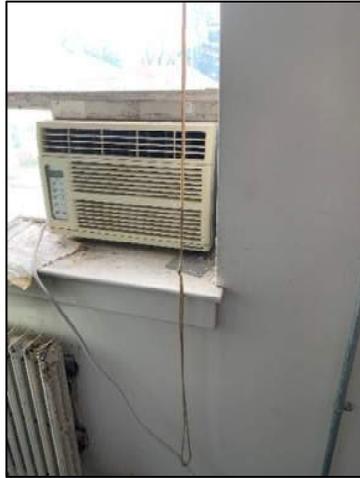
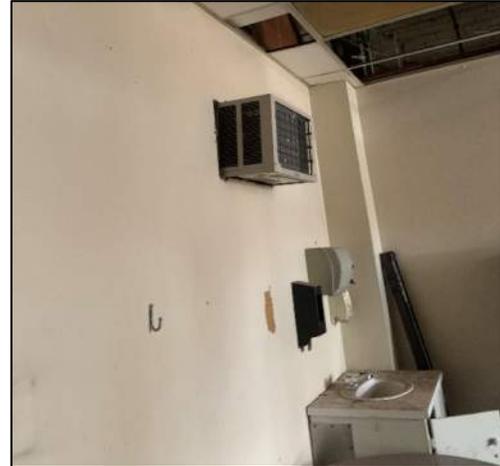
In addition, there are several window units located throughout the building that provide some spot cooling.

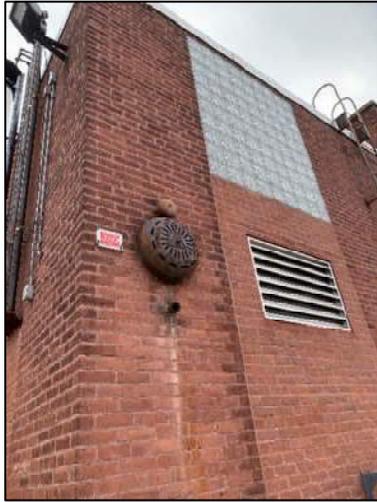
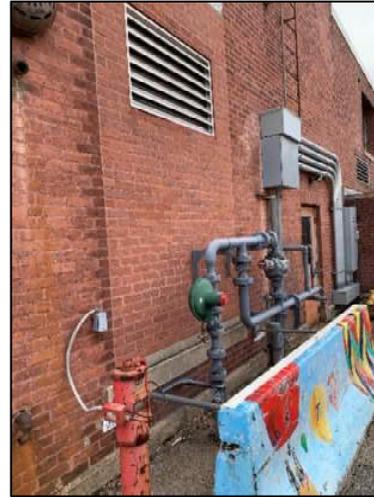
The sprinkler service enters the West side of the building into the Boiler Room. The main service is marked with a Post Indicator Valve (PIV). There is no Fire Department Connection, but there is an exterior bell.

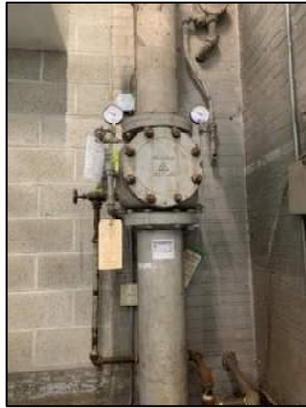
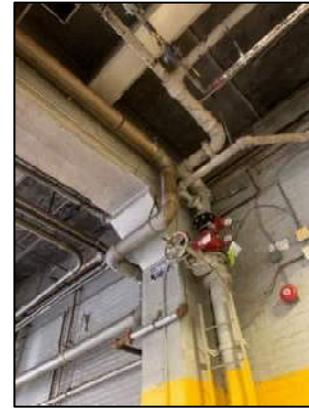
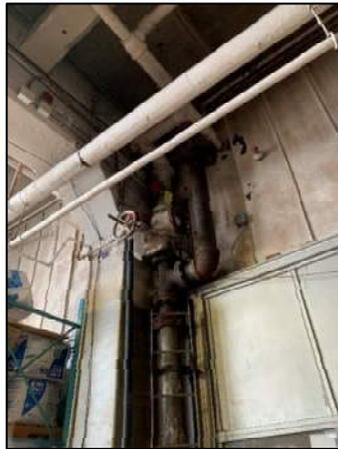
The Risers for the zones appear rather new. There are new flow switches and tamper switches in place. The riser check assemblies appear in good condition. There is an abandoned riser that previously served the air handler houses on the roof.

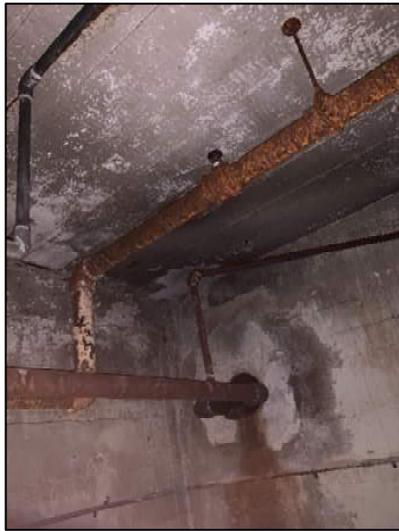
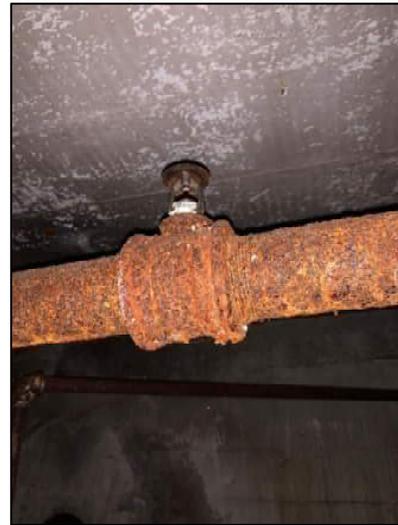
According to the maintenance team, sprinklers and branch piping have been replaced piecemeal. There are still very old sprinklers, which would require testing per NFPA 25 Table 5.1.1.2 to remain in use. Upright sprinklers are used in exposed areas. The piping is steel, which is in fair condition. The paint is gone for sprinkler piping in the basement and a good bit of corrosion is present.

Figure 48: Rusted Fire Sprinkler Line, Basement

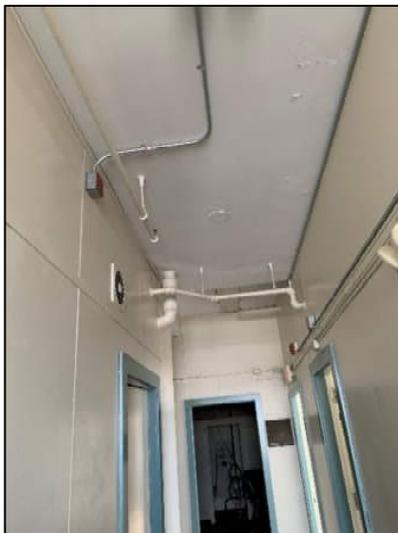
Figure 50: Sprinklered Corridor, Office Area

The office portion is not fully sprinklered. Sprinklers are present in the lobby and the corridor, but the offices, including a file storage area, do not have sprinklers.

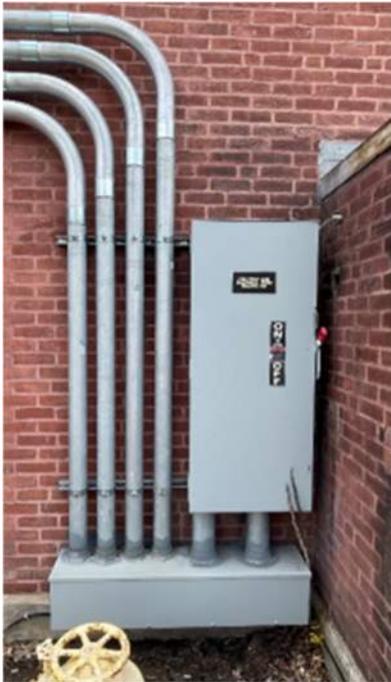
Figure 1: Main Service Disconnect

An existing 600V service was removed and replaced with a 600A, 480V service installed approximately 3-4 years ago. The service is fed from the main electrical room located in the building next door (269 Melrose) and enters a main disconnect located on the exterior (West side of the building) (*Figure 1*). Conduits enter building through boiler room and run to distribution panel on second floor mezzanine. The main objective of the new service was to feed new electrical vehicle charging stations and refeed existing Electrical distribution that was to remain. The new 480V, Main Distribution Panel ‘DP’ feeds an existing 600V elevator through a 30kVA step-up dry-type transformer. Additionally, Panel ‘DP’ (*Figure 2*) feeds a 120/208V Panelboard ‘LP8’ through a 75kVA step-down dry-type transformer. There was no access to Panel ‘LP8’, but it appears to feed the existing 120/208V panels throughout the building. Many older panelboards are deteriorating and/or are damaged (*Figure 3*) and several pieces of electrical equipment are longer in use and have been abandoned in place (*Figure 4*).

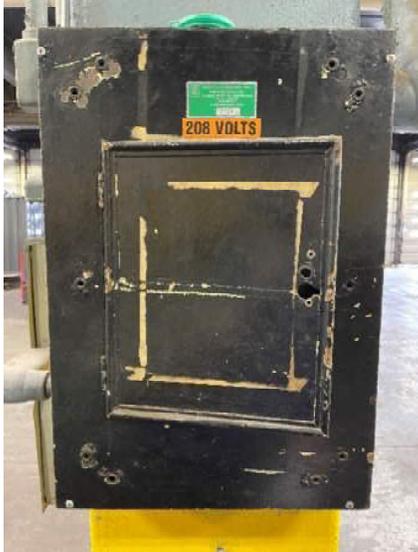
Figure 3: Deteriorating/Damaged Panelboard

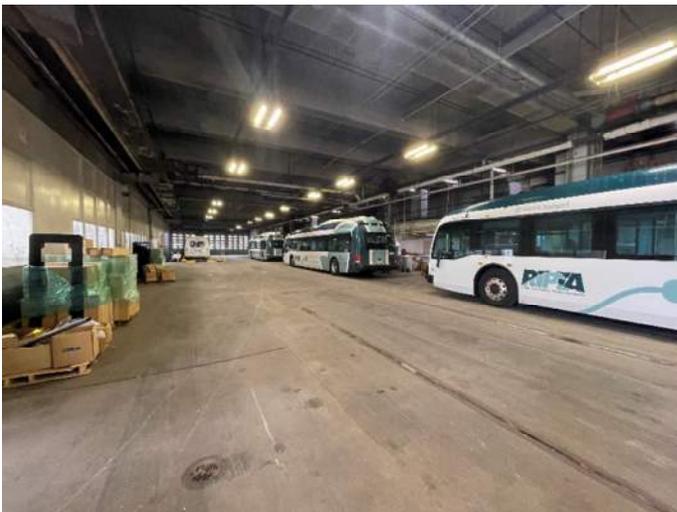
Figure 1: LED High-bay fixtures

LED high-bay fixtures with integral occupancy sensors (*Figure 1*) are installed throughout the first-floor garage space. Smaller storage spaces consist of linear LED fixtures with ceiling mounted occupancy sensors (*Figure 2*) in combination with toggle switches. All exit signs throughout the space are illuminated and appear to be completely operational.

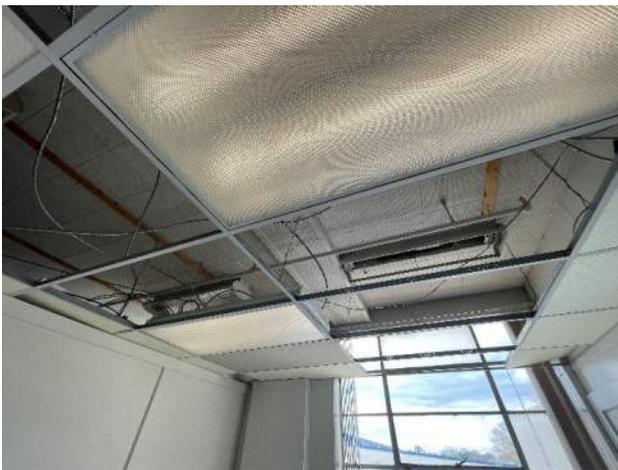
Storage/office spaces consist of fluorescent 2’X2’ and 2’X4’ troffer fixtures controlled by wall switch occupancy sensors (Figure 4). Some fixtures and controls are still operational, but the remaining system no longer in working condition. Older fixtures, before office fit-out were left abandoned in place above suspended ceiling (Figure 3). Some exit signs throughout the space were no longer illuminated (Figure 5) and are no longer operational. Emergency battery units (Figure 6) were observed throughout the space and appear to be operational, but are beyond their expected useful life.

Figure 3: Existing and abandoned fluorescent fixtures

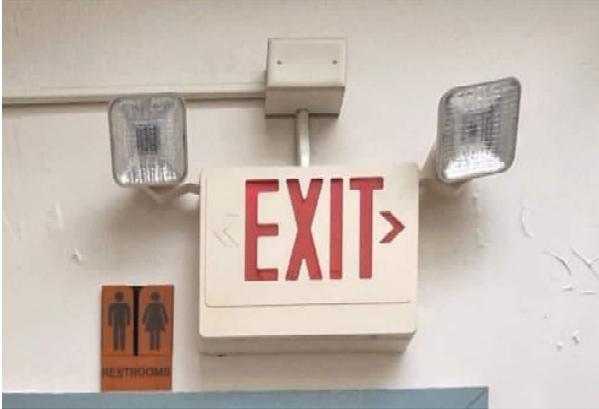
Figure 5: Unilluminated Exit sign

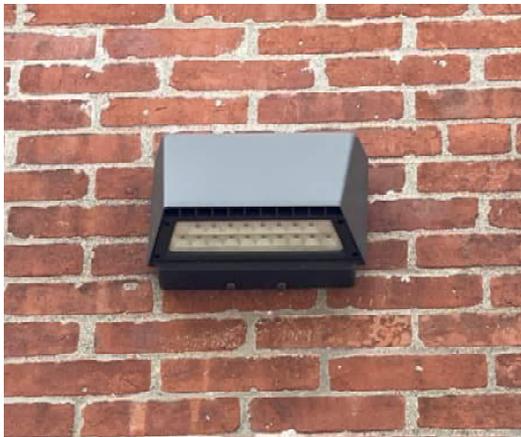
Figure 7: Exterior Wall packs

Approximately 15 wall packs (Figure 7) along perimeter of building. Emergency remote heads (Figure 8) are located above doors for emergency egress lighting.

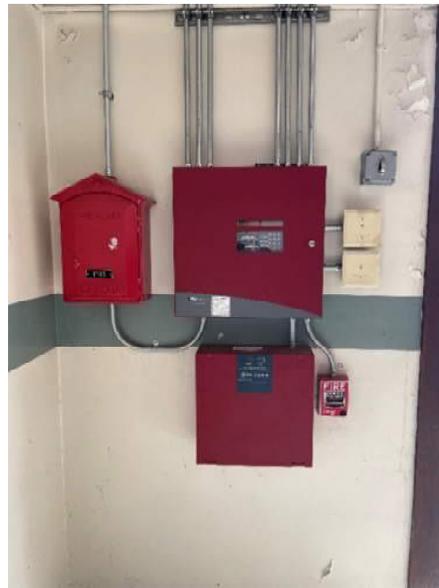
Figure 52: Fire Alarm System

Fire alarm system (*Figure 1*) consists of an addressable Fire Alarm Control Panel, battery cabinet, and devices manufactured by Honeywell. Connection to local fire department is through a Gamewell Master Box. Fire Alarm system and associated devices and wiring appear to be in working condition, however they are approaching their expected useful life based on industry standards. The system was last inspected 3-2-22.

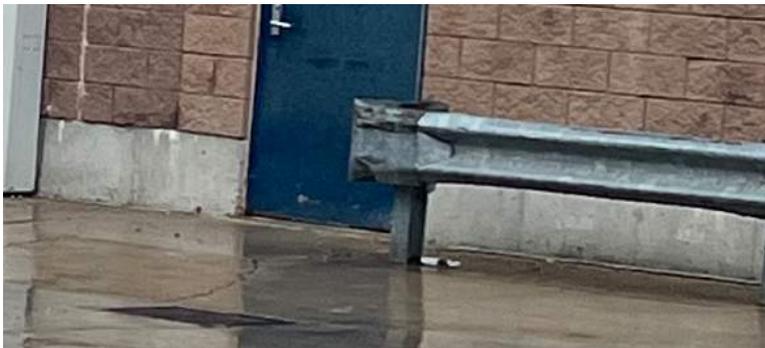
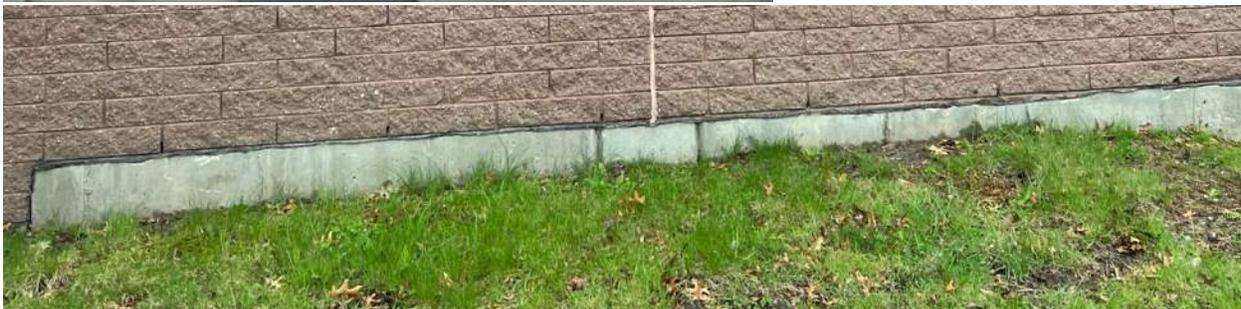
B. Coding / Field Name	Asset Description
System Name	Foundations
Condition	4
Quantity	~1,801 linear ft. at varying depths (accounted for in unit cost)
Unit Cost	Total: \$369,775.20
Year in Service	1990
Expected Useful Life	100 years
Remaining Useful Life	90 years, Estimated, Based on Date of Observation
Location	Substructure
Basis of Costing	Square Foot Costs with RSMeans Data 2022 – 43 rd Edition

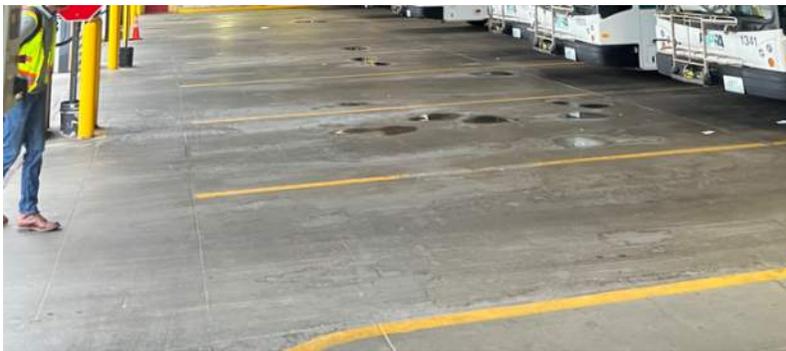
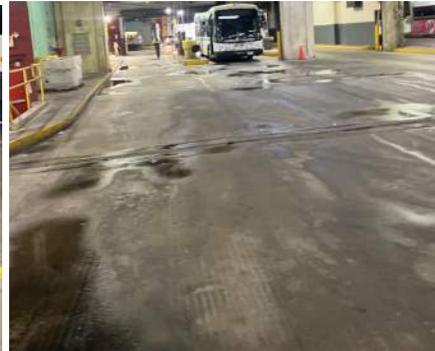
Coding / Field Name	Asset Description
System Name	Slabs on grade
Condition	4
Quantity	~94,402 sq. ft.
Unit Cost	Total: \$1,889,928.04
Year in Service	1990
Expected Useful Life	100 years
Remaining Useful Life	90 years, Estimated, Based on Date of Observation
Location	Substructure
Basis of Costing	Square Foot Costs with RSMeans Data 2022 – 43 rd Edition
