Transit Asset Management Plan

October 1, 2022 – September 30, 2026

RHODE ISLAND PUBLIC TRANSIT AUTHORITY

FINAL ASSESSMENT REPORT
August, 2022

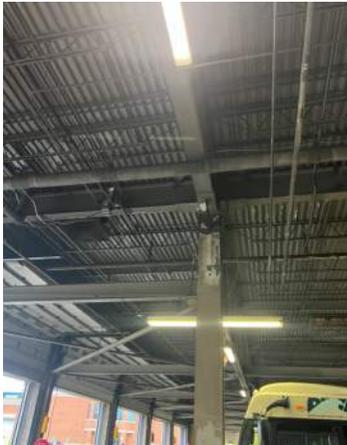
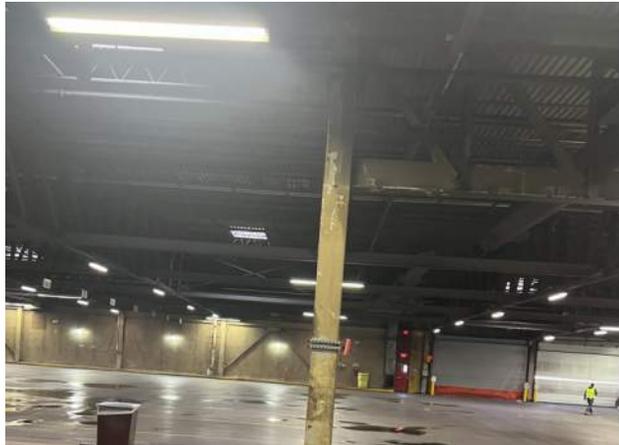
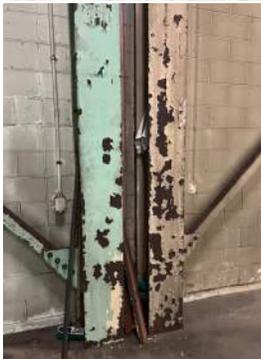
Coding / Field Name	Asset Description
System Name	Steel superstructure and metal roof decking.
Condition	4
Quantity	~94,402 sq. ft.
Unit Cost	Total: \$1,273,348.83
Year in Service	1990
Expected Useful Life	100 Years
Remaining Useful Life	80 years, Estimated, Based on Date of Observation
Location	Building structure
Basis of Costing	Square Foot Costs with RSMeans Data 2022 – 43 rd Edition

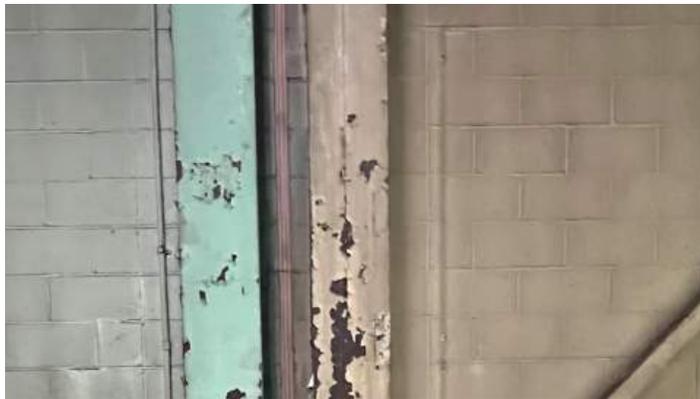
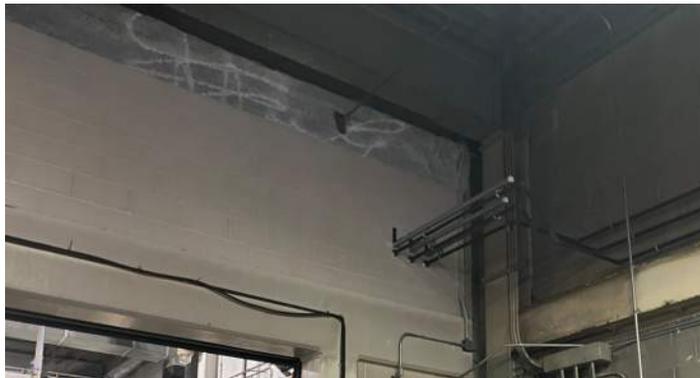
Coding / Field Name	Asset Description
System Name	CMU Walls
Condition	4
Quantity	~27,015 sq. ft.
Unit Cost	Total: \$564,613.50
Year in Service	1990
Expected Useful Life	100 years
Remaining Useful Life	90 years, Estimated, Based on Date of Observation
Location	Building exterior / interior walls
Basis of Costing	Square Foot Costs with RSMeans Data 2022 – 43 rd Edition

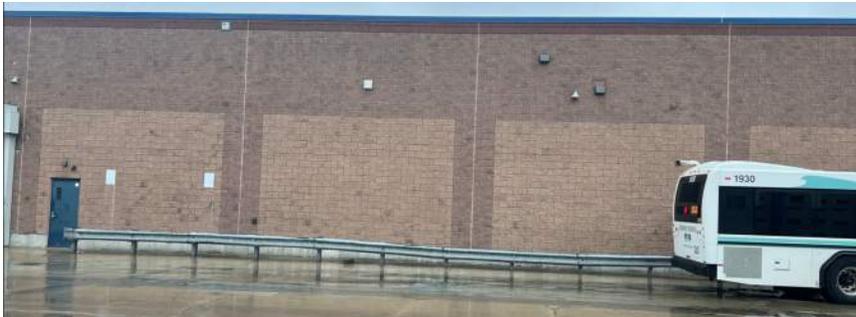
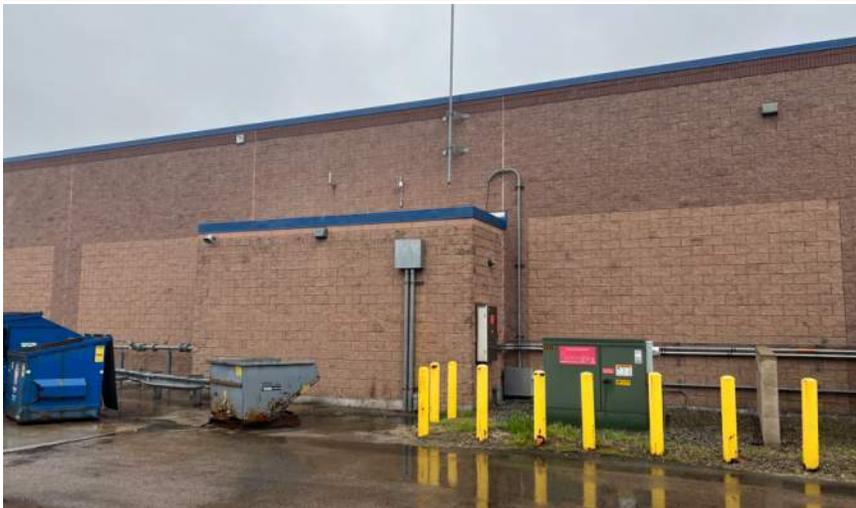
Coding / Field Name	Asset Description
System Name	Exterior split-face CMU
Condition	4
Quantity	~25,000 sq. ft.
Unit Cost	Total: \$520,000
Year in Service	1990
Expected Useful Life	100 years
Remaining Useful Life	90 years, Estimated, Based on Date of Observation
Location	Exterior walls
Basis of Costing	Square Foot Costs with RSMMeans Data 2022 – 43 rd Edition

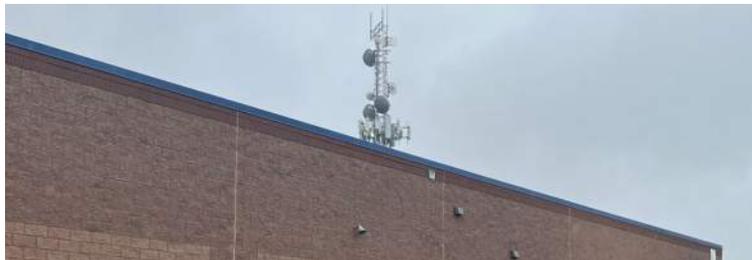
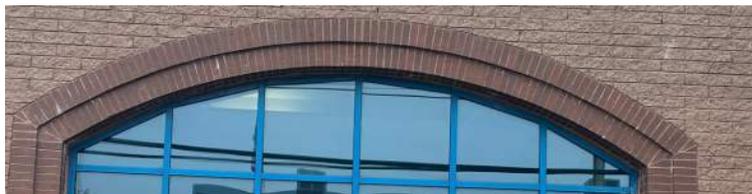
Coding / Field Name	Asset Description
System Name	Exterior brick
Condition	4
Quantity	~3,176.66 sq. ft.
Unit Cost	Total: \$91,487.81
Year in Service	1990
Expected Useful Life	100 years
Remaining Useful Life	90 years, Estimated, Based on Date of Observation
Location	Exterior
Basis of Costing	Square Foot Costs with RSMeans Data 2022 – 43 rd Edition

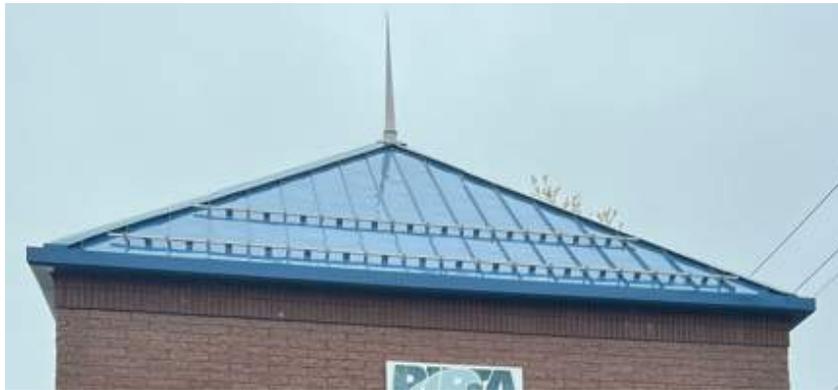
Coding / Field Name	Asset Description
System Name	Standing seam metal roof
Condition	4
Quantity	~715.56 sq. ft.
Unit Cost	Total: \$17,261.32
Year in Service	1990
Expected Useful Life	80 years
Remaining Useful Life	65 years, Estimated, Based on Date of Observation
Location	Entry roof
Basis of Costing	Square Foot Costs with RSMeans Data 2022 – 43 rd Edition

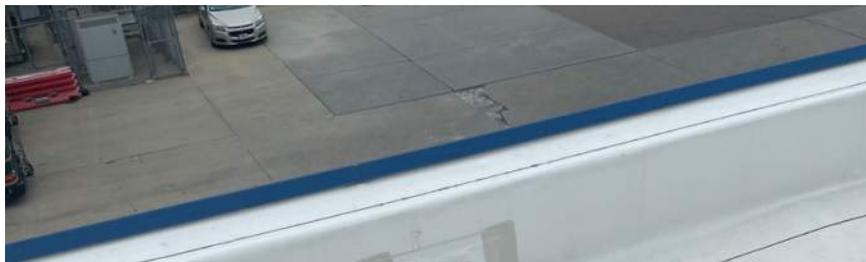
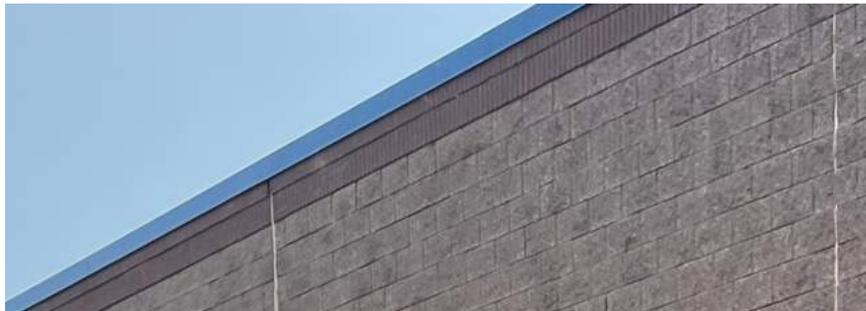
Coding / Field Name	Asset Description
System Name	Metal roof coping
Condition	4
Quantity	~1,538.33 linear ft.
Unit Cost	Total: \$45,073.06
Year in Service	1990
Expected Useful Life	80 years
Remaining Useful Life	65 years, Estimated, Based on Date of Observation
Location	Building roof edge
Basis of Costing	Square Foot Costs with RSMeans Data 2022 – 43 rd Edition

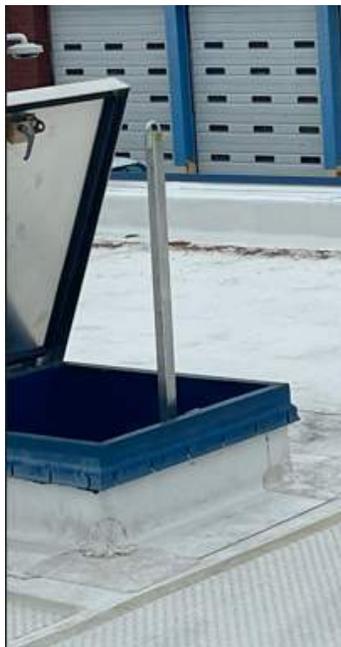
Coding / Field Name	Asset Description
System Name	Roof hatch
Condition	4
Quantity	1
Unit Cost	Total: \$3,085
Year in Service	1990
Expected Useful Life	50 years
Remaining Useful Life	35 years, Estimated, Based on Date of Observation
Location	Flat roof
Basis of Costing	Square Foot Costs with RSMMeans Data 2022 – 43 rd Edition

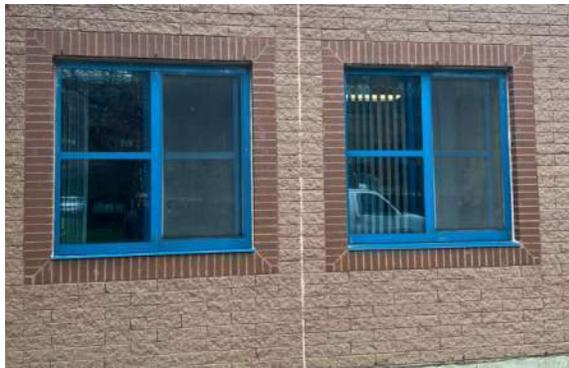
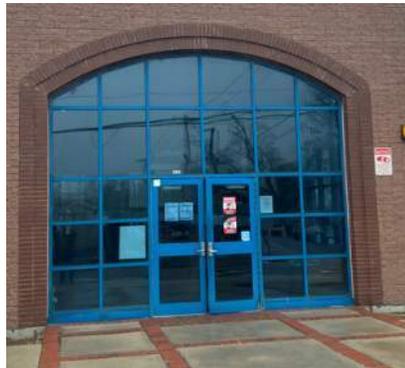
Coding / Field Name	Asset Description
System Name	Glazed aluminum curtainwall system
Condition	4
Quantity	~1,056.5 sq. ft.
Unit Cost	Total: \$29,772.88
Year in Service	1990
Expected Useful Life	70 years
Remaining Useful Life	60 years, Estimated, Based on Date of Observation
Location	Building exterior
Basis of Costing	Square Foot Costs with RSMMeans Data 2022 – 43 rd Edition

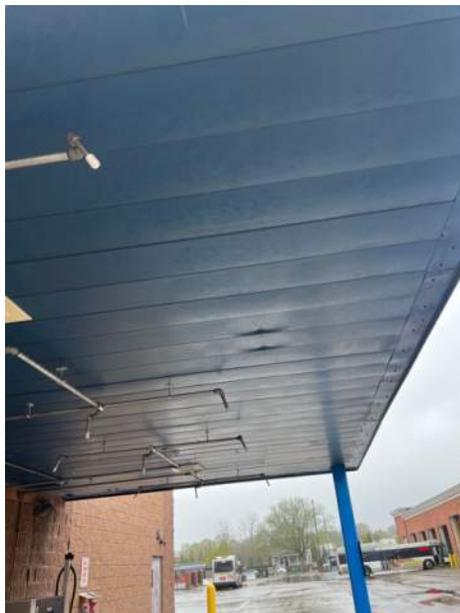
Coding / Field Name	Asset Description
System Name	Exterior metal ceilings
Condition	4
Quantity	~876 sq. ft.
Unit Cost	Total: \$4,598
Year in Service	1990
Expected Useful Life	50 years
Remaining Useful Life	35 years, Estimated, Based on Date of Observation
Location	Building exterior
Basis of Costing	Square Foot Costs with RSMMeans Data 2022 – 43 rd Edition

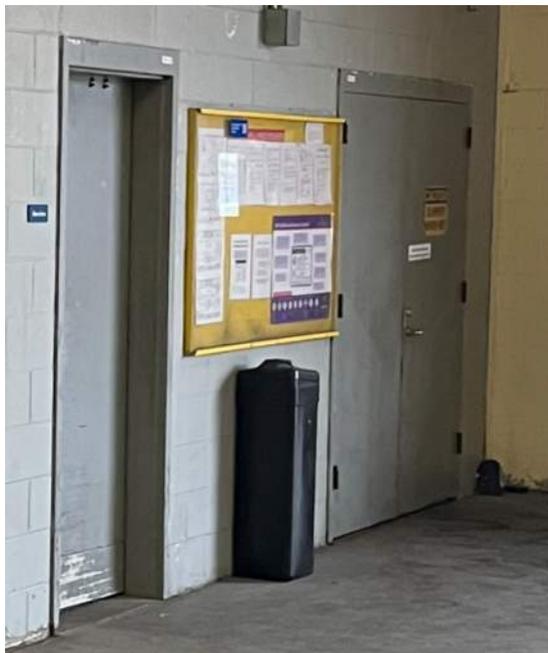
Coding / Field Name	Asset Description
System Name	Interior hm doors and frames
Condition	4
Quantity	20
Unit Cost	Total: \$29,280
Year in Service	1990
Expected Useful Life	40 years
Remaining Useful Life	25 years, Estimated, Based on Date of Observation
Location	Building interior
Basis of Costing	Square Foot Costs with RSMMeans Data 2022 – 43 rd Edition

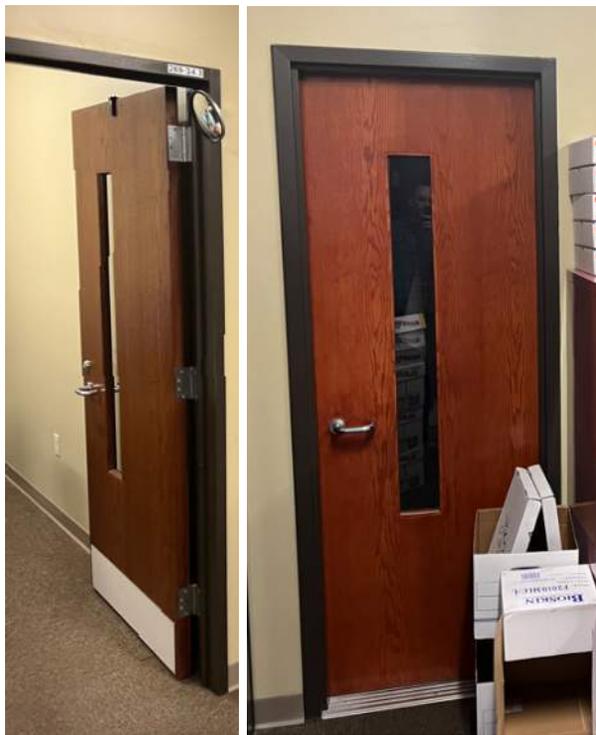
Coding / Field Name	Asset Description
System Name	Interior wood doors and frames
Condition	4
Quantity	30
Unit Cost	Total: \$39,303
Year in Service	1990
Expected Useful Life	40 years
Remaining Useful Life	35 years, Estimated, Based on Date of Observation
Location	Building interior
Basis of Costing	Square Foot Costs with RSMMeans Data 2022 – 43 rd Edition

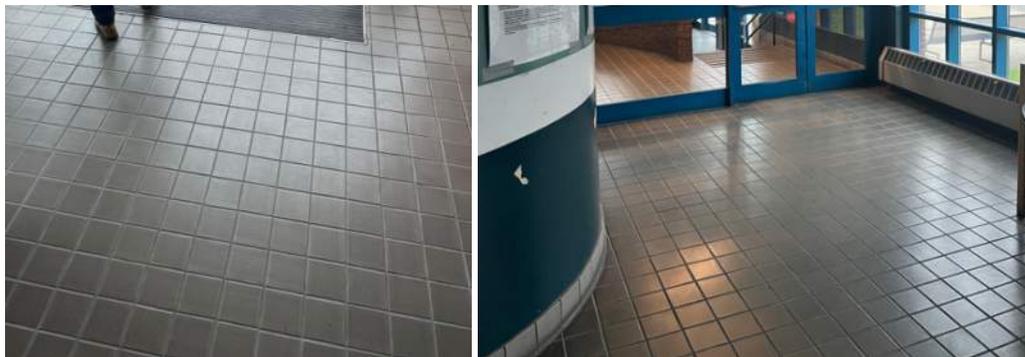
Coding / Field Name	Asset Description
System Name	Ceramic tile flooring and base
Condition	4
Quantity	~1,680 sq. ft.
Unit Cost	Total: \$22,870.18
Year in Service	1990
Expected Useful Life	75 years
Remaining Useful Life	65 years, Estimated, Based on Date of Observation
Location	Building interior
Basis of Costing	Square Foot Costs with RSMeans Data 2022 – 43 rd Edition

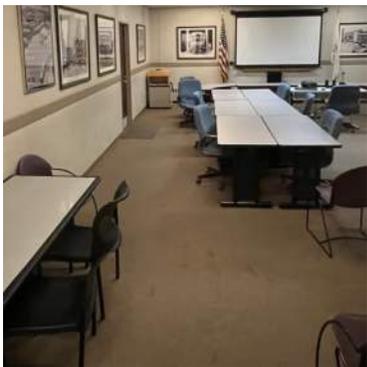
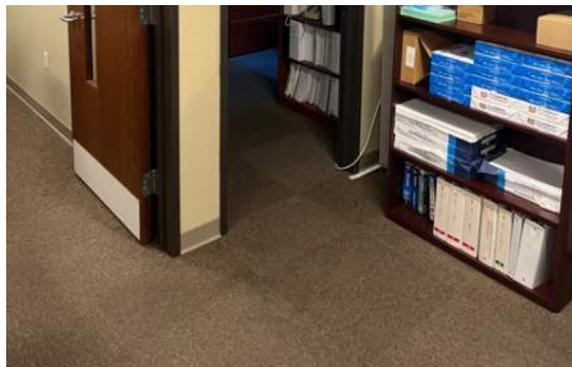
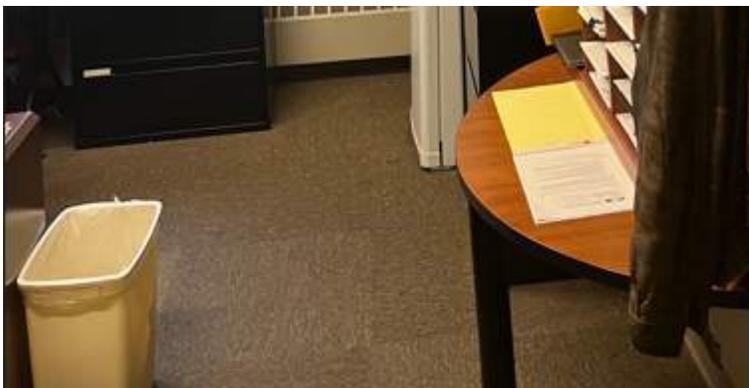
Coding / Field Name	Asset Description
System Name	Carpet tile flooring and base
Condition	3
Quantity	~2,360 sq. ft.
Unit Cost	Total: \$13,168.80
Year in Service	1990
Expected Useful Life	20 years
Remaining Useful Life	10 years, Estimated, Based on Date of Observation
Location	Building interior
Basis of Costing	Square Foot Costs with RSMeans Data 2022 – 43 rd Edition

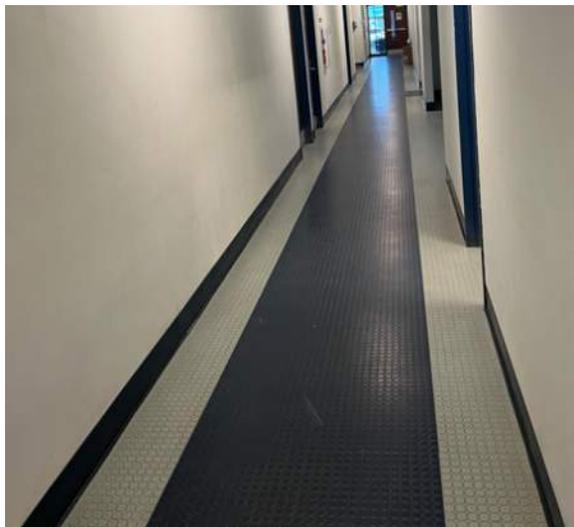
Coding / Field Name	Asset Description
System Name	Rubber flooring and base
Condition	4
Quantity	~4,480 sq. ft.
Unit Cost	Total: \$38,080
Year in Service	1990
Expected Useful Life	75 years
Remaining Useful Life	65 years, Estimated, Based on Date of Observation
Location	Building interior
Basis of Costing	Square Foot Costs with RSMeans Data 2022 – 43 rd Edition

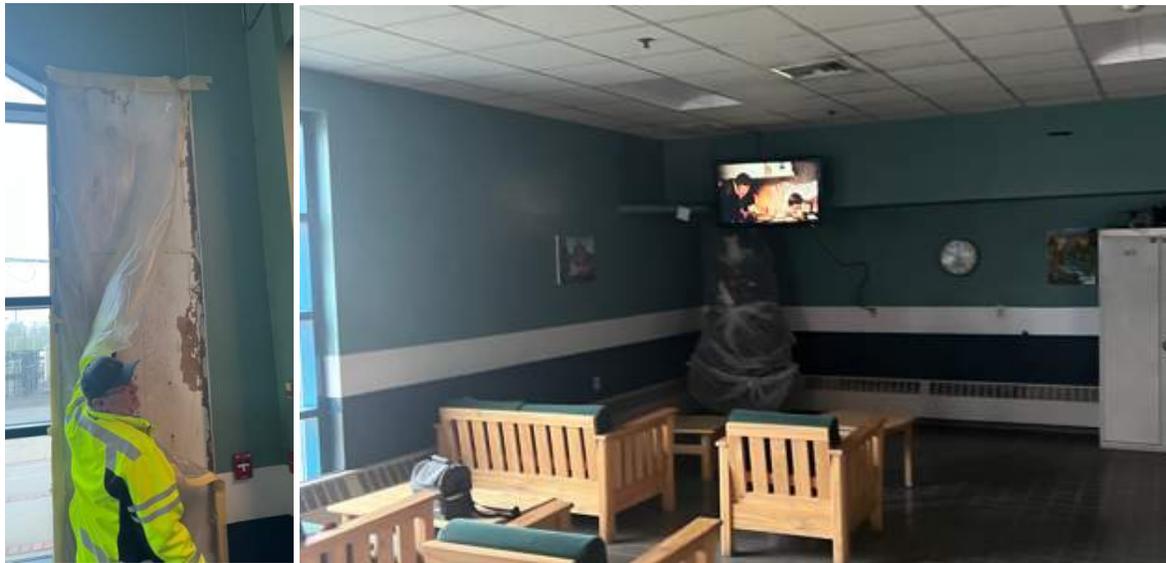
Coding / Field Name	Asset Description
System Name	Interior drywall partitions
Condition	3
Quantity	~13,320 sq. ft.
Unit Cost	Total: \$64,496
Year in Service	1990
Expected Useful Life	60 years
Remaining Useful Life	30 years, Estimated, Based on Date of Observation
Location	Building interior
Basis of Costing	Square Foot Costs with RSMeans Data 2022 – 43 rd Edition

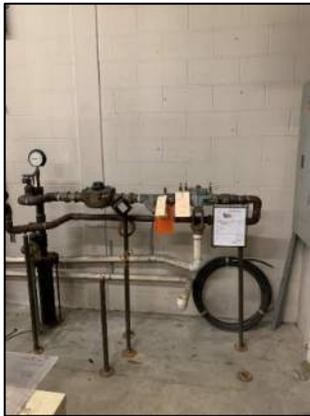
Figure 1: Domestic Water Service

The domestic water service is in the boiler room. The domestic water service lateral is 4". The domestic water meter, the reduced-pressure zone backflow preventer, and valving is 2". No pressure boosting pumps are present. The domestic water piping is done with copper. Most fittings are soldered, but there are press fittings used in places where recent repairs or additions were performed. Insulation is present on hot and cold-water piping.

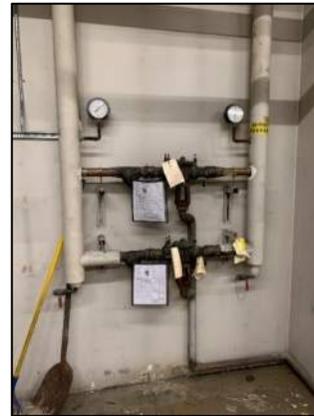
Figure 2: Non-Potable Water Backflow Preventers

A separate set of reduced-pressure zone backflow preventers are located on a branch from the main service. This branch is labelled "nonpotable water" and is routed to the garage for the Bus Wash.

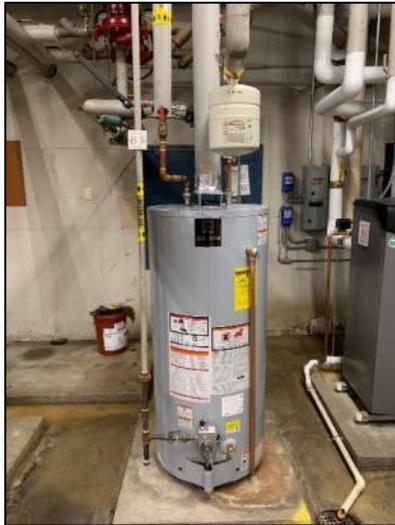
Figure 4: Gas-Fired Water Heater for Office Area

A 55-gallon, 60,000 BTU/hr water heater located in the boiler room provides hot water to the office area. A small, tank electric water heater in a janitor’s closet provides hot water for the needs for the garage.

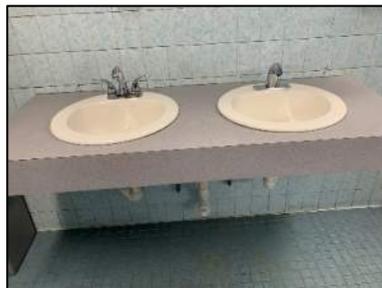
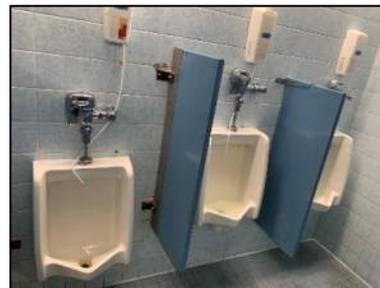
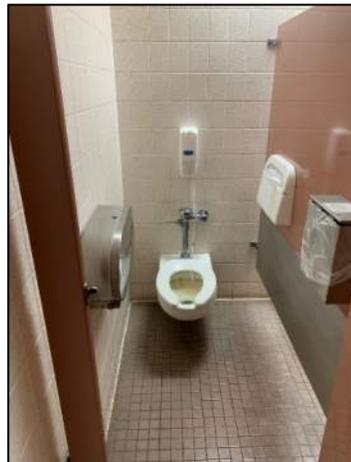
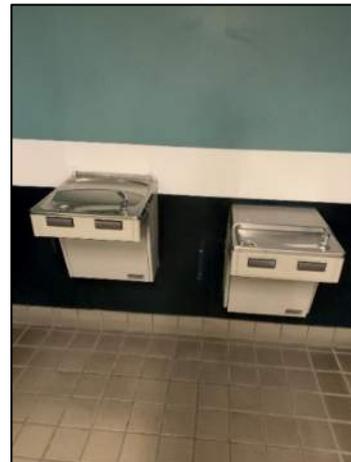
Most of the fixtures in the facility appear in good, working order. The fixtures are a variety of makes of touchless and manual controls due to repairs over the years.

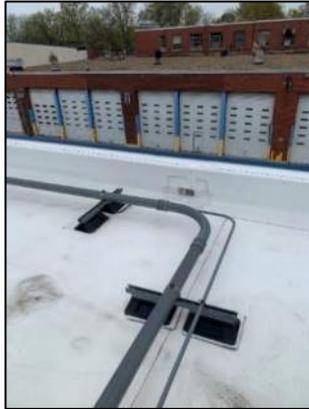
The storm drainage piping appeared to be original to the building and appeared in working order. Most piping was no-hub cast iron. The drains on the roof are original. There was some secondary drainage added recently, and the drains appear rather high. In addition, some scuppers are present.

Figure 10: Scupper for Secondary Drainage

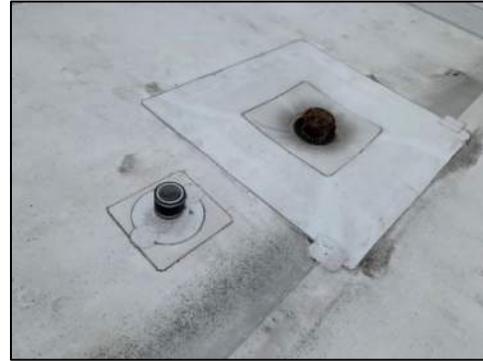
Figure 11: Added Secondary Drain Next to a Primary Drain

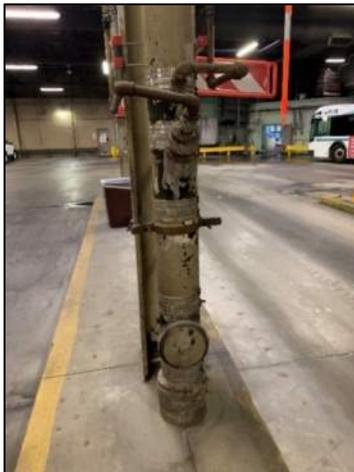
Figure 12: Storm Leader

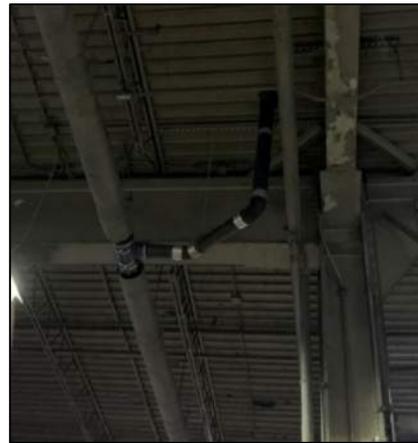
Figure 13: New Piping for Secondary Drainage

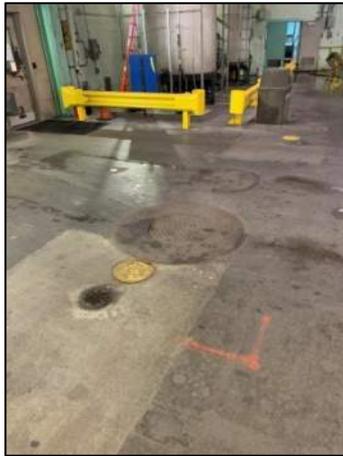
The sanitary piping is no-hub cast iron. Qty (2) Oil water separators are in the garage near the bus wash. One separator handles the drainage from the trench drains from the floor, and the other separator handles drainage from the water reclamation room.

Figure 14: Oil Interceptors in Garage

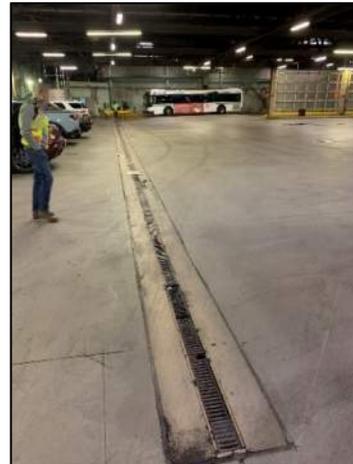
Figure 15: Trench Drain in Garage

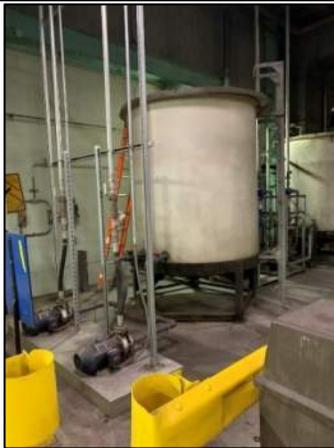
Figure 16: Bus Wash Reclamation System

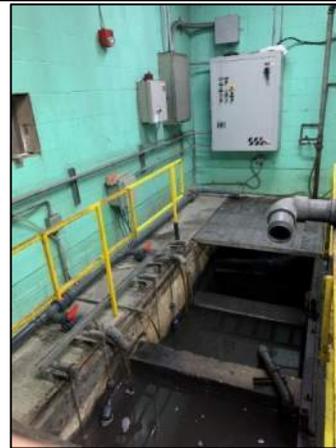
Figure 17: Bus Wash Water Reclamation Pit

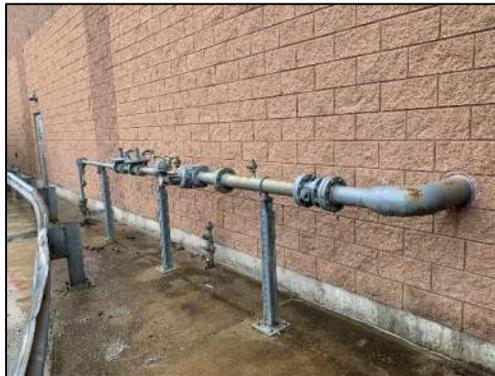
The building is served by a natural-gas system on the North side of the facility. The incoming service is ~2” and increases to ~6” after the regulators. A few items requiring gas are the boiler, the domestic water heater, and the MAUs in the garage. The service meter has a capacity of 7,000 CFH. The piping is schedule 40 steel with welded and threaded fittings.

Figure 18: Natural Gas Service

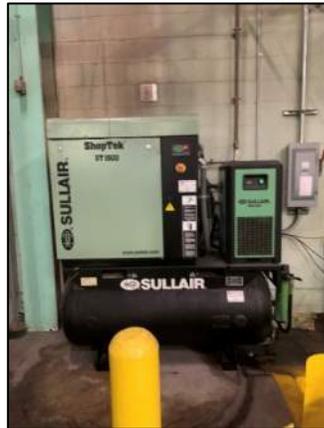
includes an air compressor, a filter/dryer, and a storage tank. The compressed air is routed to drops and cord reels. The compressed air used for hand tools and the air-operated diaphragm pumps pumping automotive fluids.

Figure 19: Compressed Air System

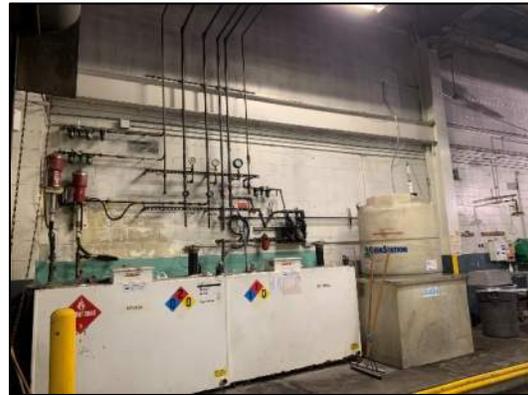
Figure 20: Lube System with Air-Operated Diaphragm Pumps

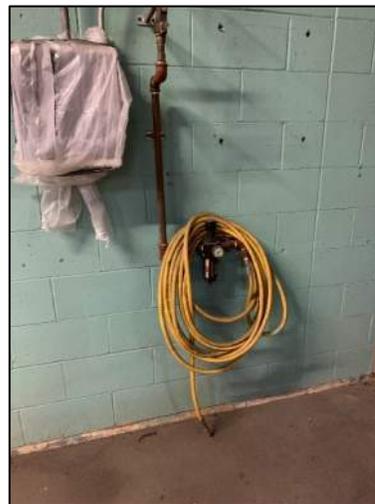
Figure 21: Compressed Air Drop

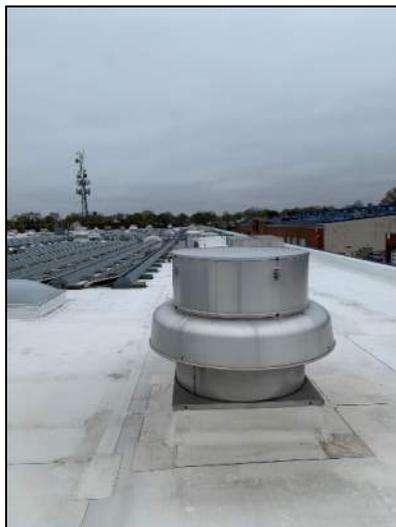
The garage is equipped with centrifugal down-blast exhaust fans and mechanically operated dampers.

Figure 36: Centrifugal Down-blast Exhaust Fan

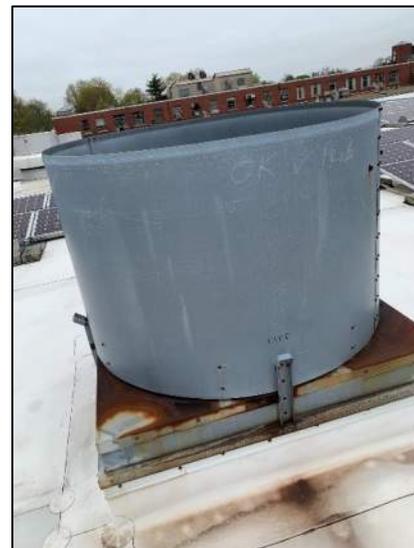
Figure 37: Exhaust Damper

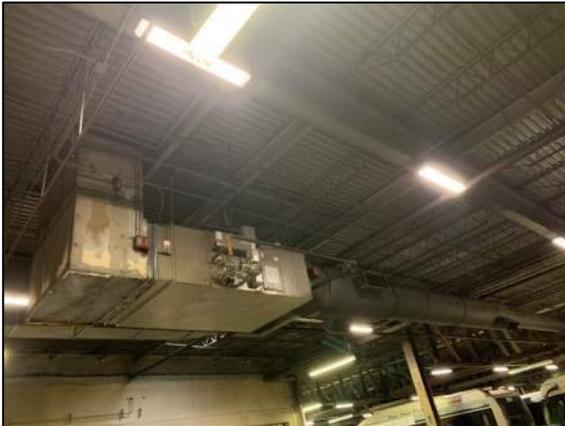
The garage is equipped with Qty (8) Make-up Air Units. The MAUs have gas-fired coils to provide tempered air to replace the air exhausted from the various exhaust fans. The MAUs are hung from the ceiling at locations on the perimeter of the garage area. These units are ducted across the garage and to various rooms along the perimeter. The exhaust fans and MAUs are controlled with CO₂ and NO₂ gas-monitoring systems. The maintenance team mentioned the gas burners in the MAUs were prone to clogging, which they believe is due to the various fumes from the buses. To remedy this, the burners were having to be redrilled due to the hardness of the buildup on the burners. The MAUs were installed within the last 10 years, but they have aged worse than MAUs in similar facilities, according to the maintenance team.

Figure 38: Makeup Air Unit and ducting

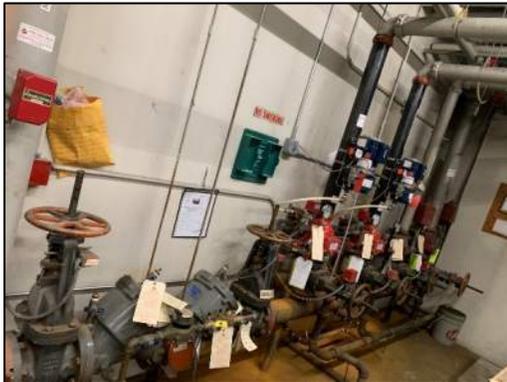
The fire sprinkler system is composed of wet-pipe and dry-pipe risers. The main service is a central system located in the boiler room. An 8” service lateral immediately reduces to 6” inside the building. The Double-Check Valve assembly is 6”, and it includes a bypass meter. The system has Qty (4) risers: Qty (2) wet-pie and Qty (2) dry-pipe risers. A Fire Department Connection is located on the North side of the facility where the 8” service lateral enters.

Figure 42: Fire Protection Service

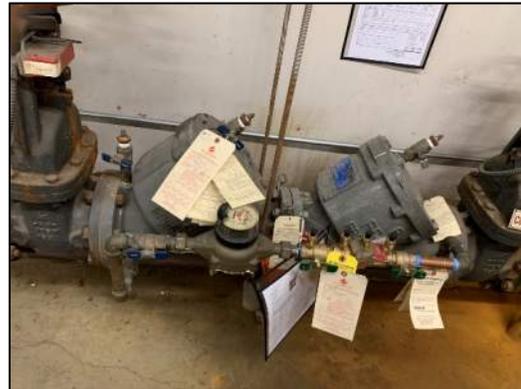
Figure 43: Double-Check Valve Assembly

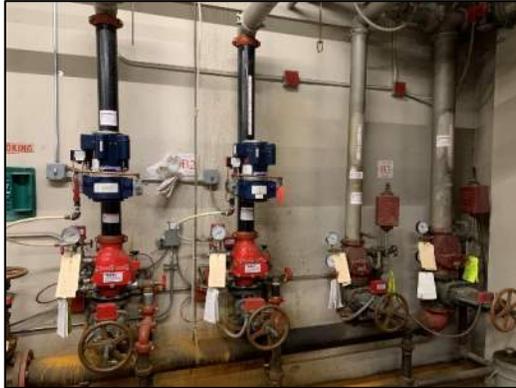
The riser check valve assemblies for the wet zones appear original to the building. The riser check valve assemblies for the dry zones appear to be recently installed. The dry-system air compressors are both single-phase, riser-mounted air compressors with a 1 HP motor. There are new flow switches and tamper switches in place.

Figure 44: Risers Off of Fire Service Mains

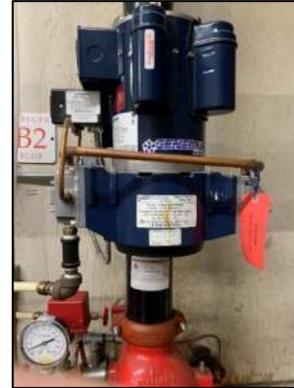
Figure 45: Riser-Mounted Air Compressor

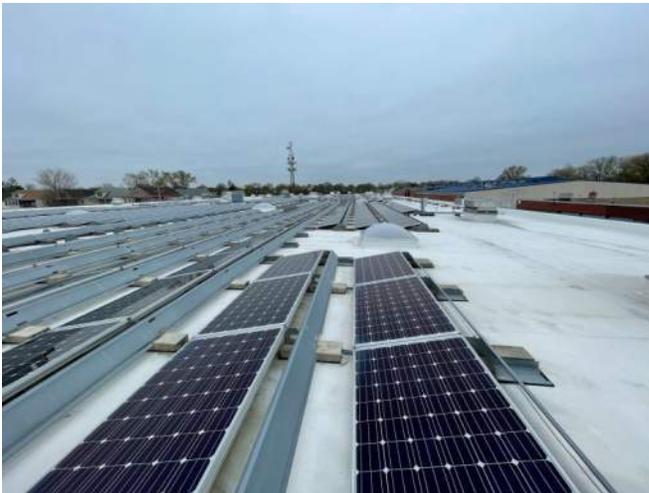
Figure 1: PV Solar System

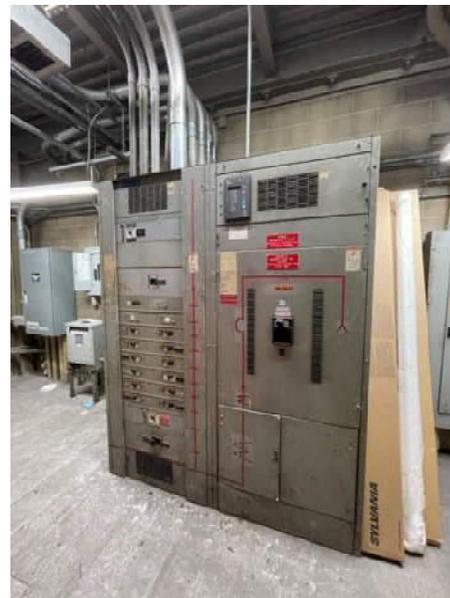
Figure 2: Switchboard (277/480V)

A 1,600A, 480V service installed approximately 33 years ago. The service is fed from the pad mounted transformer (North side of the building) (*Figure 4*) and enters the main switchboard (*Figure 2*) located in the Electrical Alcove. There is a PV Solar system (*Figure 1*) on the roof installed approximately 10 years ago. Maintenance mentioned shorting issues due to screws penetrating conduit when insulation was installed. Building has two backup generators. Many older panelboards are deteriorating and/or are damaged. Some panelboard covers are not secure and/or circuit breaker covers are missing leaving exposed live wires (*Figure 3*).

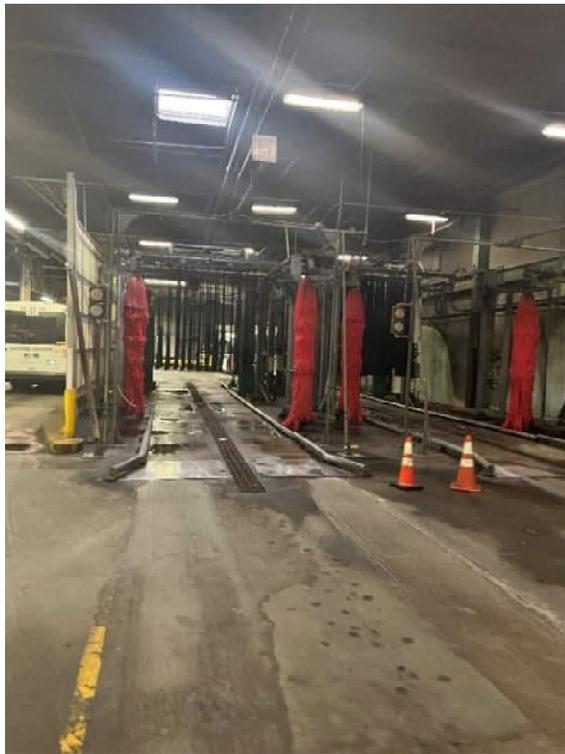
Coding / Field Name	Asset Description
System Name	Bus Wash
Condition	2
Quantity	2
Unit Cost	Total: \$99,172
Year in Service	1993
Expected Useful Life	25 years
Remaining Useful Life	4 years, Estimated, Based on Date of Observation
Location	Building exterior.
Basis of Costing	Square Foot Costs with RSMeans Data 2022 – 43 rd Edition

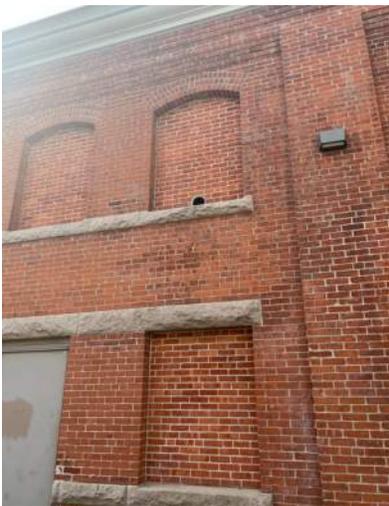
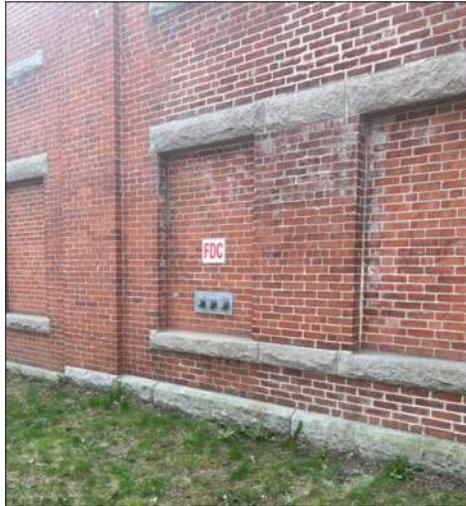
Coding / Field Name	Asset Description
System Name	Exterior brick (West elevation – original facade)
Condition	3
Quantity	~9,230 sq. ft.
Unit Cost	Total: \$265,824
Year in Service	N/A
Expected Useful Life	100 years
Remaining Useful Life	60 years, Estimated, Based on Date of Observation
Location	Exterior walls – West Elevation
Basis of Costing	Square Foot Costs with RSMMeans Data 2022 – 43 rd Edition

No insulation on existing wall. Some cracks, pitting, and efflorescence staining observed.

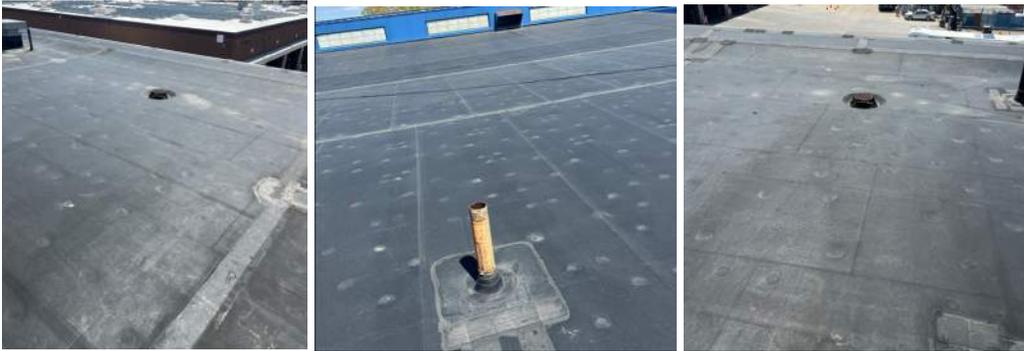
Coding / Field Name	Asset Description
System Name	Membrane roofing + rigid insulation
Condition	2
Quantity	~22,390 sq. ft.
Unit Cost	Total: \$170,691
Year in Service	2020
Expected Useful Life	40 years
Remaining Useful Life	10 years, Estimated, Based on Date of Observation
Location	Flat Roofs
Basis of Costing	Square Foot Costs with RSMeans Data 2022 – 43 rd Edition

Roof over compressor room leaking because EPDM roofing nails. Flat roof was just done.

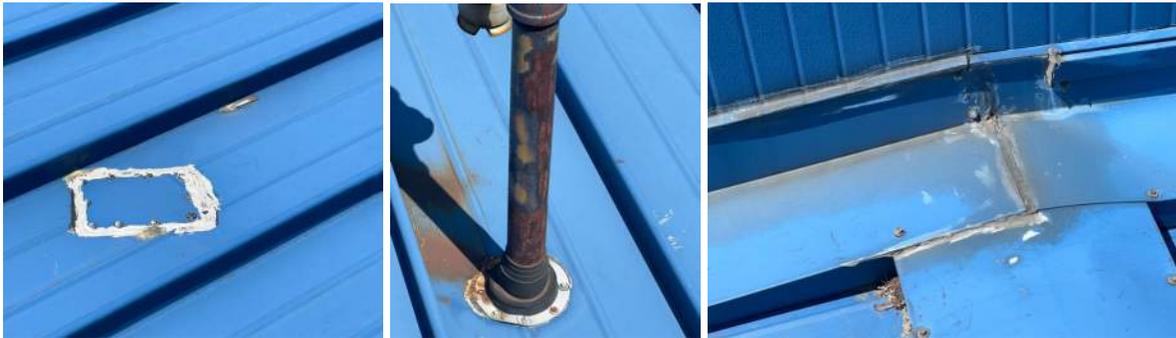
Coding / Field Name	Asset Description
System Name	Standing seam metal roof
Condition	3
Quantity	~72,370 sq. ft.
Unit Cost	Total: \$551,715.40
Year in Service	2000
Expected Useful Life	80 years
Remaining Useful Life	50 years, Estimated, Based on Date of Observation
Location	Sloped roofs
Basis of Costing	Square Foot Costs with RSMeans Data 2022 – 43 rd Edition

Rust / staining from roof elements. Sealants / joinery issues.

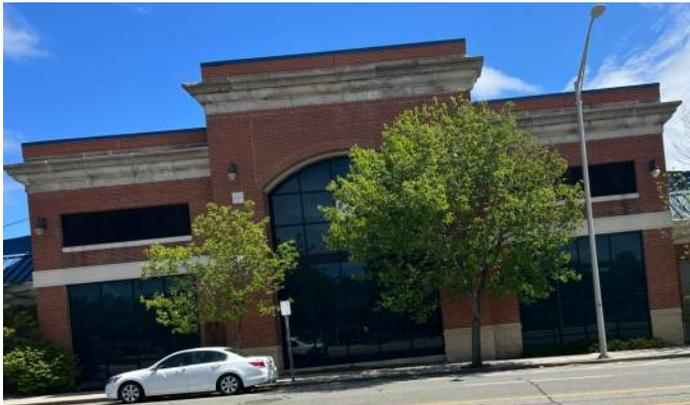
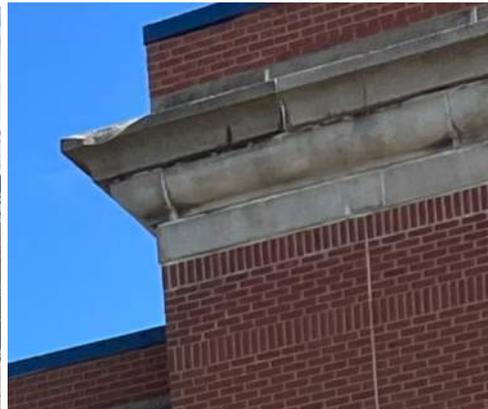
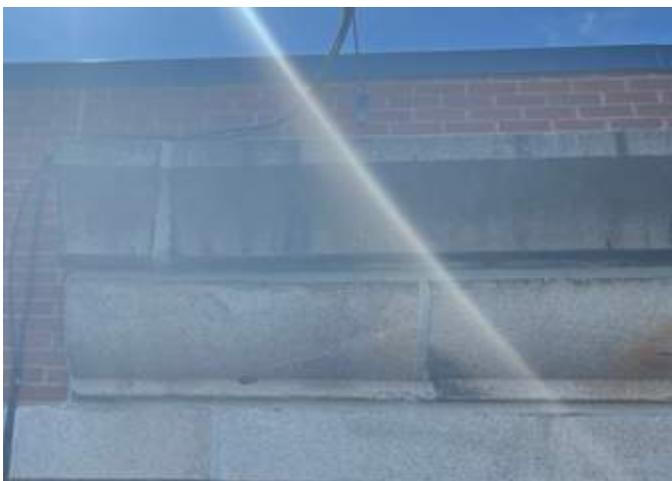
Coding / Field Name	Asset Description
System Name	Existing relocated granite cornice
Condition	2
Quantity	~875 sq. ft.
Unit Cost	Total: \$ 58,187.50
Year in Service	N/A
Expected Useful Life	100 years
Remaining Useful Life	20 years, Estimated, Based on Date of Observation
Location	Building roof edge
Basis of Costing	Square Foot Costs with RSMeans Data 2022 – 43 rd Edition

Cracking and staining evident.

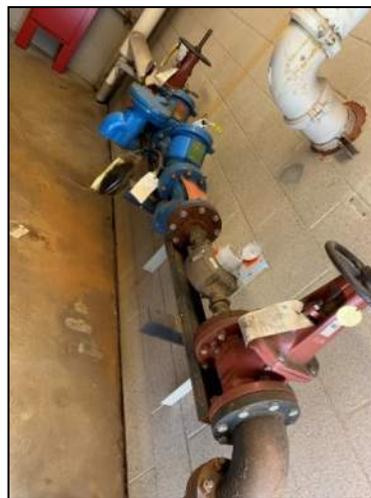
Figure 1: Domestic Water Service

The domestic water service is in the water room with the fire service equipment. The domestic water service lateral is 4". The domestic water meter is 1-1/2" and the reduced-pressure zone backflow preventer and valving match the lateral size of 4". No pressure boosting pumps are present. The domestic water is piped with copper throughout the building. The copper appears to be in fair condition. The fittings were soldered. Insulation is present on hot or cold-water piping.

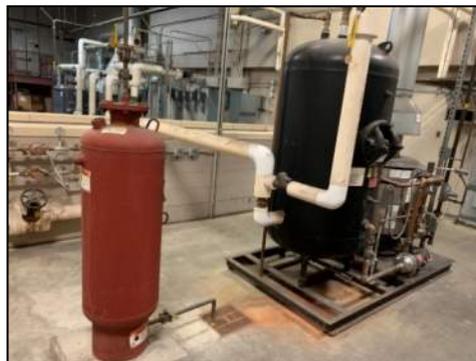
Figure 2: Domestic Water Boiler and Storage Tank

Coding / Field Name	Asset Description
Domestic Hot Water Systems	Water heaters
Condition	2-Marginal
Quantity	~1 Gas-Fired Boiler and Storage Tank
Unit Cost	\$50,000
Year in Service	~2002
Expected Useful Life (EUL)	~20 Years
Remaining Useful Life (RUL)	~0 Years
Location	Boiler Room
Basis of Costing	RMS Means Data with Contingencies Added

On the mechanical mezzanine, a gas-fired boiler with an accompanying 200-gallon tank provides the facility domestic hot water. Recirculation pumps provide recirculation through the facility.

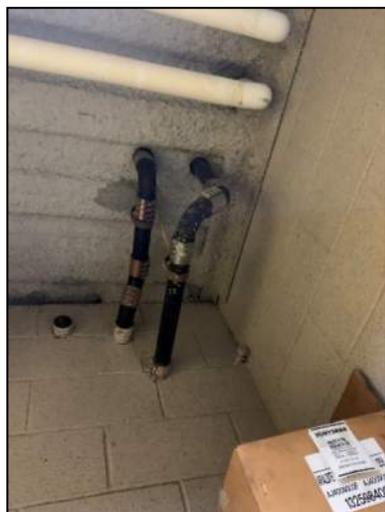
Figure 9: Sanitary Drainage Piping

The sanitary piping is no-hub cast iron. The piping appears in good, working order. A water-oil separator is present in the garage. This separator handles the runoff from the parts cleaning room, the bus bays, and other areas that have drains that could be contaminated with oil.

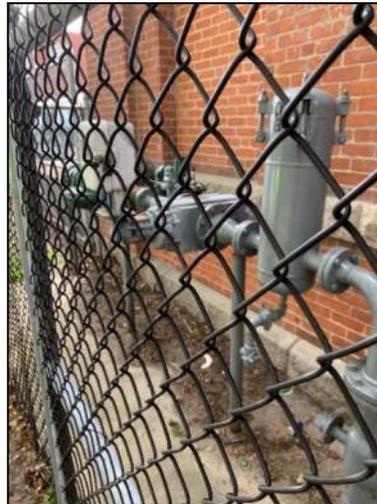
Figure 13: Gas Service Meter and Regulator

The building is served by a natural-gas system on the North side of the facility. The incoming service is ~2” and increases to ~3” after the compressors. A few items requiring gas are the boilers for the hydronic and domestic water and the boilers in the water treatment room.

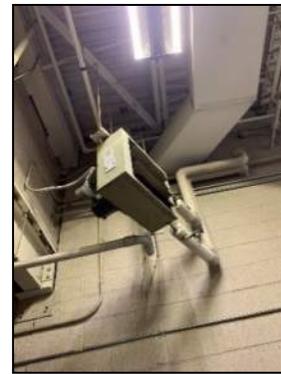
Figure 19: Hot-Water Unit Heater

There are many small, hot-water unit heaters located throughout the facility. These heaters appear to be locally controlled with a thermostat mounted on the unit.

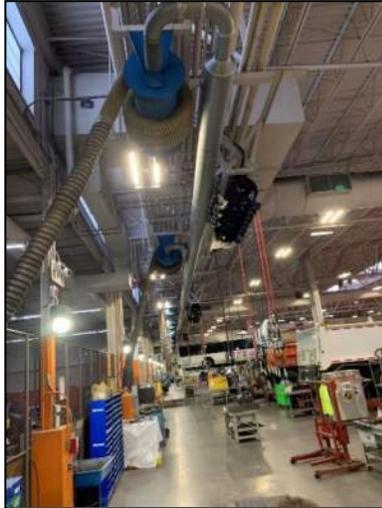
Figure 26: Localized Exhaust Systems

The garage is equipped with motor driven exhaust fans that have branch ducting with a rope-and-pulley system for localized exhaust. The local exhaust systems appear in good, working order. The fan drives for the exhaust systems are mounted on the roof. Some fans appear newer, and some appear to be original with the building.

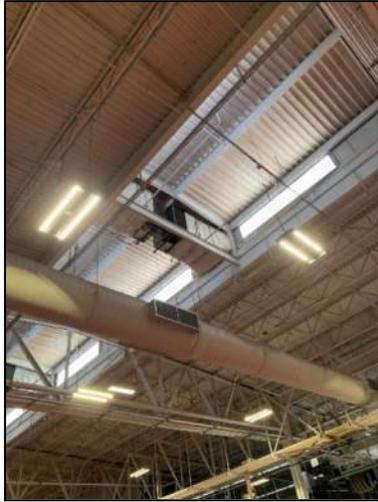
Figure 30: Exhaust Fans at Ceiling Peak

The main floor of the garage has exhaust fans mounted on both sides of the peak of the ceiling. These exhaust fans face one another and exhaust directly to the exterior. On the walls of the garage, there are control sensors that measure CO and NO₂ and control the fans.

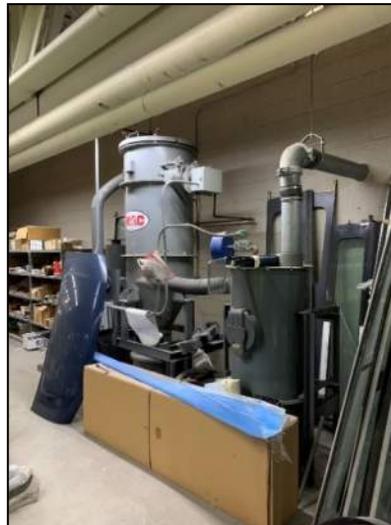
Figure 32: Smoke Exhaust System

The Body Shop is equipped with a localized smoke exhaust. The machine appears in working order.

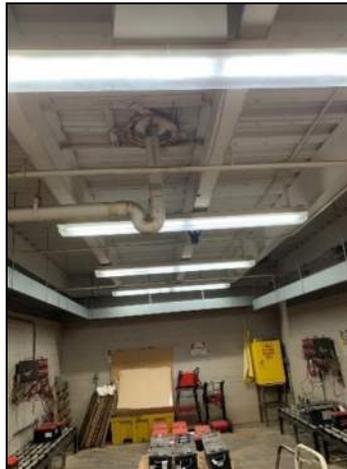
Figure 36: Battery Storage Room

The battery storage room has makeup air to it, but there is not a control system in place to exhaust the room if there is a dangerous buildup of off gasses from the batteries.

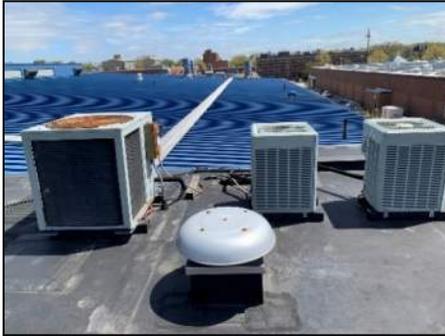
Figure 37: Air Conditioning Condensers on Flat Roof

comfort cooling systems are in place around the facility. The office area is equipped with a standard split, direct expansion system. The condensers are located on the flat roof on the South Side of the building, above the office area. The indoor units are hung from the ceiling in a mechanical space adjacent to the office area.

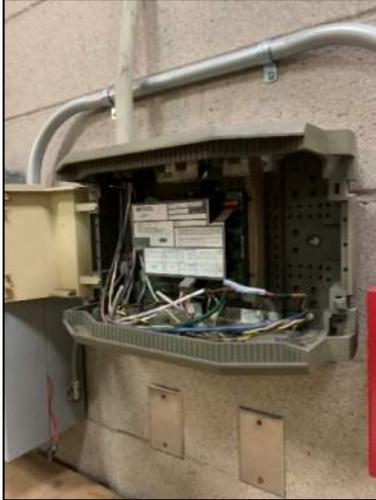
Figure 44: Abandoned BMS Control Panel

An abandoned in-place BMS controls system panel is in the parts storage room. The abandoned system is JCI MetaSys system. The working controls system panel is in the boiler room. The working BMS controls system is JCI Facility Explorer.

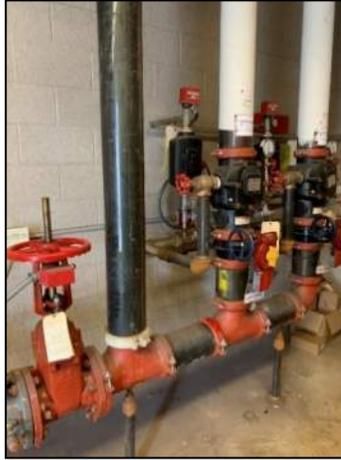
Figure 49: Fire Sprinkler Risers

The Risers for the zones appear rather new. There are new flow switches and tamper switches in place. The riser check assemblies appear in good condition.

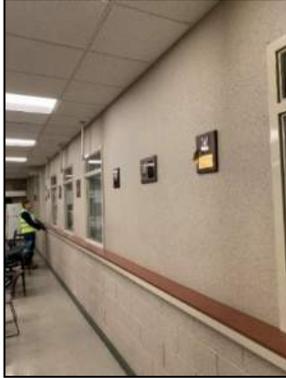
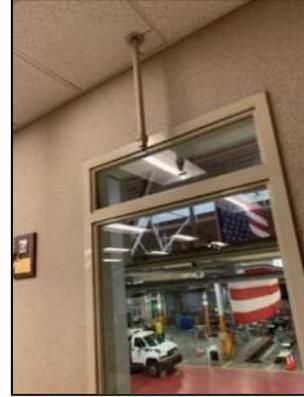
All sprinklers appear to be original to the building and appear in good, working order. Recessed sprinklers are in the office portion. Uprights and drops are in other areas. The mezzanine overlooking the garage floor was equipped with window sprinklers on both sides of the windows. The piping is steel, which is in fair condition.

Figure 51: Window Sprinklers in Breakroom

Figure 52: Window Sprinklers in Breakroom

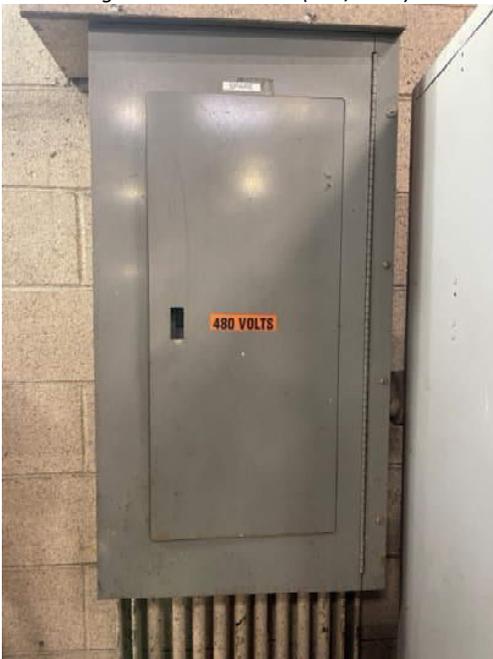
Figure 3: Abandoned/Damaged Panelboard

A 1,600A, 480V service installed approximately 20 years ago. The service is fed from the pad mounted transformer (South side of the building) (*Figure 2*) and enters the main switchboard (*Figure 1*) located in the Electrical Room. Building is served by a 265KW backup diesel generator (*Figure 4*). Many older panelboards are deteriorating and/or are damaged or abandoned in place (*Figure 3*).

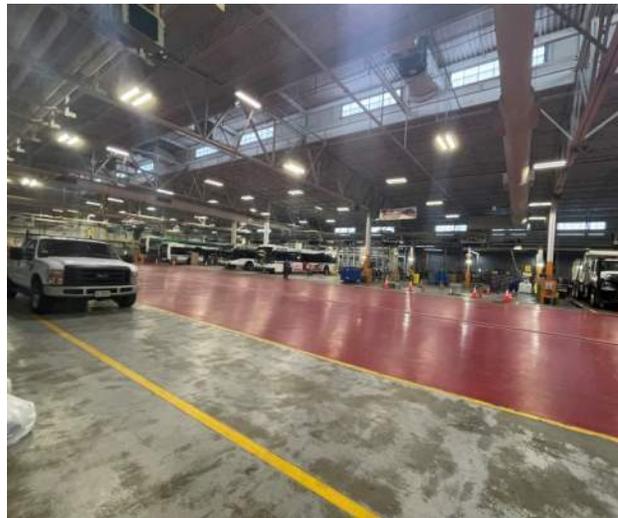
Figure 2: LED High-bay and fluorescent fixtures

LED high-bay fixtures with integral occupancy sensors (*Figure 1*) are installed throughout the first-floor garage space. Older fluorescent fixtures were left in place (*Figure 2*). All exit signs throughout the space are illuminated and appear to be completely operational.

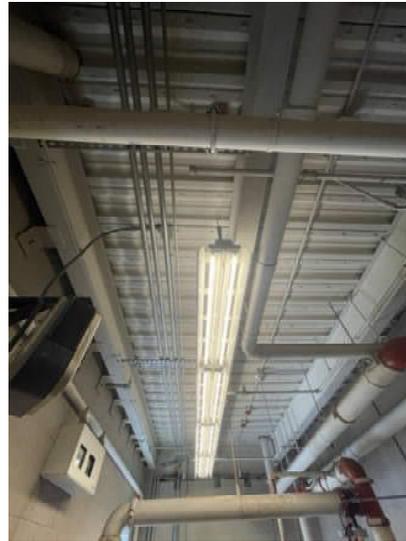
Figure 6: Fluorescent Fixtures

Storage/office spaces consist of LED 2’X2’ and 2’X4’ troffer fixtures (Figure 3) and linear LED fixtures controlled by a combination of toggle switches (Figure 7), ceiling mounted occupancy sensors (Figure 4), and wall switch occupancy sensors (Figure 8). Exit signs were observed throughout the space and appear to be fully operational (Figure 5). Emergency battery units were observed in some storage/mechanical/electrical rooms. In addition to emergency battery units, lighting fixtures throughout the office space are on generator backup. Fluorescent fixtures (Figure 6) are still operational throughout the office space and storage areas.

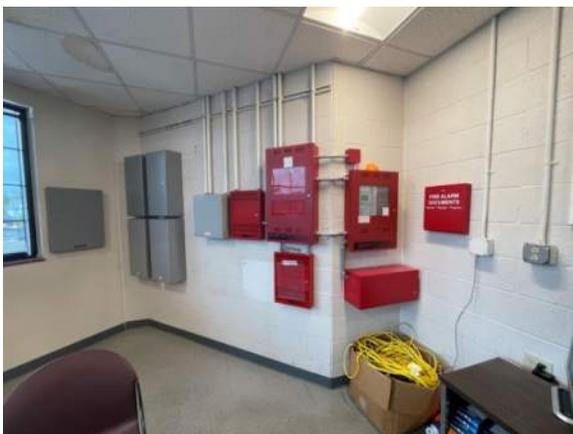
Figure 1: Fire Alarm System

Fire alarm system (*Figure 1*) consists of an addressable Fire Alarm Control Panel (Edwards EST-3) and associated devices manufactured by Edwards. Connection to local fire department is through a Gamewell Master Box. CO detection system is installed throughout the garage space (*Figure 2*). Fire Alarm system and associated devices and wiring appear to be in working condition, however some devices are approaching their expected useful life based on industry standards.
