Transit Asset Management Plan

October 1, 2022 – September 30, 2026

RHODE ISLAND PUBLIC TRANSIT AUTHORITY

FINAL ASSESSMENT REPORT
August, 2022

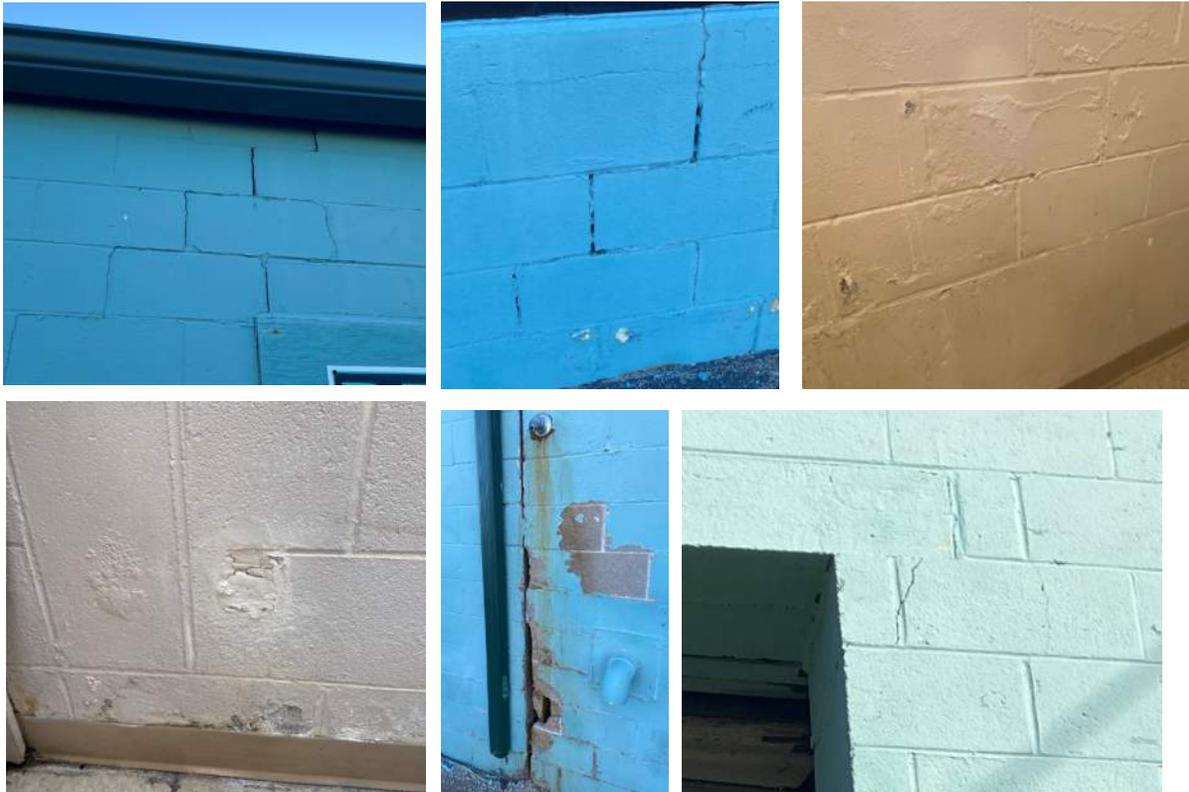
Various cracks, moisture damage, failing expansion joints, chipping, and deterioration.

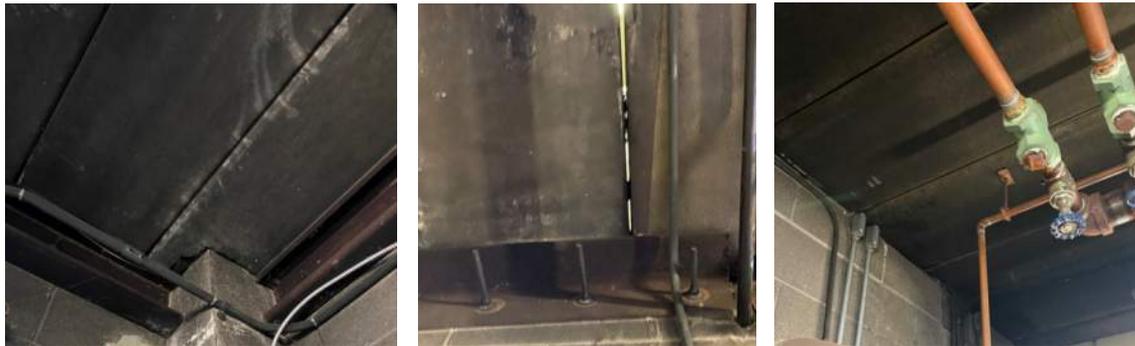
Some gaps between planks but overall fair condition.

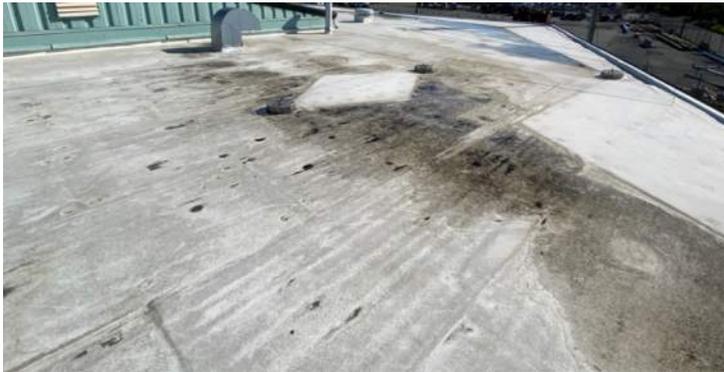
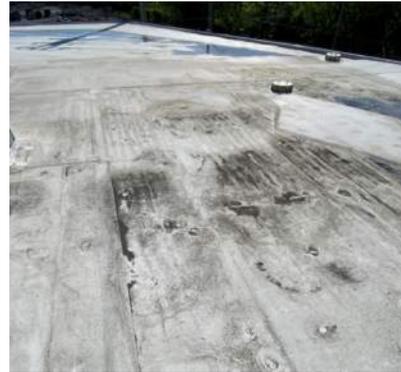
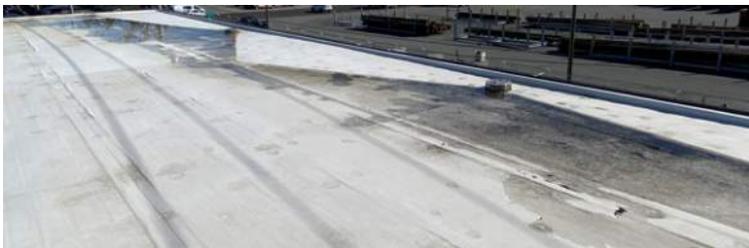
Evidence of ponding, membrane bubbling, staining, potentially blocked roof drains.

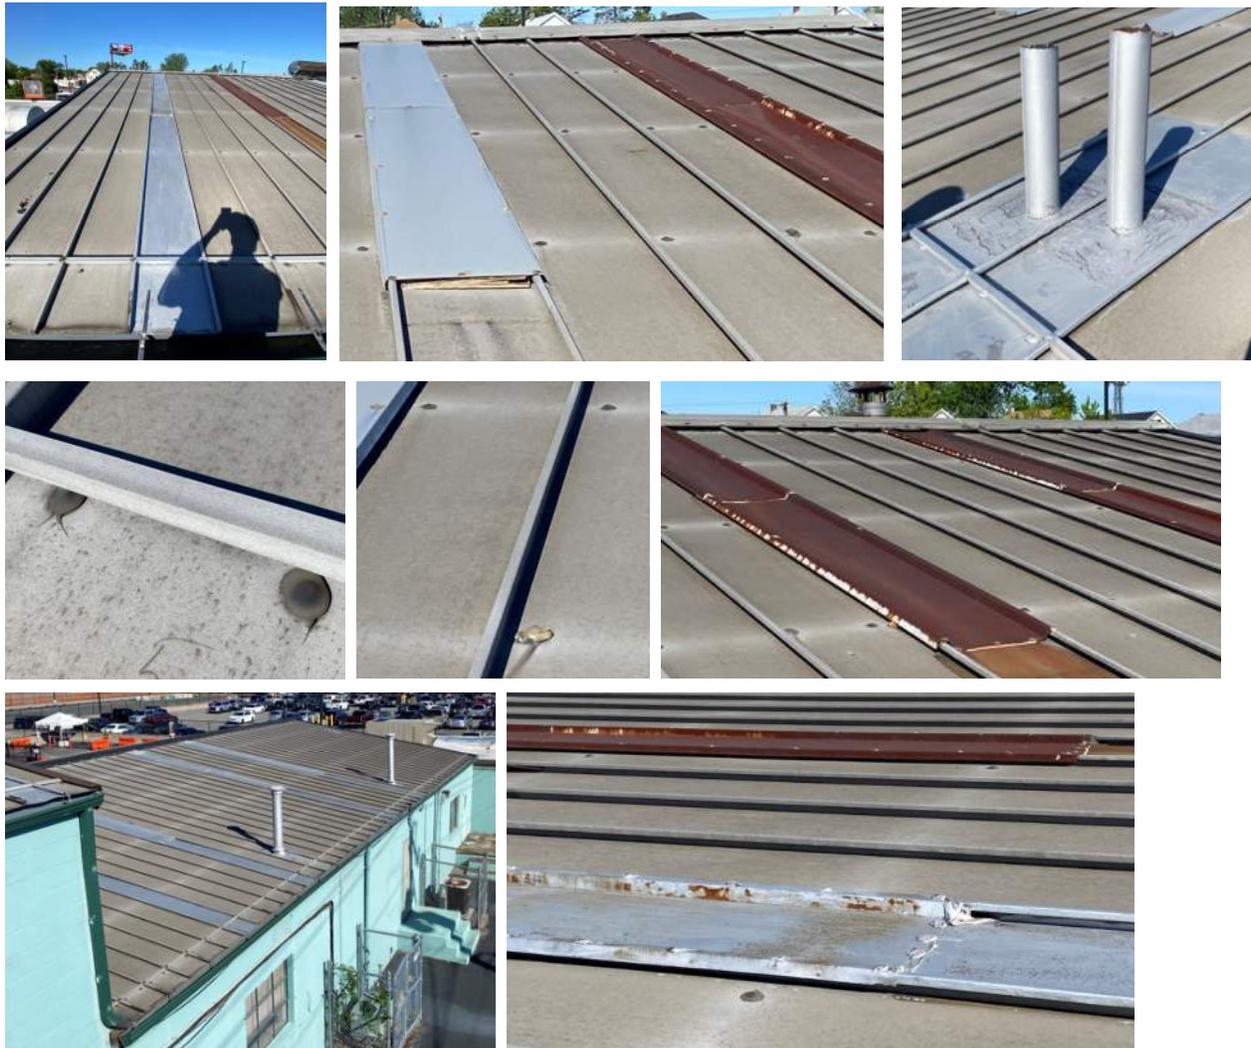
Leaking through fasteners, various inconsistent spot patches and repairs, rust and corrosion.

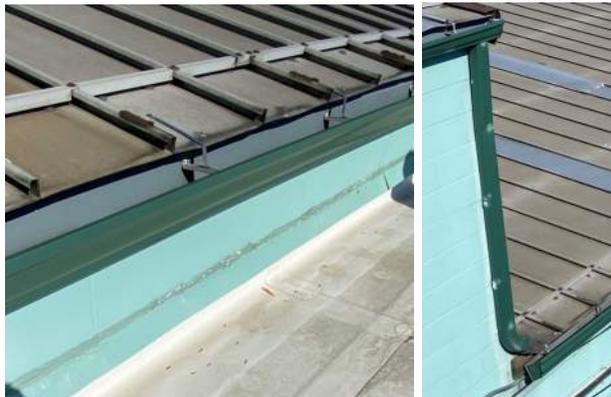
Gutters and downspouts in fair condition but fasteners may require maintenance.

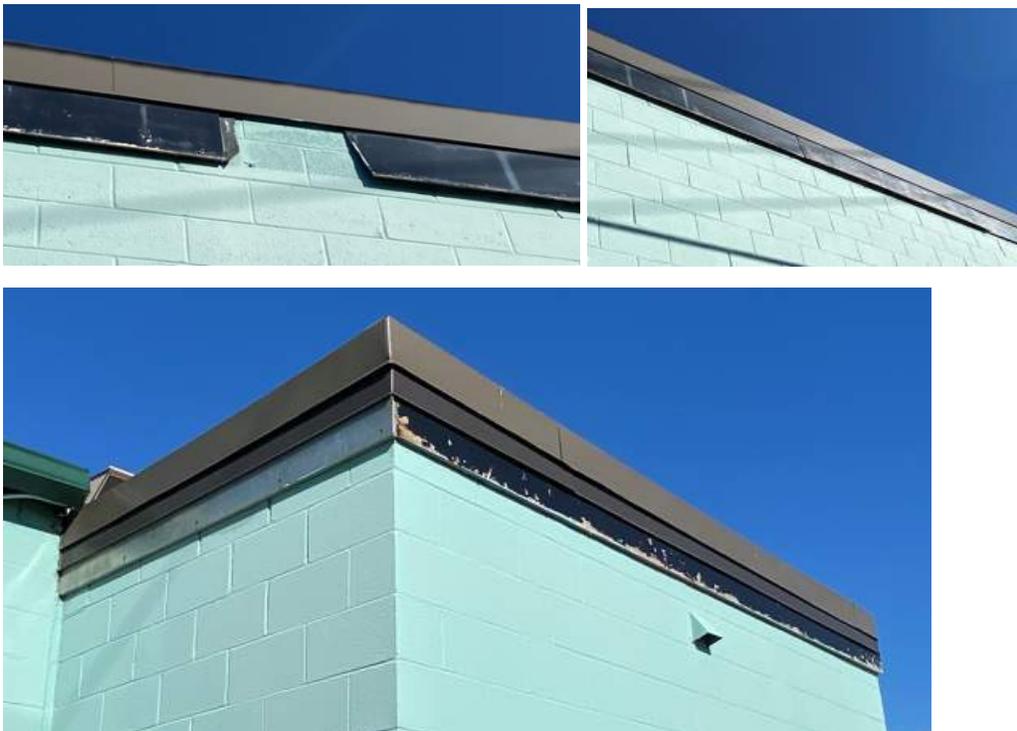
Coping itself appears in fair condition but older fascia/coping and membrane flashing beneath top coping may have issues.

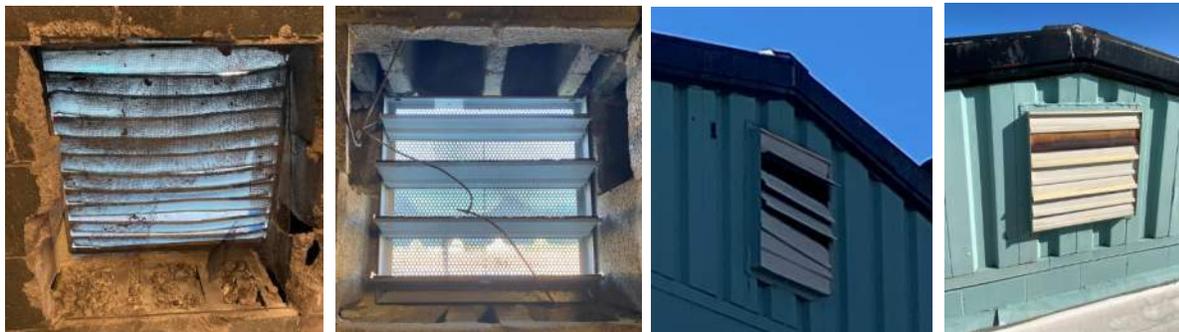
Louver blades missing / unseated. Screens pulled away from screen. Damage to openings.

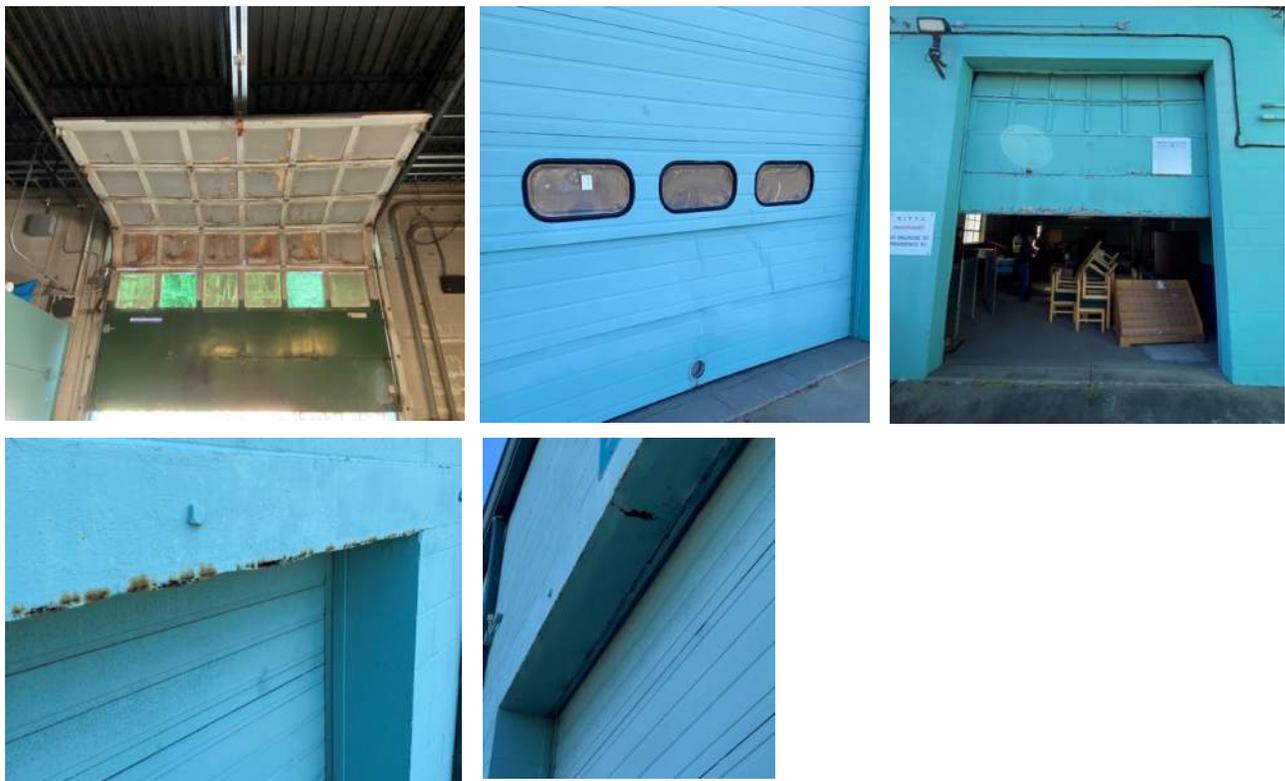
Inspection garage doors are better condition than storage garage. Denting, chipping, warping, corroded lintels.

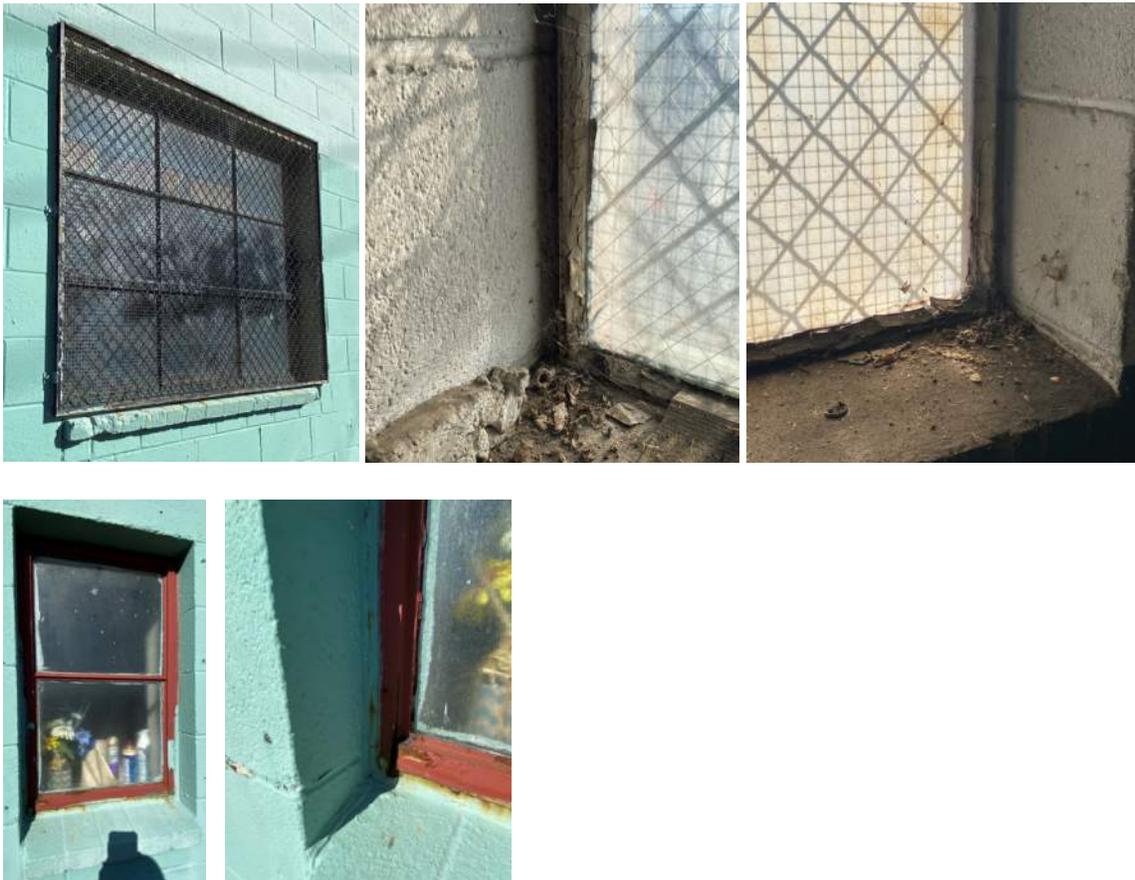
Corroded sealant, damage to glazing.

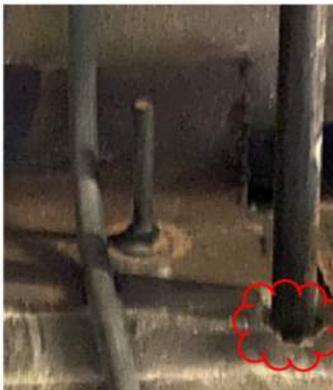
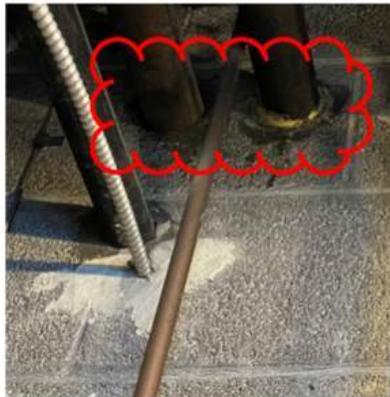
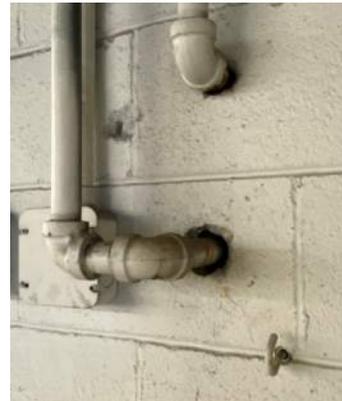
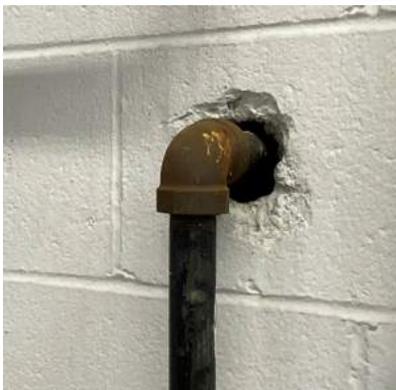
Through-wall penetration sealants and sleeving deteriorating or not installed. Potential issues with penetration of fire-rated ceiling, wall, etc. assemblies.

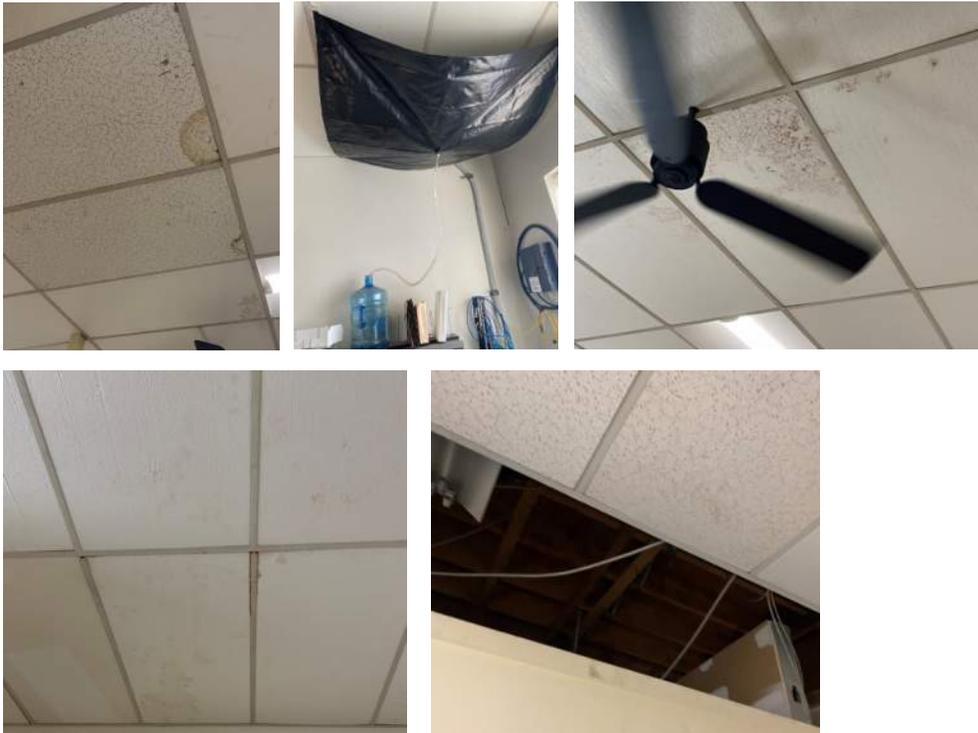
Water damage, missing tiles, corroded grids.

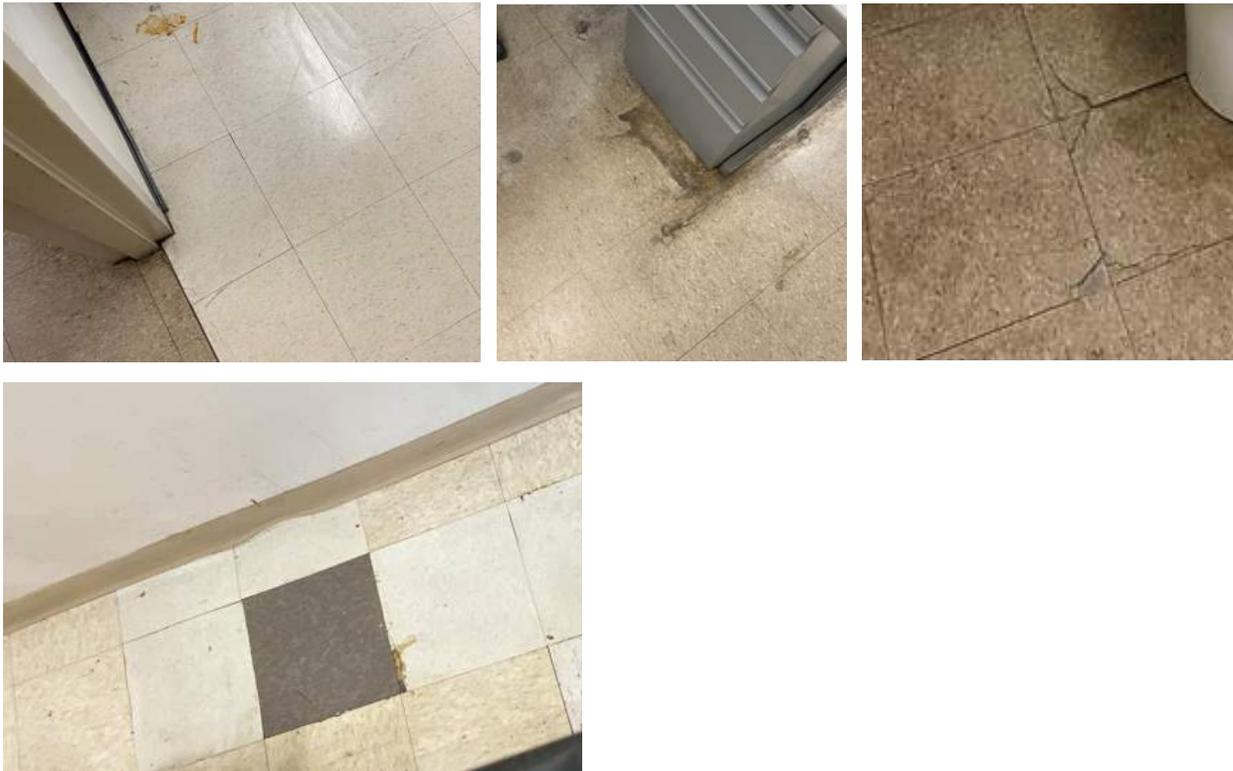
Cracked / missing tiles, damaged tiles, discoloration, staining.

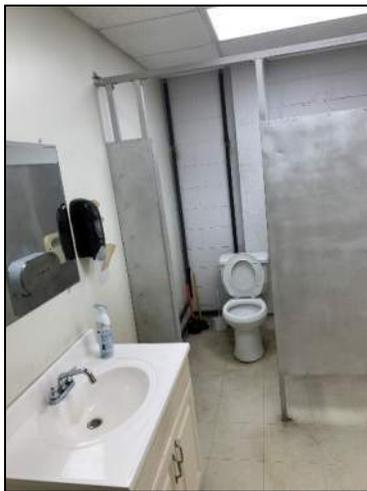
Figure 4: Floor Mounted Water Closet

The plumbing fixtures are dated. Most are manually operated, are not ADA compliant, and are not water-saving fixtures.

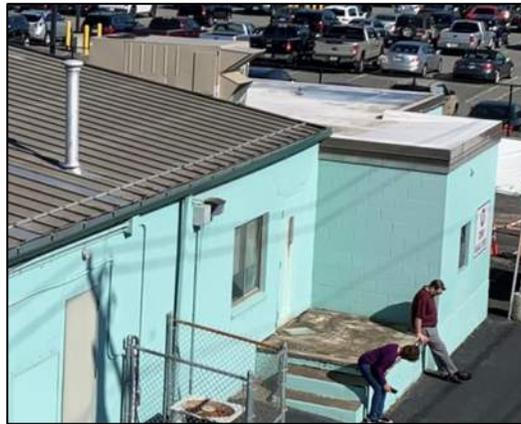
Figure 10: Rooftop Unit Over Office

A rooftop unit provides primary heating and cooling for the office portion of the building. The unit appears to be a constant-volume, single zone system. The RTU provides outdoor air with a damper and economizer.

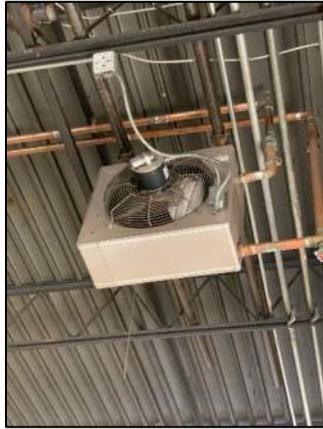
Figure 13: Hydronic Unit Heater

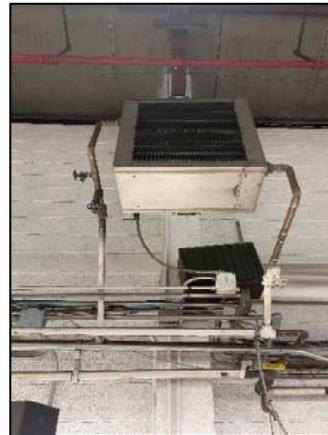
Figure 14: Hydronic Unit Heater

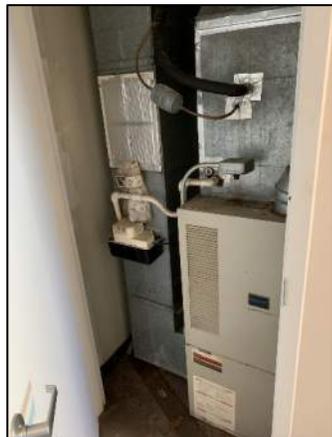
Figure 15: Indoor Evaporator with Gas-Fire Furnace

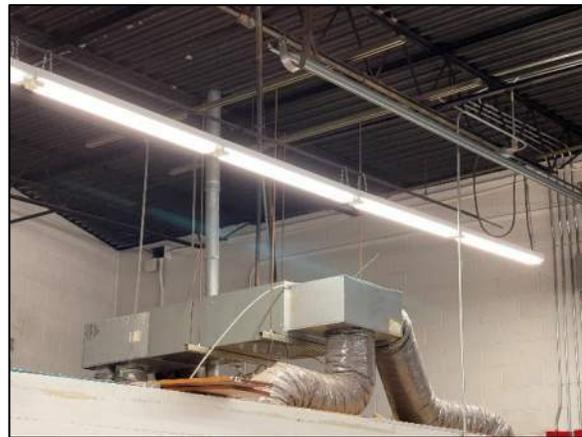
Figure 16: Abandoned Indoor Evaporator

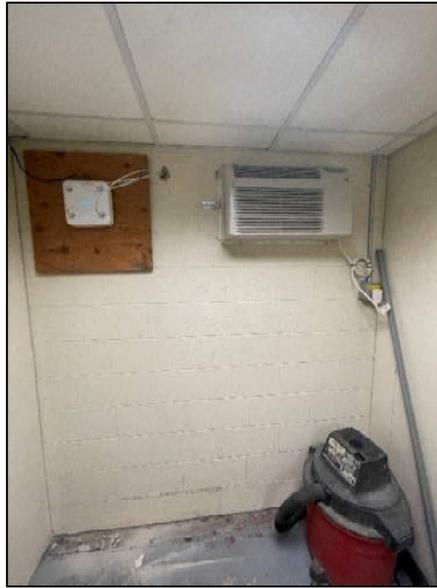
The IT room is equipped with a window-unit air conditioner.

Figure 21: Window-Unit in IT Room

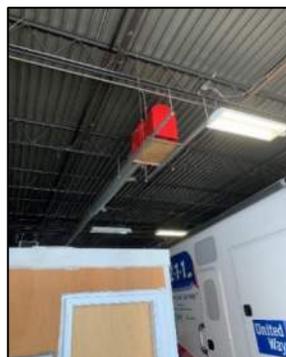
The shop is equipped with an exhaust fan that was ducted for use with trunks for local exhaust. These ducts are now missing, and it is not clear if the system is still operational.

Figure 22: Exhaust Fan

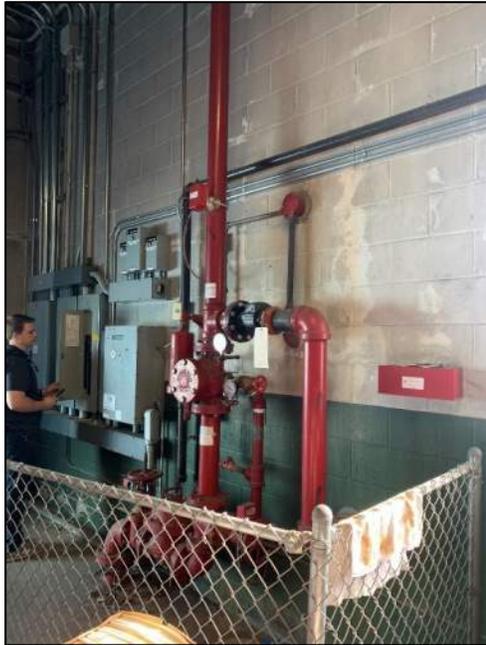
The fire sprinkler system is a wet-pipe system served by a 6” lateral. A Fire Department Connection is located on the street side of the shop where an alarm bell is situated. The shop appears to be fully sprinklered, but the office areas are not sprinklered.

Figure 23: Fire-Service Main

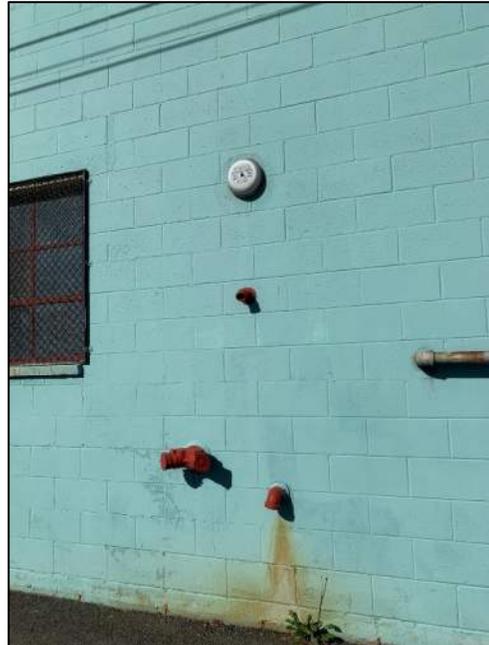
Figure 24: Alarm Bell and Fire-Department Connection

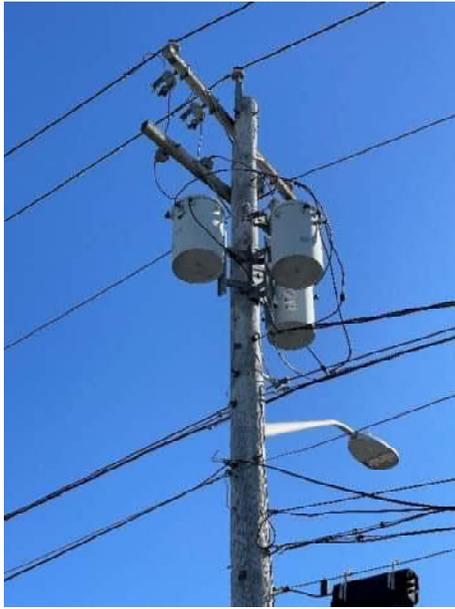
A 400A, 3 phase service installed over 30 years ago. The service is fed from the pole mounted transformers (North side of the building) (*Figure 1*) and enters the main disconnect (*Figure 3*) and distribution equipment (*Figure 2*) located in the fenced off Electrical area. Building is served by a backup generator (*Figure 4*). Many older panelboards are deteriorating and/or are damaged or abandoned in place (*Figure 5*).

Figure 1: Pole Mounted Transformers

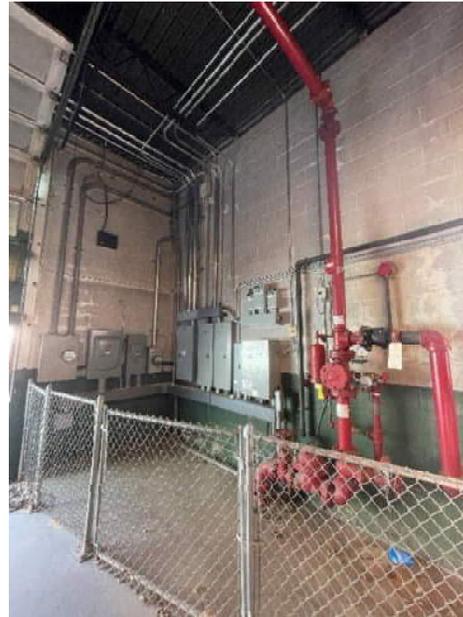
Figure 2: Distribution Equipment

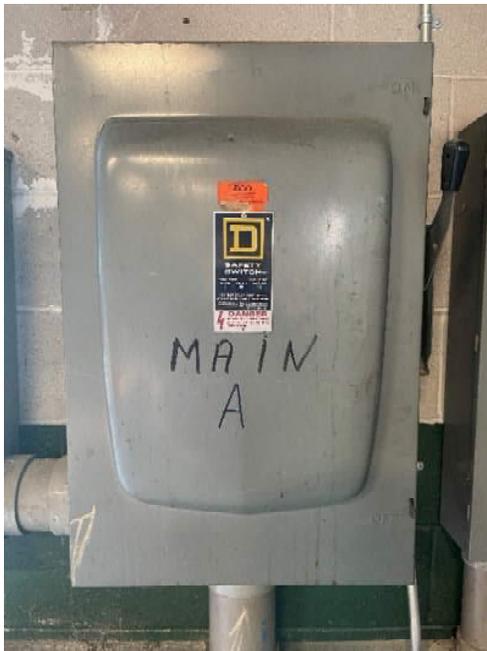
Figure 3: Main Disconnect

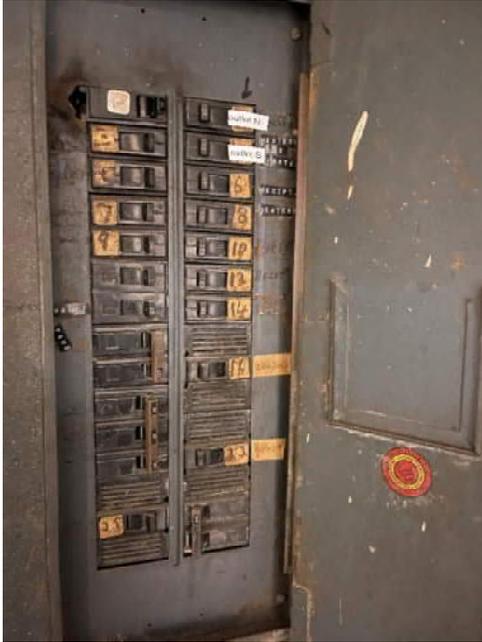
Figure 5: Deteriorating panelboard

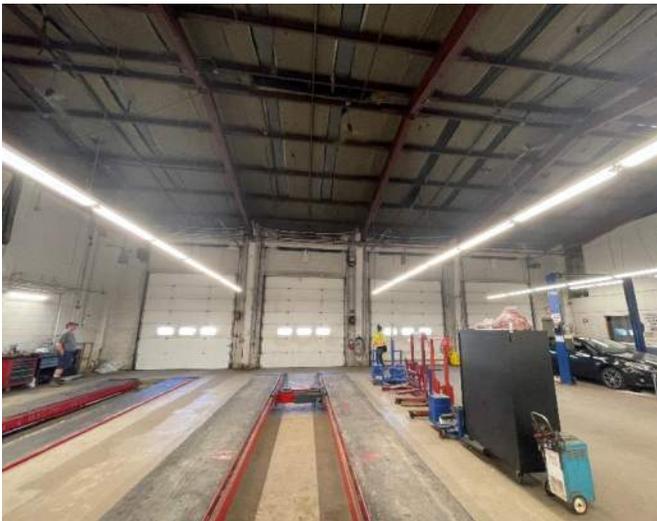
Fluorescent high-bay fixtures (*Figure 1*) are installed throughout the first floor garage space. All exit signs (*Figure 2*) throughout the space are illuminated and appear to be completely operational. Garage lighting has reached the end of the expected useful life.

Figure 1: Fluorescent High-bay fixtures

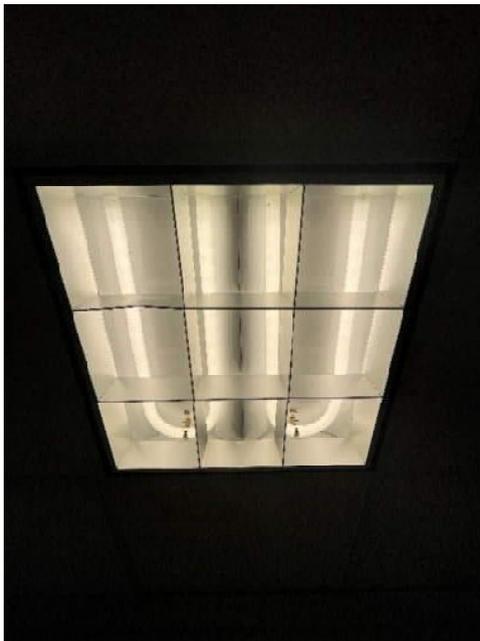
Storage/office spaces consist of LED 2’X2’ and 2’X4’ troffer fixtures (Figure 3) and linear LED fixtures controlled by a combination of toggle switches, ceiling mounted occupancy sensors (Figure 4), and wall switch occupancy sensors (Figure 8). Exit signs were observed throughout the space and appear to be fully operational (Figure 5). Emergency battery units (Figure 6) were observed in some storage/mechanical/electrical rooms. In addition to emergency battery units, lighting fixtures throughout the office space are on generator backup. Fluorescent fixtures (Figure 7) are still operational throughout the office space and storage areas.

Figure 7: Fluorescent Fixture

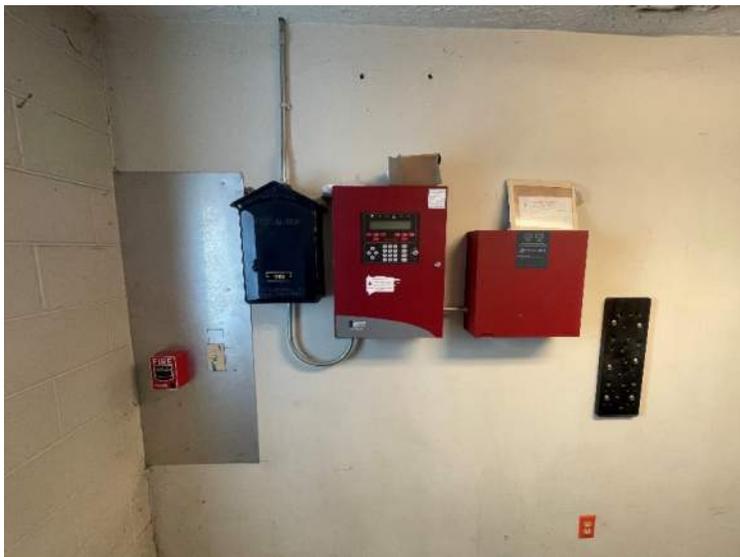
Fire alarm system (*Figure 1*) consists of an addressable Fire Alarm Control Panel, battery cabinet, and associated devices manufactured by Honeywell. Connection to local fire department is through a Gamewell Master Box. Fire Alarm system and associated devices and wiring appear to be in working condition, however some devices are approaching their expected useful life based on industry standards.

Figure 1: Fire Alarm System

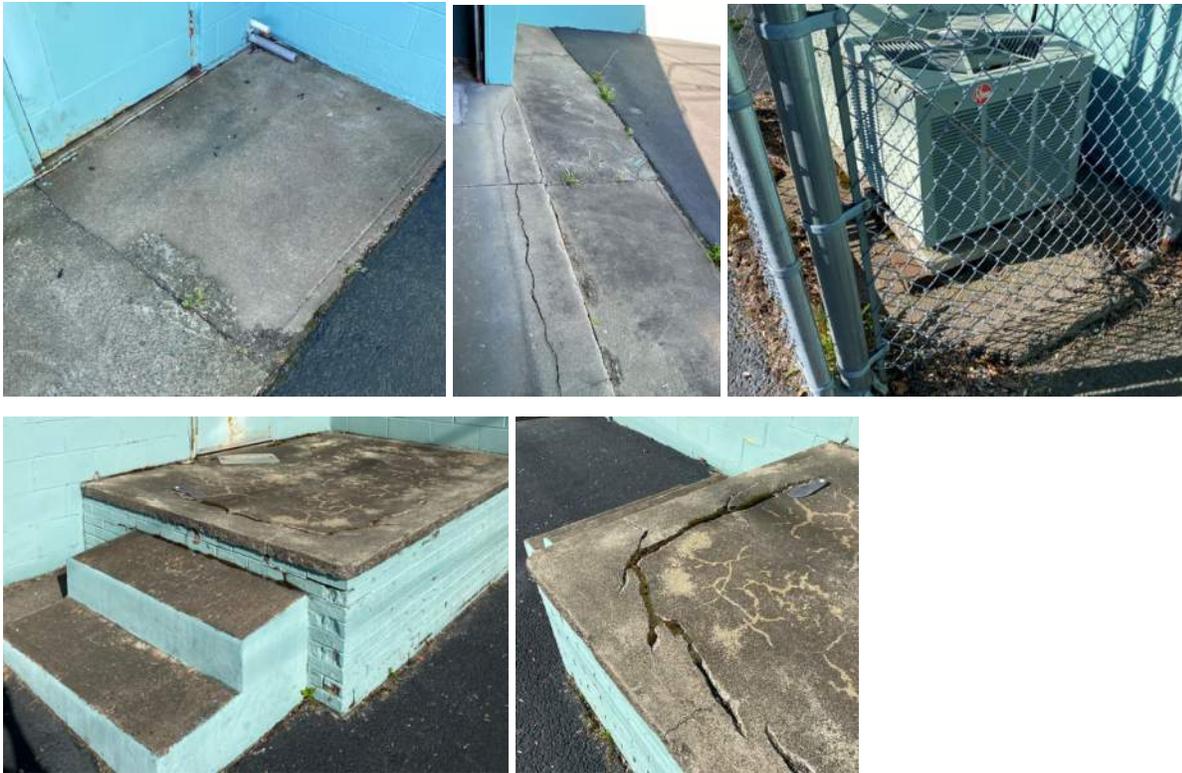
Cracking, settling, chipping.

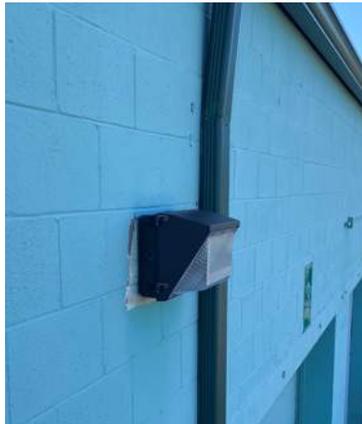
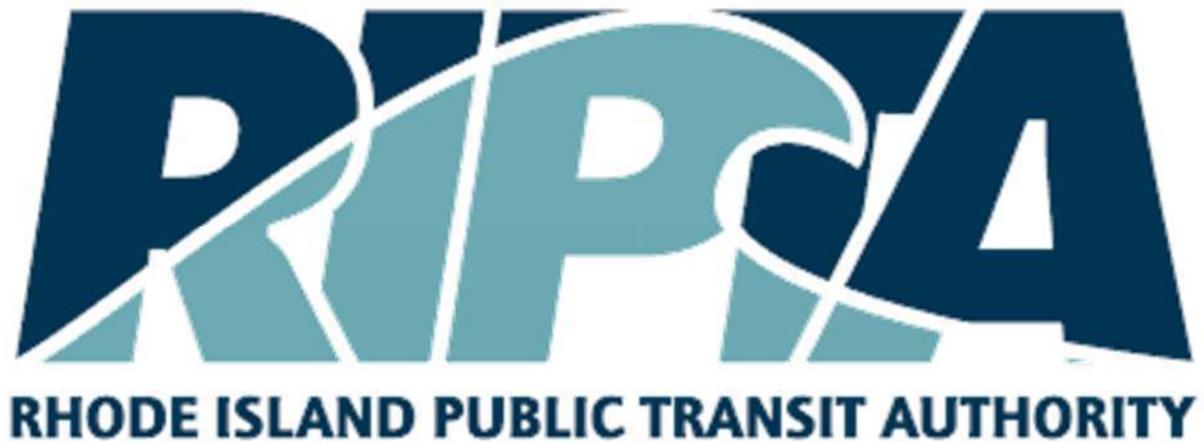
Light fixtures in good working condition at time of inspection.

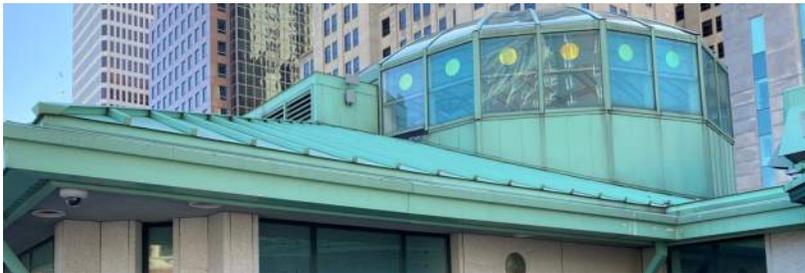
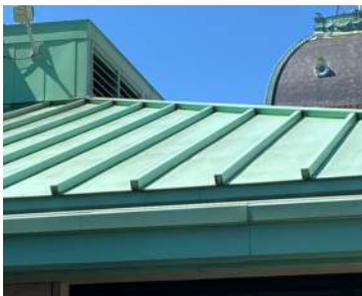
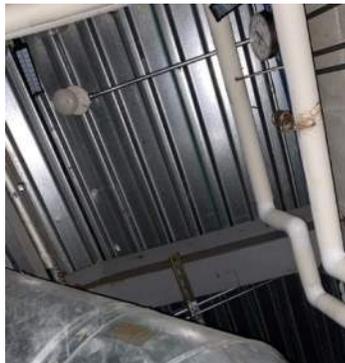
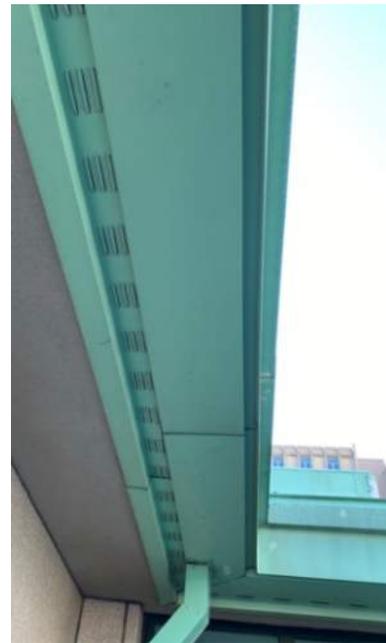
Coding / Field Name	Asset Description
System Name	Metal roof, insulation, and decking. Fascias, soffits, and downspouts
Condition	3
Quantity	~5,000 sq. ft.
Unit Cost	Total: \$255,458.50
Year in Service	2001
Expected Useful Life	70 years
Remaining Useful Life	49 years, Estimated, Based on Date of Observation
Location	Roof
Basis of Costing	Square Foot Costs with RSMeans Data 2022 – 43 rd Edition

Roof and accessories in fair condition. Some staining evident.

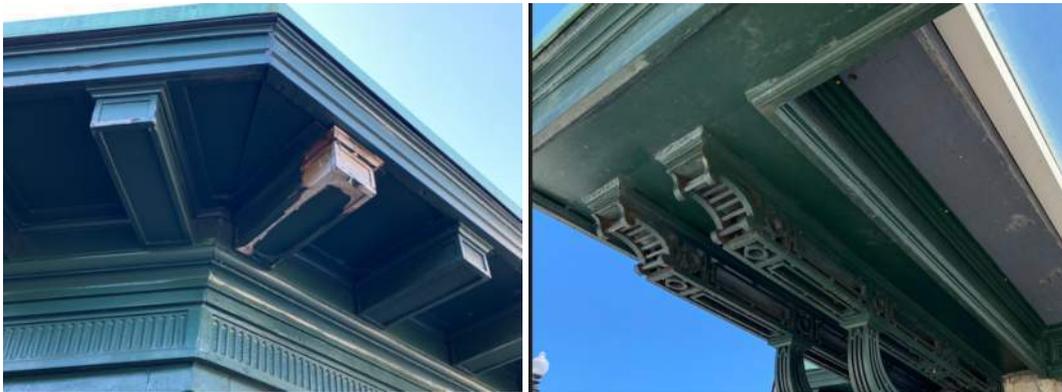
Coding / Field Name	Asset Description
System Name	Exterior ornamental wood soffits and molding.
Condition	3
Quantity	~70 linear ft.
Unit Cost	Total: \$2500
Year in Service	2001
Expected Useful Life	45 years
Remaining Useful Life	24 years, Estimated, Based on Date of Observation
Location	Building exterior
Basis of Costing

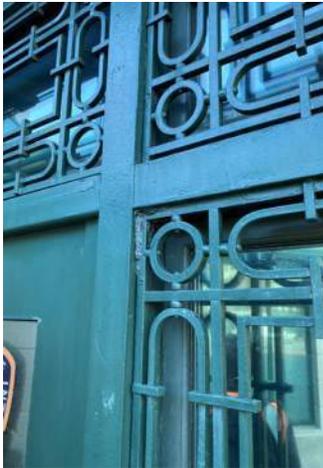
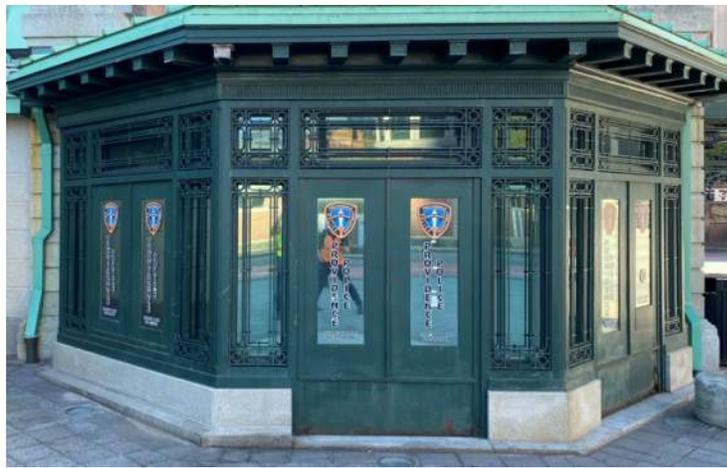
Coding / Field Name	Asset Description
System Name	Exterior ornamental metal work
Condition	3
Quantity	~650 sq. ft.
Unit Cost	Total: \$32,500
Year in Service	2001
Expected Useful Life	50 years
Remaining Useful Life	29 years, Estimated, Based on Date of Observation
Location	Building exterior
Basis of Costing	Square Foot Costs with RSMeans Data 2022 – 43 rd Edition

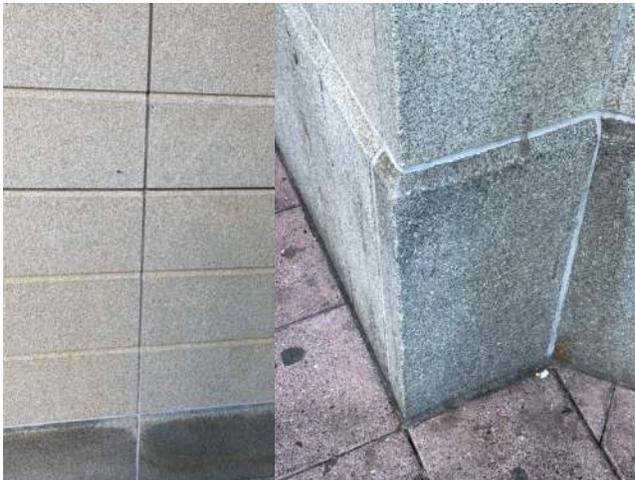
Coding / Field Name	Asset Description
System Name	Exterior granite cladding and base
Condition	4
Quantity	~1,300 sq. ft.
Unit Cost	Total: \$110,500
Year in Service	2001
Expected Useful Life	100 years
Remaining Useful Life	79 years, Estimated, Based on Date of Observation
Location	Building exterior
Basis of Costing	Square Foot Costs with RSMMeans Data 2022 – 43 rd Edition

Generally in fair condition. Regular maintenance and cleaning are crucial to prolonging life of this exterior in high traffic site.

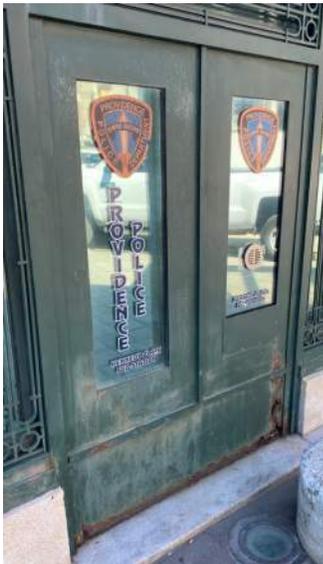
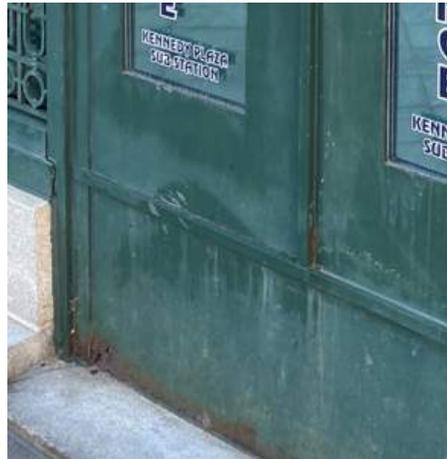
Coding / Field Name	Asset Description
System Name	Exterior Steel Wall Panels
Condition	3
Quantity	12
Unit Cost	Total: \$8423.54
Year in Service	2001
Expected Useful Life	50 years
Remaining Useful Life	29 years, Estimated, Based on Date of Observation
Location	Building exterior
Basis of Costing	Square Foot Costs with RSMMeans Data 2022 – 43 rd Edition

Rust and wear evident.

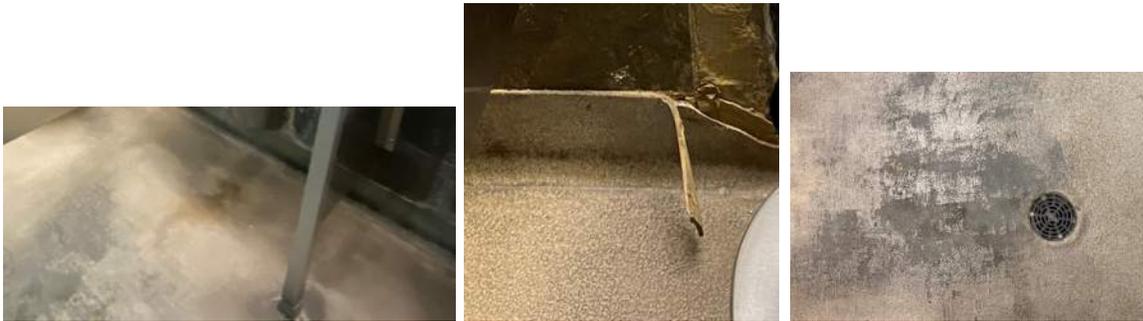
Coding / Field Name	Asset Description
System Name	Epoxy flooring and cove base
Condition	2
Quantity	~1000 sq. ft.
Unit Cost	Total: \$12,451
Year in Service	2001
Expected Useful Life	40 years
Remaining Useful Life	5 years, Estimated, Based on Date of Observation
Location	Restrooms / maintenance areas.
Basis of Costing	Square Foot Costs with RSMeans Data 2022 – 43 rd Edition

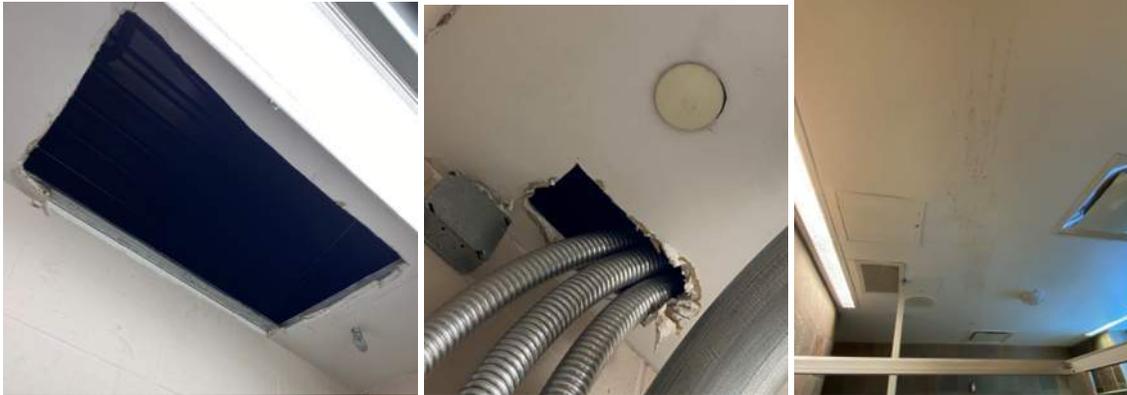
Coding / Field Name	Asset Description
System Name	Gypsum ceilings
Condition	2
Quantity	~1000 sq. ft.
Unit Cost	Total: \$12,345
Year in Service	2001
Expected Useful Life	20 years
Remaining Useful Life	5 years, Estimated, Based on Date of Observation
Location	Building interior
Basis of Costing	Square Foot Costs with RSMMeans Data 2022 – 43 rd Edition

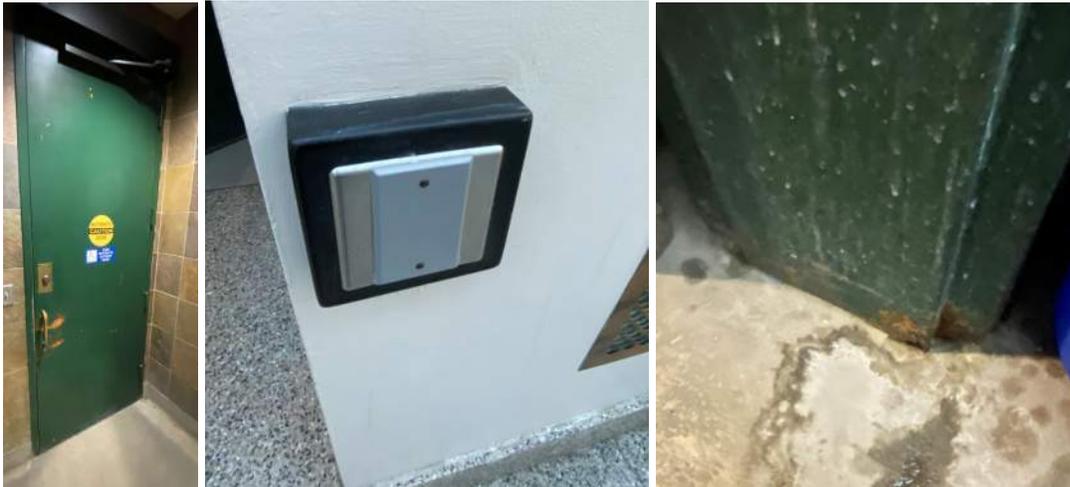
Coding / Field Name	Asset Description
System Name	Interior steel doors and frames.
Condition	3
Quantity	~10
Unit Cost	Total: \$28,820
Year in Service	2001
Expected Useful Life	50 years
Remaining Useful Life	29 years, Estimated, Based on Date of Observation
Location	Building interior
Basis of Costing	Square Foot Costs with RSMeans Data 2022 – 43 rd Edition

Ada push buttons not operable on some doors.

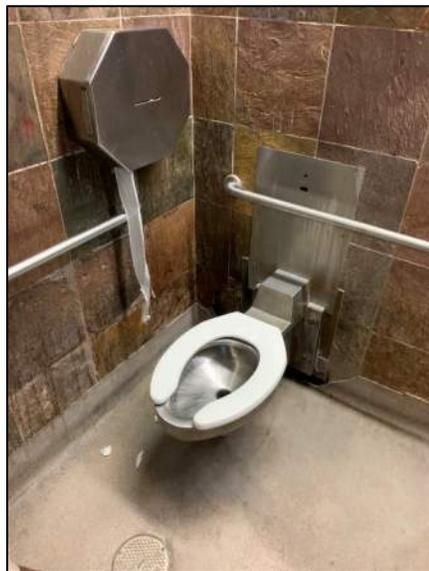
Figure 3: Public Water Closet

The plumbing fixtures are sparse, vandal-proof, touchless fixtures. There is wear and tear due to the transient population using the fixtures.

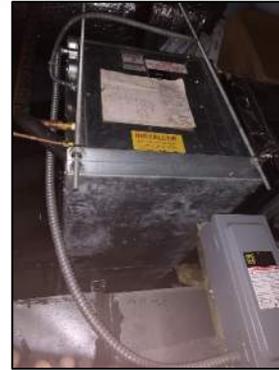
Figure 8: Unitary Air-Conditioning Unit in Attic Above Boiler Room

Originally, Qty (2) unitary air-conditioning units mounted in the attic provided comfort cooling, base comfort heating, and ventilation. The air conditioning units had several ducted zones controlled by variable-air-volume boxes and reheat coils that were supplied hot water from the boilers. The largest zone, the Concourse/Waiting room, was supplied by both systems. Most ductwork is hidden by drop-ceilings, but due to the vaulted ceilings, the large Waiting area is supplied via underground ducts that branch to the perimeter windows.

Due to the issues with the cooling system, the unitary air-conditioning units are no longer used for cooling and heating. The fans operate to provide ventilation, but the cooling and supplemental heating are provided by an exterior mounted unitary air-conditioner (a rooftop unit) and by a split system variable refrigerant flow (VRF) system consisting of Qty (4) wall-mounted indoor units and Qty (1) roof-mounted condenser.

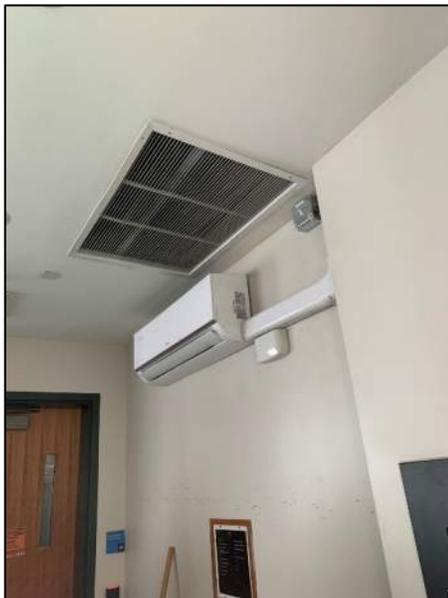
Figure 13: Wall-Mounted Indoor Unit in Dispatch Room

The Central Dispatch Room and the Telephone/Electrical Room were provided heating and cooling with separate VRF systems with ceiling mounted indoor units and condensing units in the attic. Due to issues with the Central Dispatch Room unit, a head from the new VRF system was added to heat and cool the space. The split system unit for the Telephone/Electrical Room appears to be original, and the condenser for this unit is still in place in the unit.

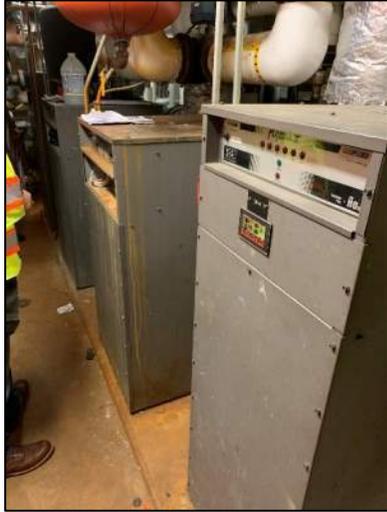
Figure 18: Qty Four Boilers

The Boiler Room is equipped with Qty (4) gas-fired 1,000,000 BTUh boilers. However, only Qty (1) boiler is operational. The boilers provide hot water for hydronic heating to the reheat coils, the unitary air-conditioners, and they also provide hot water for radiant flooring and a snowmelt system. The radiant flooring and snowmelt systems are supplied by Qty (2) separate heat exchangers. The radiant flooring is broken into Qty (5) zones: Large Waiting Room, Ticket Office, Concourse/Waiting Room, Small Waiting Room, and the Café/Vending Room. The radiant flooring is used as the primary source of heat, and the VRF system and Rooftop are used for supplementary heating. The snowmelt system is supplied hot water by another heat-exchanger, but the system is no

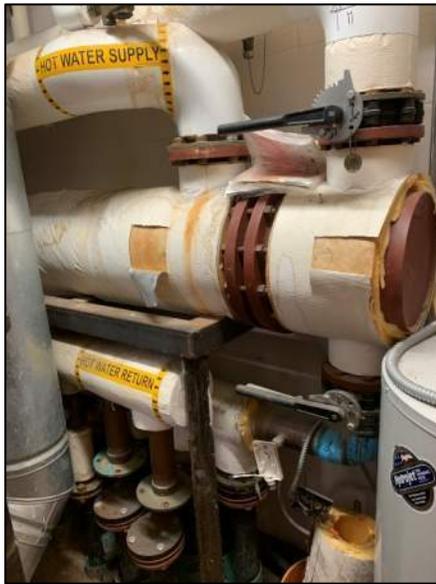
Figure 20: Capped Lines for Heat Exchanger for Abandoned Snow Melt System

longer functioning. The snow melt system was made of Qty (4) zones covering the plaza.

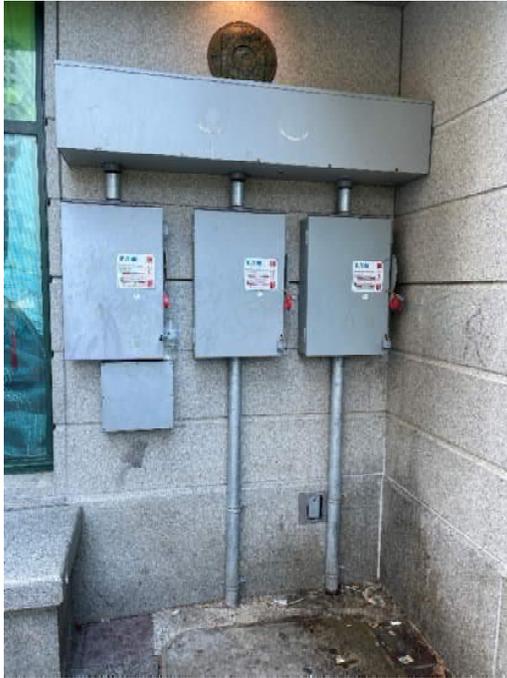
Figure 1: Main Service Disconnects

It appears that three 200A, 208V services enter the building through 3 disconnect switches (Figure 1) located on the North side of the building into the main Electric Room (Figures 2-3) installed approximately 20 years ago. Building is served by a 37.5KW backup generator (Figure 4). Distribution equipment appears to be in adequate condition but is approaching its expected useful life based on industry standards.
