Transit Asset Management Plan

October 1, 2022 – September 30, 2026

RHODE ISLAND PUBLIC TRANSIT AUTHORITY

FINAL ASSESSMENT REPORT
August, 2022

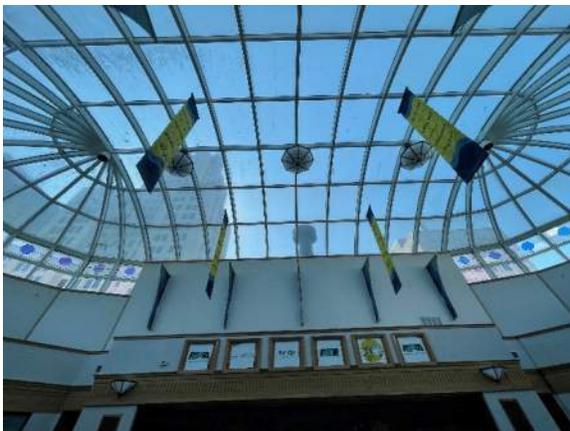
Figure 1: Decorative fluorescent pedants/wall mounted fixtures

Main lobby consist of decorative fluorescent pedants and wall mounted architectural fixtures (Figure 1). Storage/office spaces consist of fluorescent 2’X2’ troffers (Figure 2), downlights (Figure 3), linear fixtures (Figure 4), and track lighting (Figure 5) controlled by toggle switches (Figure 6). Fixtures and controls are still operational but are at the end of their expected useful life. Exit signs throughout the space were still illuminated (Figure 7) and are no longer operational. It appears lighting throughout the space is on generator backup for emergency lighting.

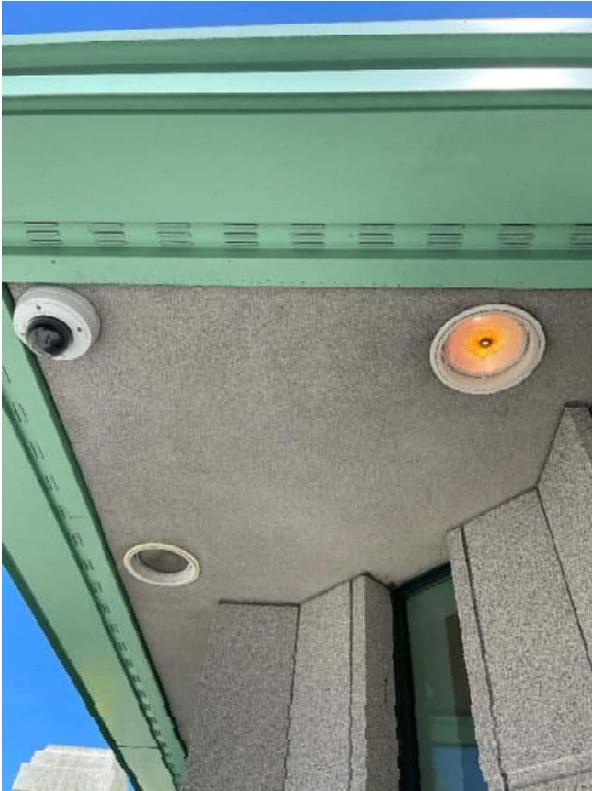
Figure 8: Exterior downlights

Exterior downlights (*Figure 8*) are installed along perimeter of building. Inground LED RGB fixtures (*Figure 9*) are installed throughout plaza to provide accent lighting.

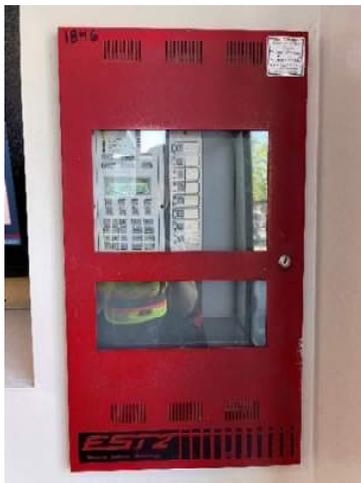
Figure 1: Fire Alarm Control Panel

Fire alarm system consists of an addressable Fire Alarm Control Panel (Edwards EST-2) (Figure 1) and devices manufactured by EdwardsI. Fire Alarm system and associated devices and wiring appear to be in working condition, however they are approaching their expected useful life based on industry standards.

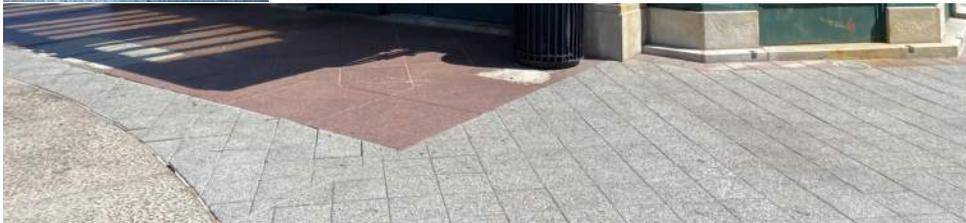
Many surfaces and textures create accessibility / tripping concerns. Maintenance is difficult with many connecting surfaces requiring differing treatment.

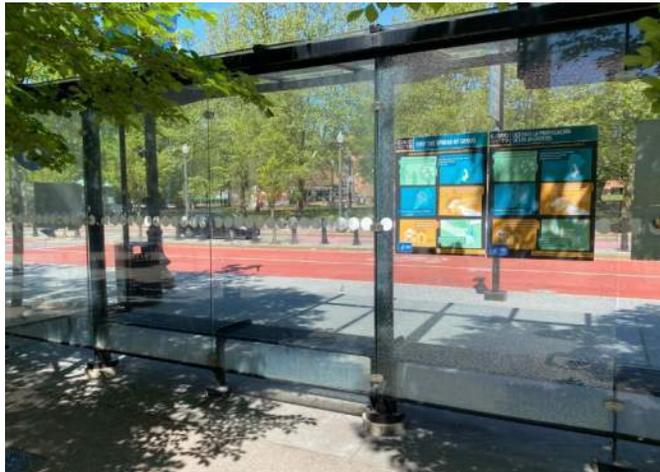
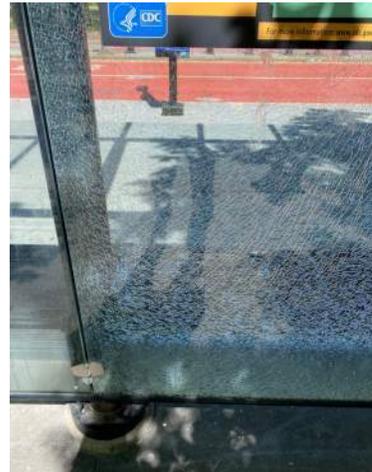
Glazing material resulting in cracked units.

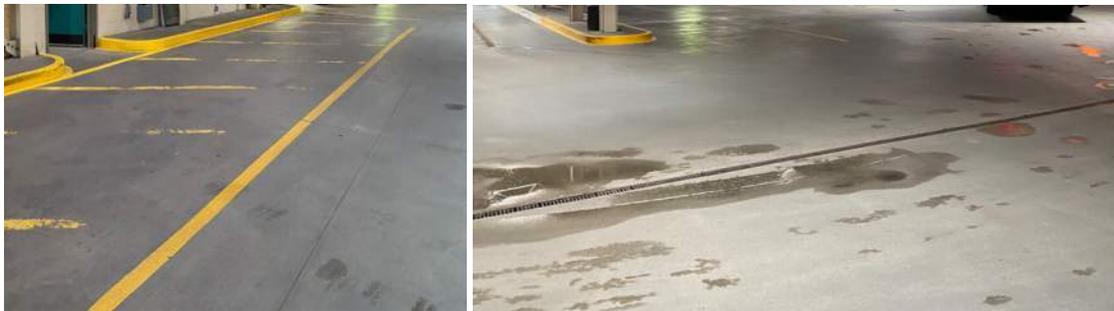
Some cracking and minor wear.

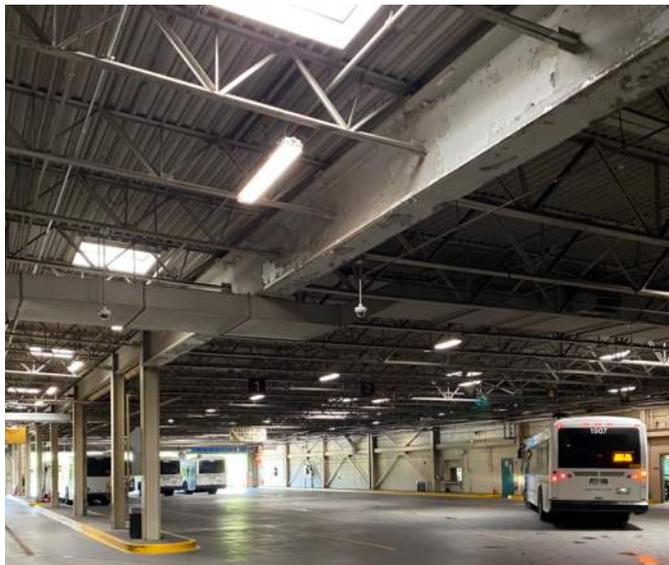
Paint and coating wear and peeling.

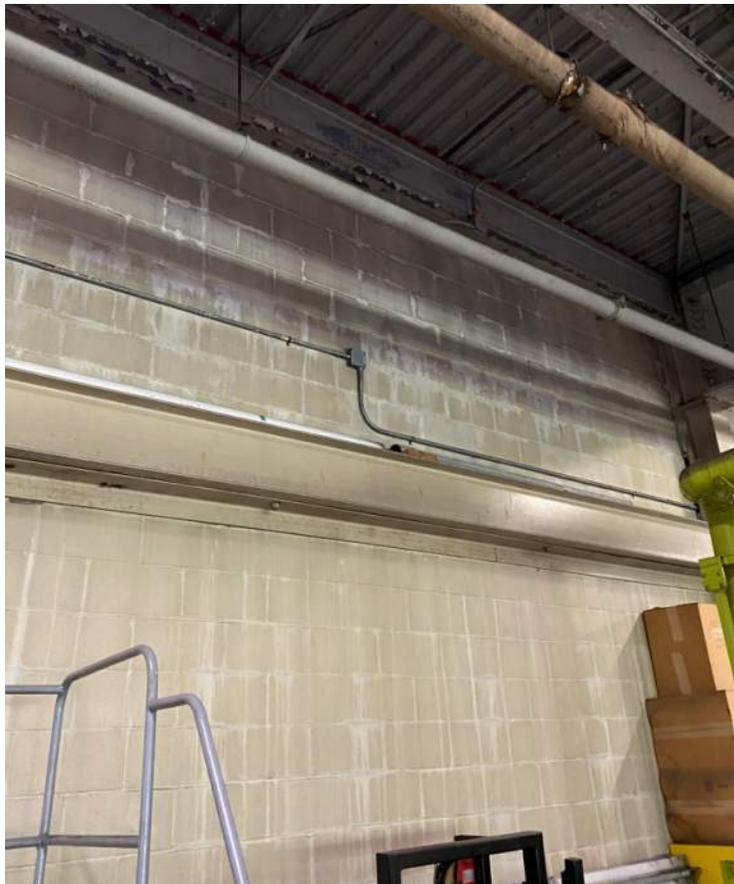
CMU walls appear in fair condition, however there is evidence of potential moisture buildup and efflorescence staining. Weep holes were not observed on the exterior, which are called for in the original construction documents.

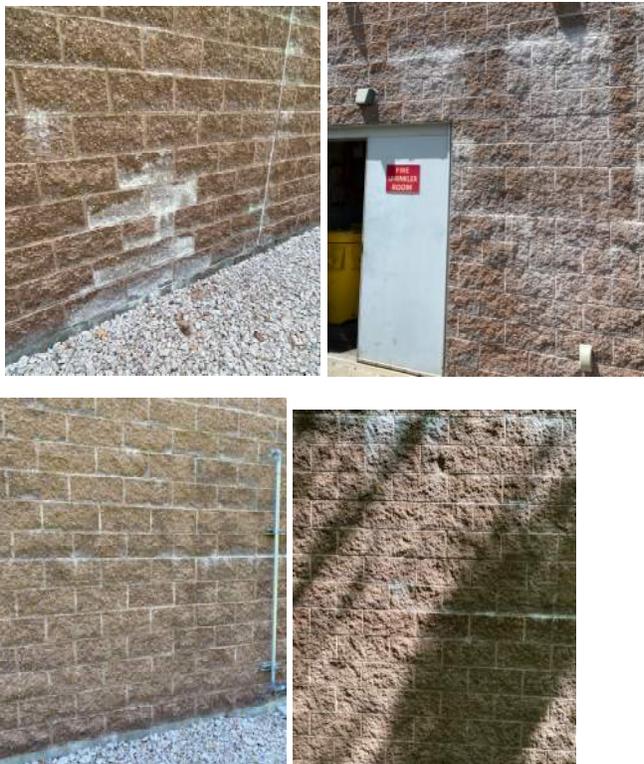
Split-face CMU walls appear in fair condition, however there is evidence of potential moisture buildup and efflorescence staining. Weep holes were not observed on the exterior, which are called for in the original construction documents.

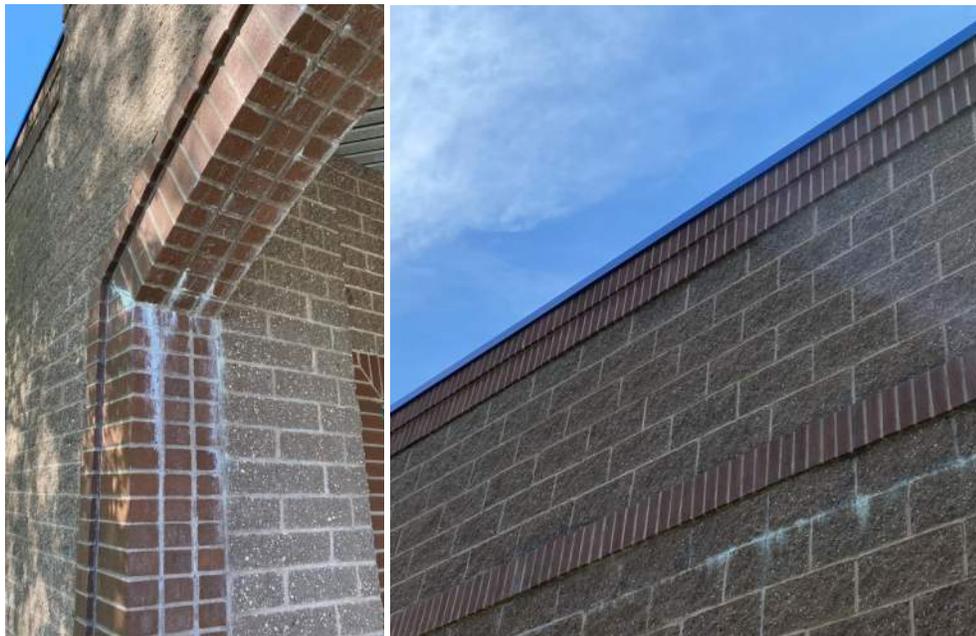
Exterior brick work appears in fair condition, however there is some evidence of potential moisture buildup and efflorescence staining.

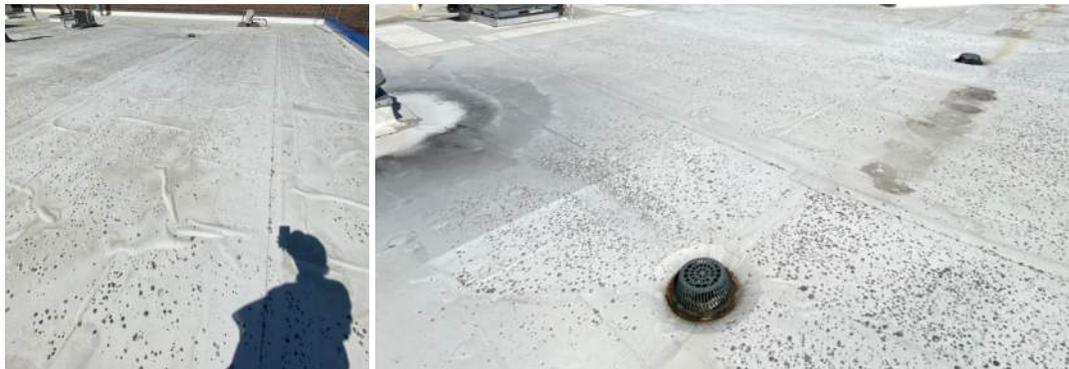
Rigid insulation not visible during inspection. Membrane roof covering in fair condition. Evidence of bubbling and some staining.

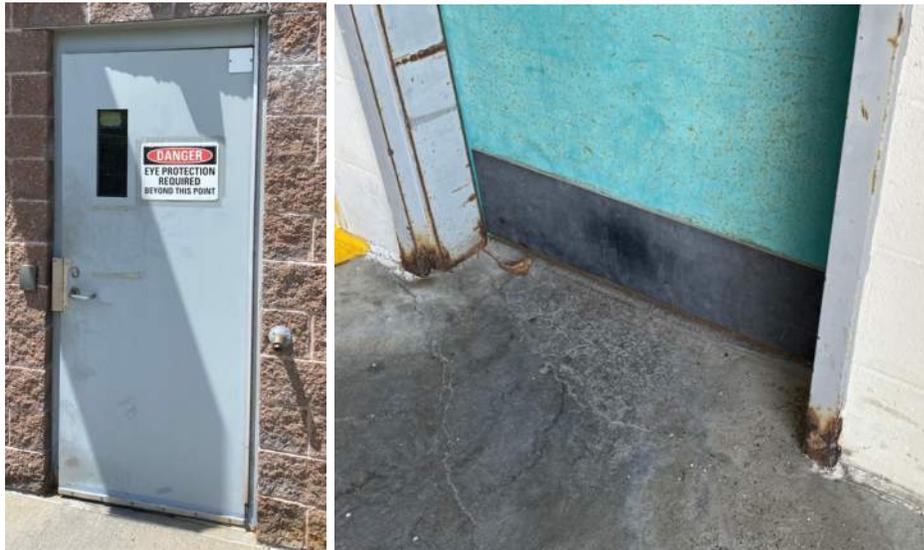
Deterioration/rust evident at base of doors and frames.

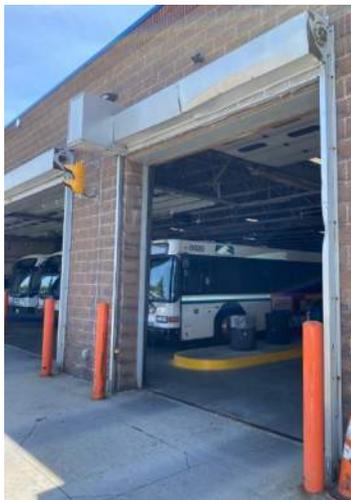
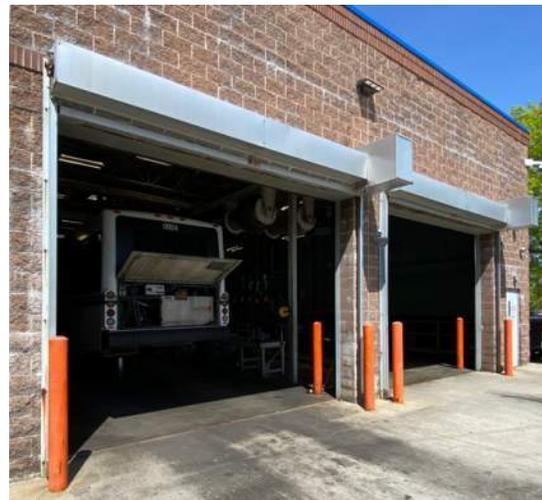
Some denting and rust evident.

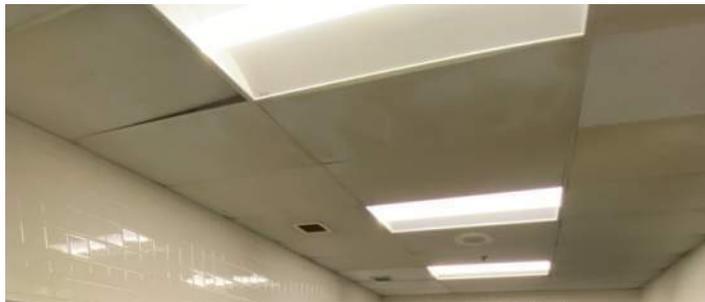
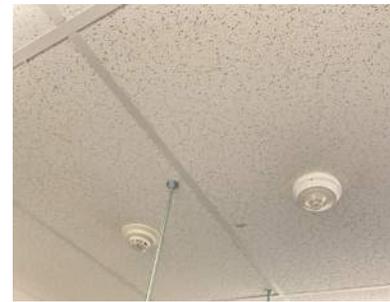
Water damage, missing tiles, corroded grids.

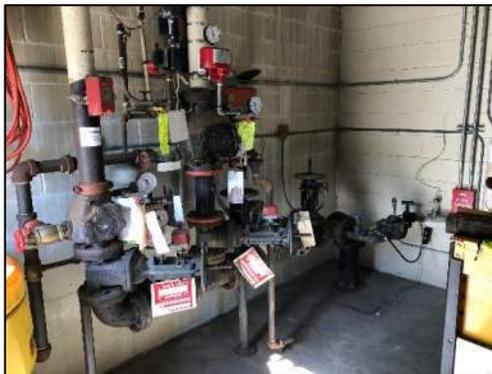
Figure 1: Fire and Water Services

The fire protection and domestic water systems connect to a common 6”-service lateral from the street. The domestic service has a 2” copper line. There is a 2” water meter and a pair of 2” reduced-pressure zone backflow preventer in parallel protect the system.

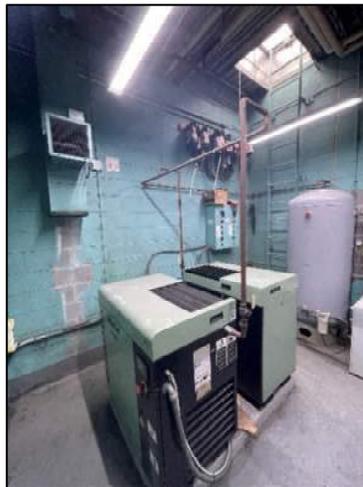
Figure 6: Compressed Air System

A compressed air system is in the Mechanical Room. The system includes an air compressor, a filter/dryer, and a storage tank. The compressed air is routed to drops and cord reels. The compressed air is used for hand tools and the air-operated diaphragm pumps pumping automotive fluids.

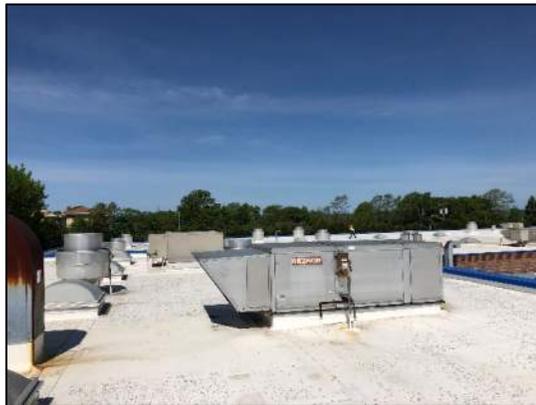
Figure 16: Makeup Air Unit

The maintenance bays are supplied with local rope-and-pully exhaust at each hydraulic lift and pit. Centrifugal upblast fans exhaust the maintenance areas. On the roof, existing make-up air units (MAUs) are original to the building (1993). The existing control system detecting CO and NO2 is not operational.

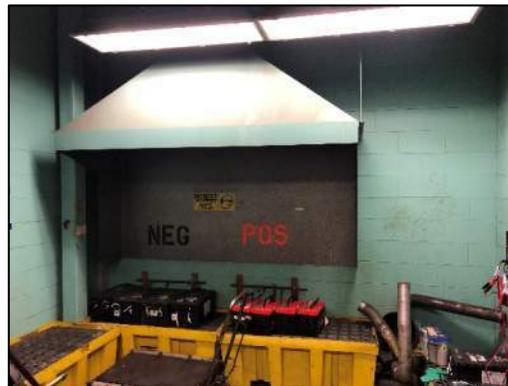
Figure 22: Battery Exhaust Hood

Centrifugal downblast fans exhaust restrooms and housekeeping areas. A battery charging station is equipped with a dedicated exhaust system that is no longer operational.

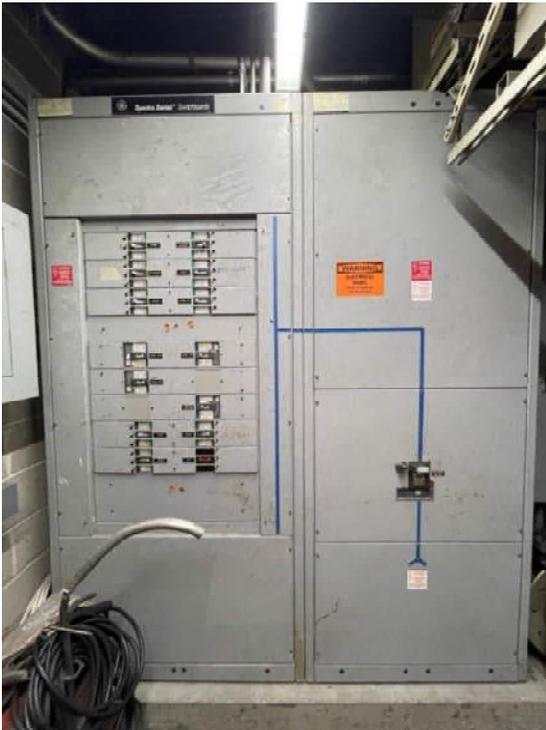
Figure 1: Switchboard (277/480V)

A 800A, 480V service installed approximately 30 years ago. The service is fed from the pad mounted transformer (Figure 2) (South side of the building) and enters the main switchboard (Figure 1) located in the Electrical Room. Building is served by a backup diesel generator (Figure 3). All distribution equipment appears to be in adequate condition, but it is approaching expected useful life based on industry standards.

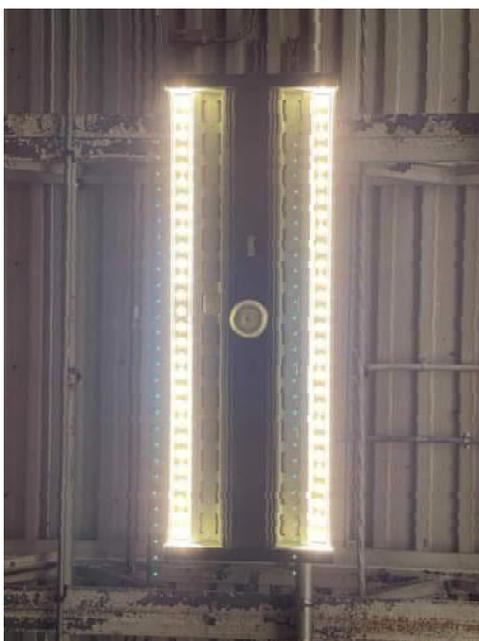
Figure 1: LED High-bay fixtures with integral occupancy sensor

LED high-bay fixtures with integral occupancy sensors (Figure 1) are installed throughout the first-floor garage space and appear to be in good condition. Exit signs (Figure 2) throughout the space do not appear to be illuminated and are not operational.

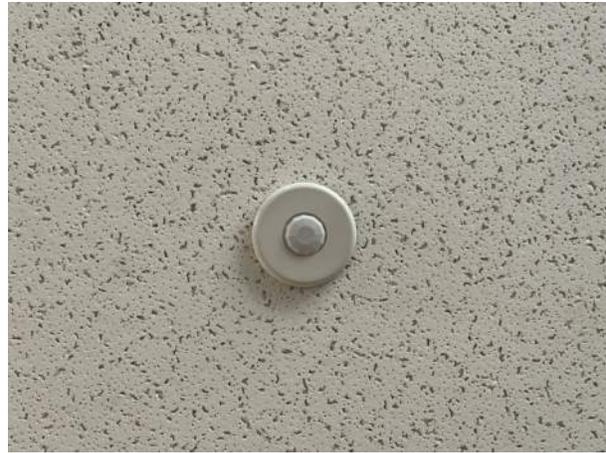
Figure 3: LED 2'X2' troffer fixtures

Storage/office spaces consist of LED 2’X2’ and 2’X4’ troffer fixtures (Figure 3) and linear LED fixtures controlled by a combination of toggle switches (Figure 7), ceiling mounted occupancy sensors (Figure 4), and wall switch occupancy sensors (Figure 8). Exit signs were observed throughout the space and appear to be fully operational (Figure 5). Lighting fixtures throughout

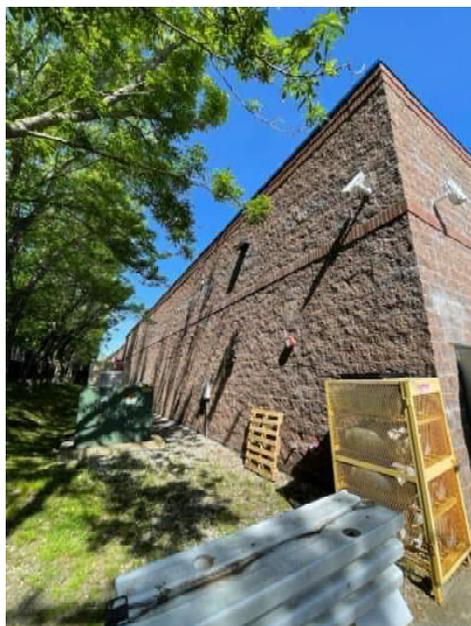
Figure 9: Exterior Wall packs

Wall packs (*Figure 9*) are installed along perimeter of building. Photocells on wall packs appear to have issues (lights staying on throughout the day). Emergency wall packs (*Figure 10*) are located above doors for emergency egress lighting.

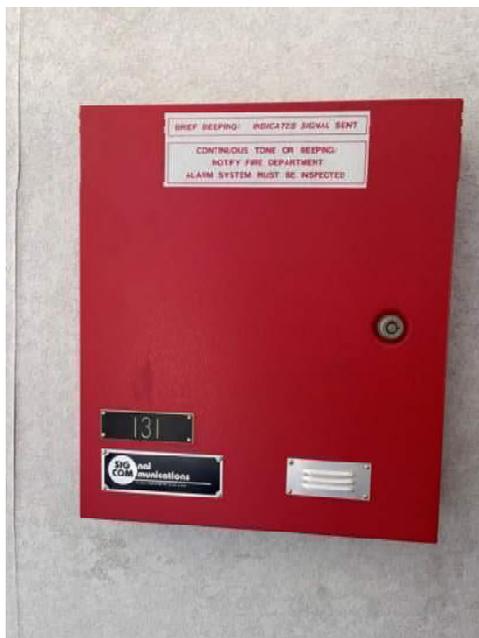
Figure 1: Gamewell Master Box

Fire alarm system consists of an addressable Fire Alarm Control Panel (Figure 2) (Simplex 4007) and associated devices manufactured by Simplex. Connection to local fire department is through a Radio Master Box (Figure 1). Pneumatic CO detection system installed throughout the garage space is no longer operational. One operational CO detection device was observed throughout the space (Figure 3). A fire suppression system is installed in the IT room (Figure 4). Fire Alarm system and associated devices and wiring appear to be in good condition.

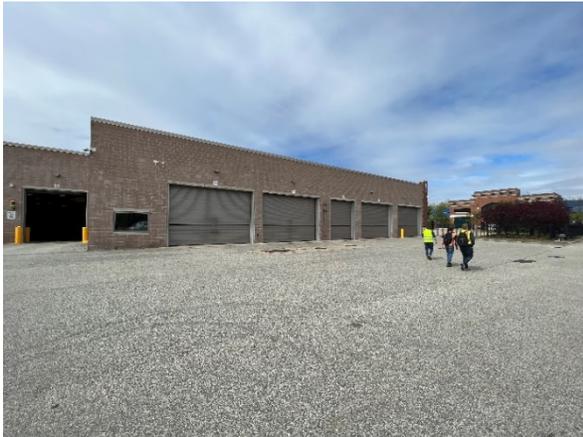
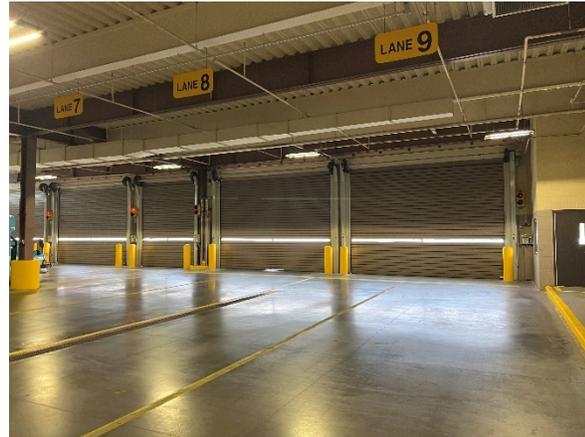
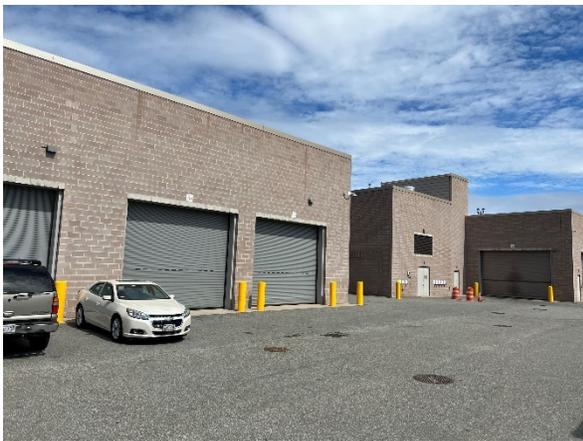
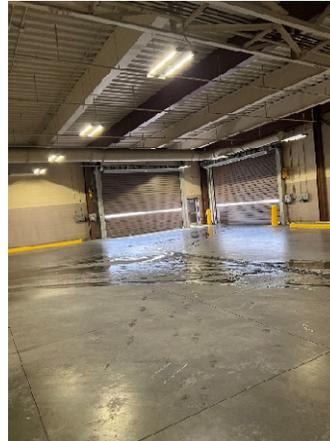
Coding / Field Name	Asset Description
System Name	Overhead coiling doors
Condition	3
Quantity	12
Unit Cost	\$93,490
Year in Service	2009
Expected Useful Life	30 years
Remaining Useful Life	20 years, Estimated, Based on Date of Observation
Location	Building exterior
Basis of Costing	Square Foot Costs with RSMeans Data 2022 – 43 rd Edition

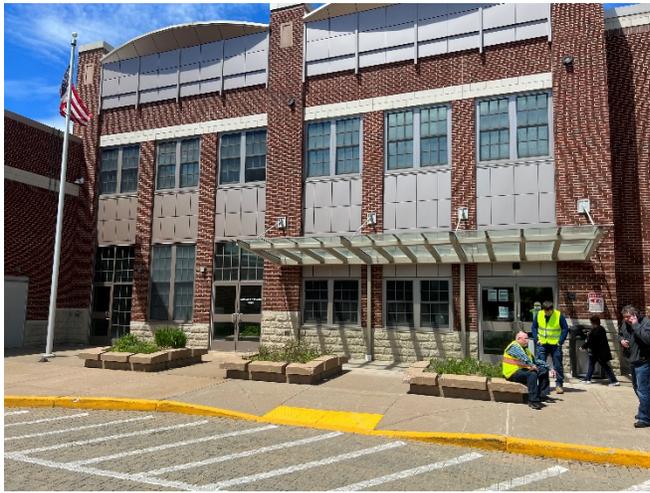
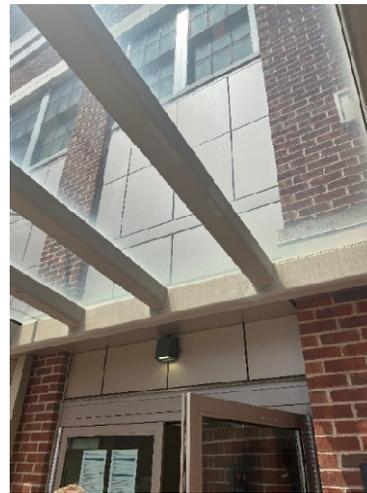
Coding / Field Name	Asset Description
System Name	Exterior glazing
Condition	4
Quantity	~2,200 sq. ft.
Unit Cost	\$61,997.48
Year in Service	2009
Expected Useful Life	70 years
Remaining Useful Life	60 years
Location	Building exterior
Basis of Costing	Square Foot Costs with RSMeans Data 2022 – 43 rd Edition

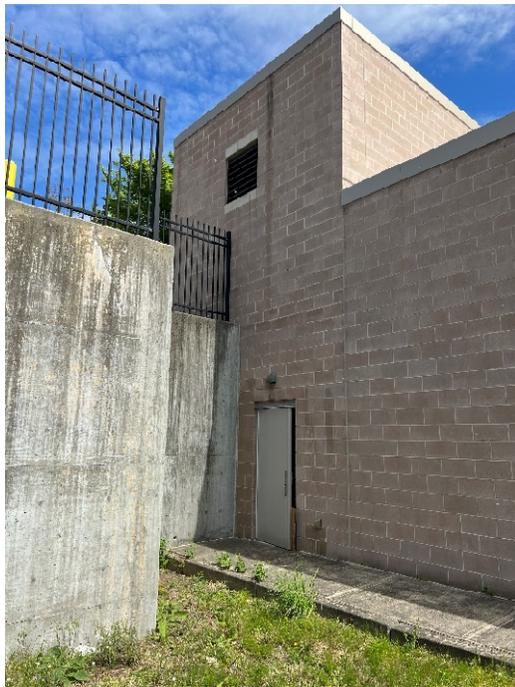
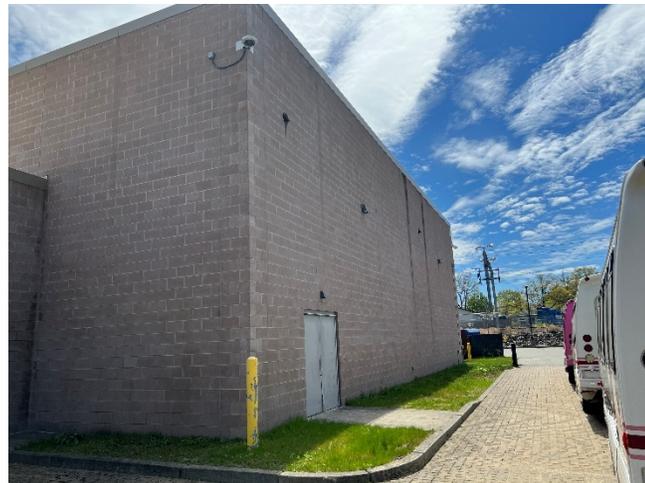
Coding / Field Name	Asset Description
System Name	Exterior metal doors & frames
Condition	3
Quantity	27
Unit Cost	Total: \$56,366
Year in Service	2009
Expected Useful Life	50 years
Remaining Useful Life	40 years, Estimated, Based on Date of Observation
Location	Building exterior
Basis of Costing	Square Foot Costs with RSMMeans Data 2022 – 43 rd Edition

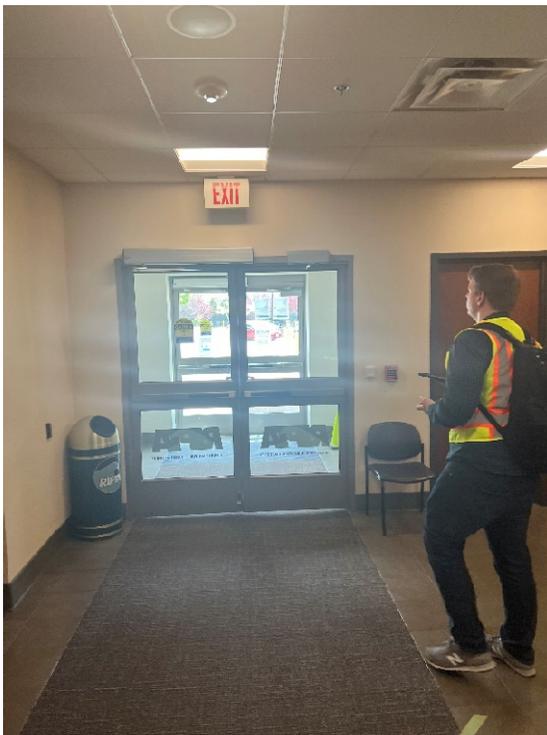
Coding / Field Name	Asset Description
System Name	Aluminum automatic entrances
Condition	3
Quantity	2
Unit Cost	\$29,650
Year in Service	2009
Expected Useful Life	25 years
Remaining Useful Life	15 years, Estimated, Based on Date of Observation
Location	Building exterior
Basis of Costing	Square Foot Costs with RSMMeans Data 2022 – 43 rd Edition

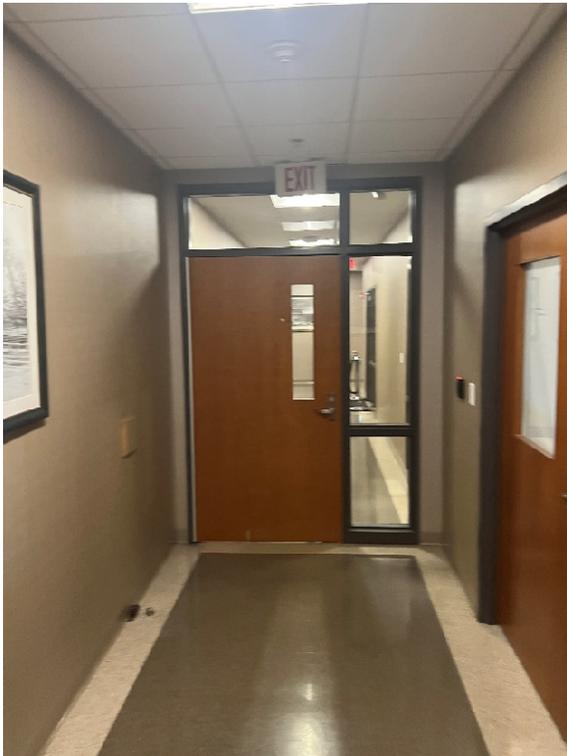
Coding / Field Name	Asset Description
System Name	Interior wood doors and frames
Condition	4
Quantity	81
Unit Cost	\$106,118.1
Year in Service	2009
Expected Useful Life	50 years
Remaining Useful Life	40 years, Estimated, Based on Date of Observation
Location	Building interior
Basis of Costing	Square Foot Costs with RSMeans Data 2022 – 43 rd Edition

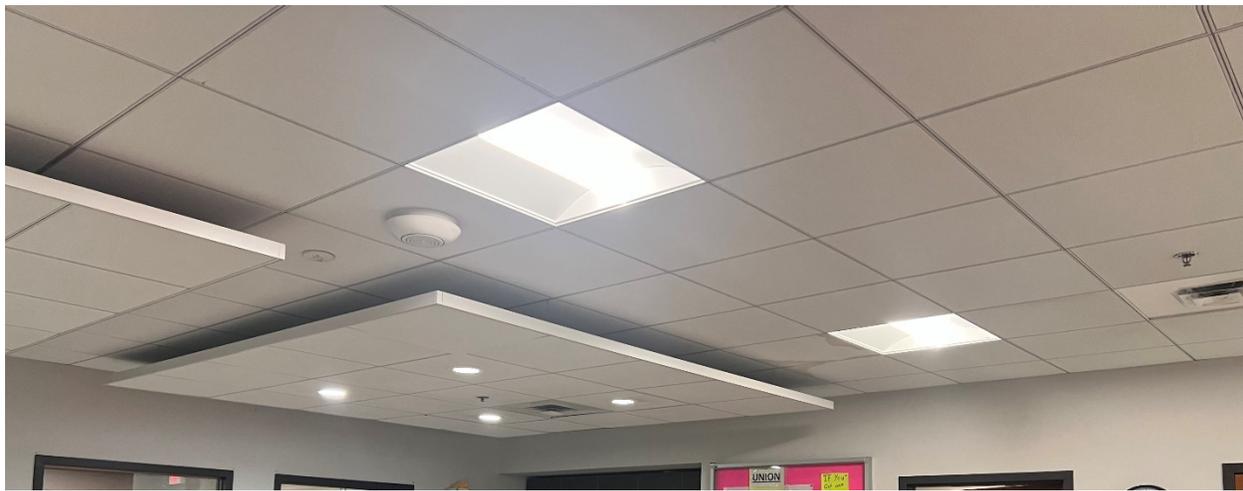
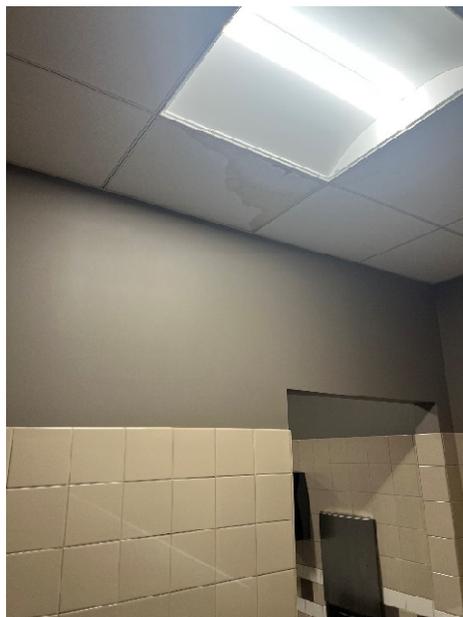
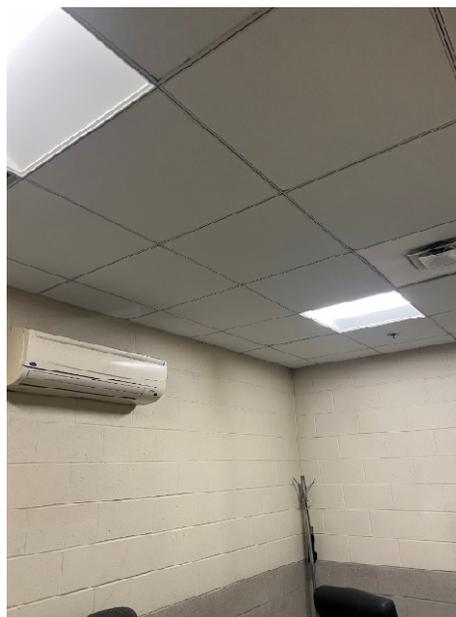
Coding / Field Name	Asset Description
System Name	Acoustic ceiling tiles and grids
Condition	4
Quantity	~26,040 sq. ft.
Unit Cost	\$280,711.23
Year in Service	2009
Expected Useful Life	40 years
Remaining Useful Life	30 years, Estimated, Based on Date of Observation
Location	Building interior
Basis of Costing	Square Foot Costs with RSMeans Data 2022 – 43 rd Edition

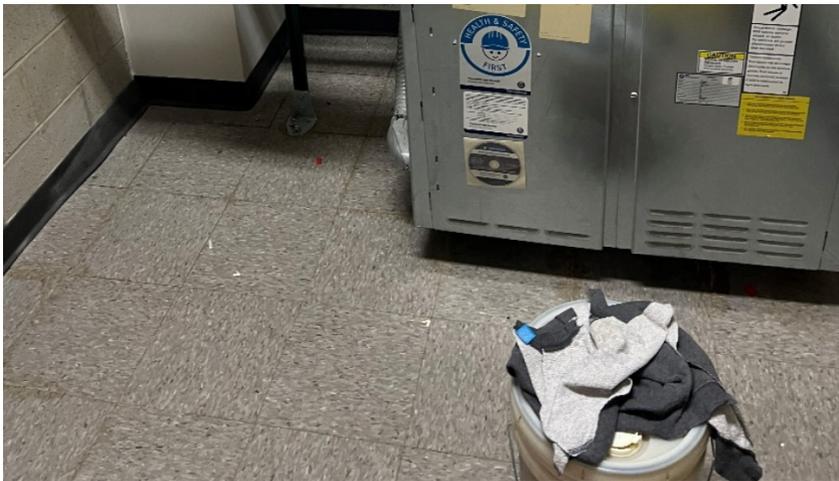
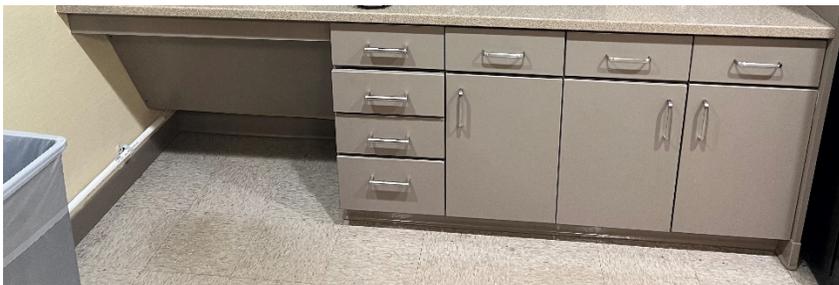
Coding / Field Name	Asset Description
System Name	Vinyl composition tile
Condition	3
Quantity	~26,040 sq. ft.
Unit Cost	\$175,770
Year in Service	2009
Expected Useful Life	50 years
Remaining Useful Life	25 years, Estimated, Based on Date of Observation
Location	Building interior
Basis of Costing	Square Foot Costs with RSMeans Data 2022 – 43 rd Edition

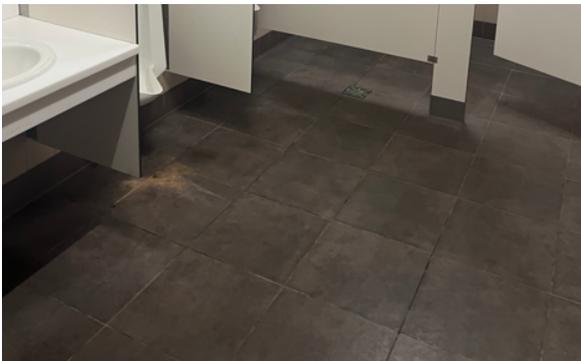
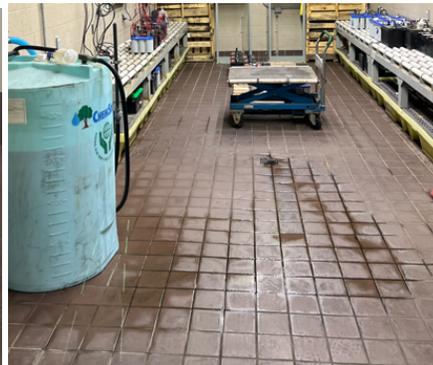
Coding / Field Name	Asset Description
System Name	Ceramic Tile Floor & base
Condition	3
Quantity	~1,200 sq. ft.
Unit Cost	\$16,335.84
Year in Service	2009
Expected Useful Life	75 years
Remaining Useful Life	60 years, Estimated, Based on Date of Observation
Location	Building interior
Basis of Costing	Square Foot Costs with RSMeans Data 2022 – 43 rd Edition

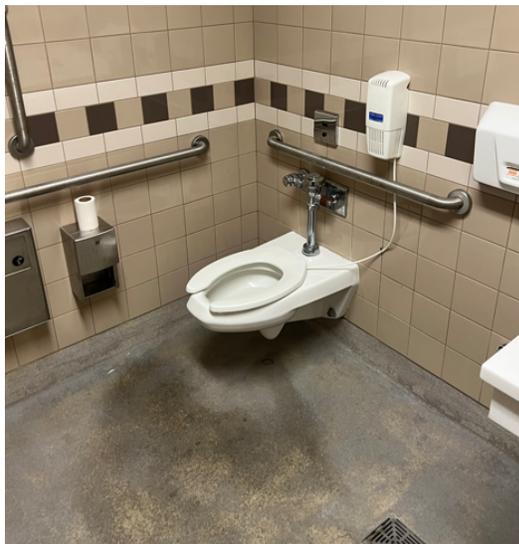
Coding / Field Name	Asset Description
System Name	Restroom fixtures and accessories
Condition	3
Quantity	4 restrooms
Unit Cost	Total: \$65,196
Year in Service	2009
Expected Useful Life	30 years
Remaining Useful Life	20 years, Estimated, Based on Date of Observation
Location	Building interior
Basis of Costing	Square Foot Costs with RSMeans Data 2022 – 43 rd Edition

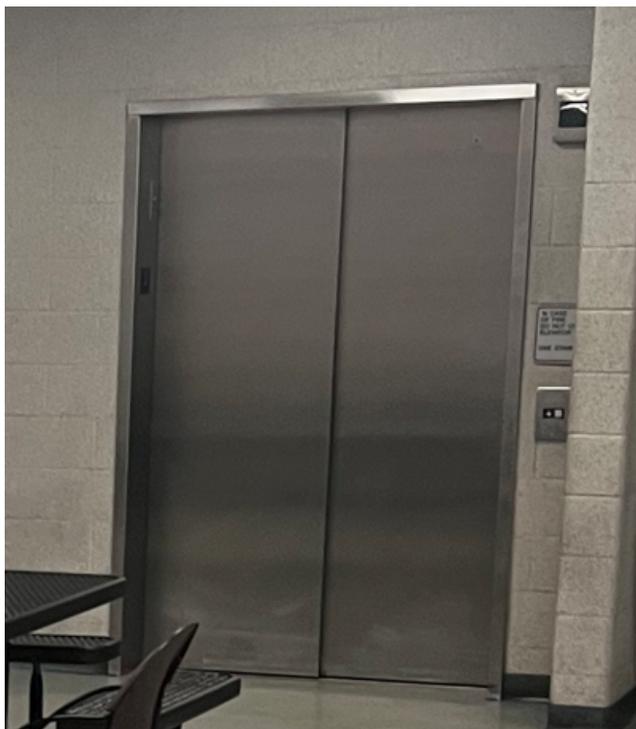
Coding / Field Name	Asset Description
System Name	Elevator
Condition	3
Quantity	1
Unit Cost	\$453,500
Year in Service	2009
Expected Useful Life	25 years
Remaining Useful Life	10 years, Estimated, Based on Date of Observation
Location	Building interior
Basis of Costing	Square Foot Costs with RSMeans Data 2022 – 43 rd Edition

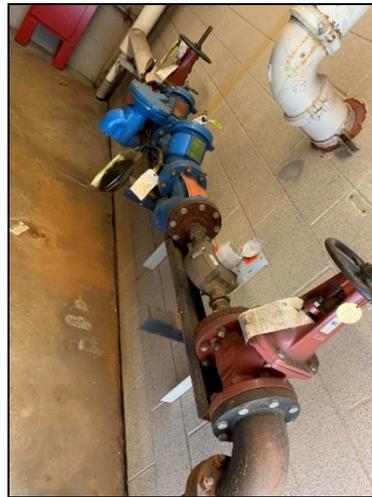
Figure 1: Domestic Water Service

Coding / Field Name	Asset Description
Domestic Water Distribution	Domestic water service and piping distribution
Condition	3-Maginal
Quantity	~80,000 SF
Unit Cost	\$3/square foot for distribution & Labor Total: \$240,000
Year in Service	~2002 with sporadic modifications through the years
Expected Useful Life (EUL)	~50 Years
Remaining Useful Life (RUL)	~30 Years
Location	Entire Facility
Basis of Costing	RMS Means Data with Contingencies Added

The domestic water service is in the water room with the fire service equipment. The domestic water service lateral is 4". The domestic water meter is 1-1/2" and the reduced-pressure zone backflow preventer and valving match the lateral size of 4". No pressure boosting pumps are present. The domestic water is piped with copper throughout the building. The copper appears to be in fair condition. The fittings were soldered. Insulation is present on hot or cold-water piping.

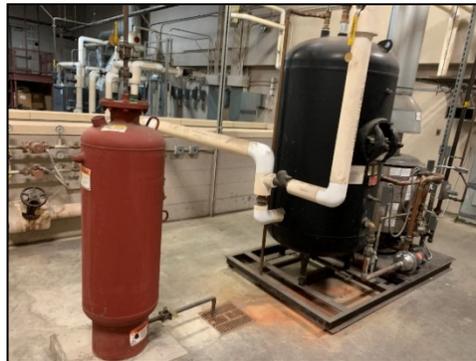
Figure 2: Domestic Water Boiler and Storage Tank

Coding / Field Name	Asset Description
Domestic Hot Water Systems	Water heaters
Condition	2-Marginal
Quantity	~1 Gas-Fired Boiler and Storage Tank
Unit Cost	\$50,000
Year in Service	~2002
Expected Useful Life (EUL)	~20 Years
Remaining Useful Life (RUL)	~0 Years
Location	Boiler Room
Basis of Costing	RMS Means Data with Contingencies Added

On the mechanical mezzanine, a gas-fired boiler with an accompanying 200-gallon tank provides the facility domestic hot water. Recirculation pumps provide recirculation through the facility.

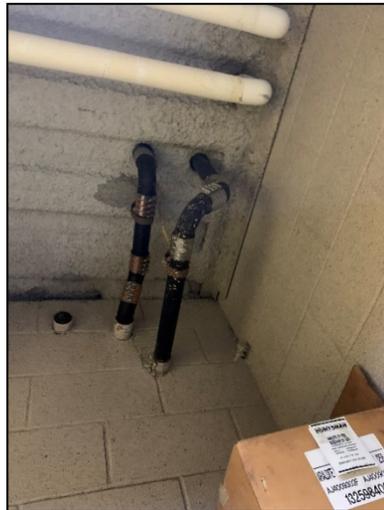
Figure 9: Sanitary Drainage Piping

The sanitary piping is no-hub cast iron. The piping appears in good, working order. A water-oil separator is present in the garage. This separator handles the runoff from the parts cleaning room, the bus bays, and other areas that have drains that could be contaminated with oil.

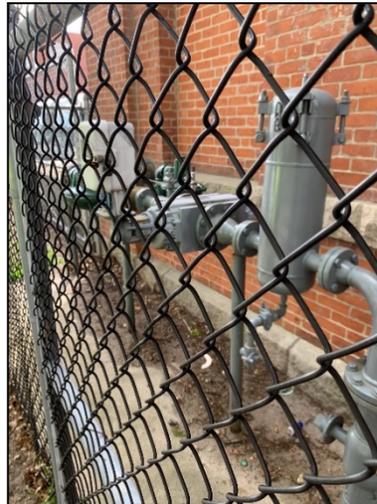
Figure 13: Gas Service Meter and Regulator

The building is served by a natural-gas system on the North side of the facility. The incoming service is ~2” and increases to ~3” after the compressors. A few items requiring gas are the boilers for the hydronic and domestic water and the boilers in the water treatment room.

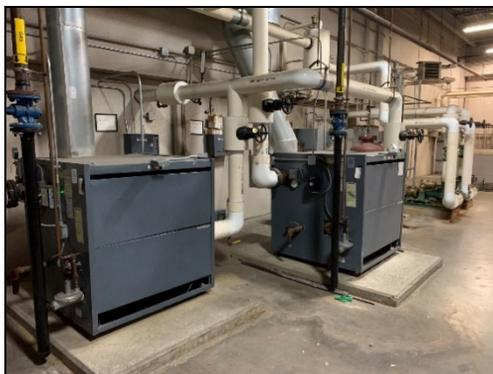
Figure 18: Hydronic Heating System Boilers

Coding / Field Name	Asset Description
Comfort Heating Systems	Hot-water boiler, piping, ancillary equipment, and terminal devices (radiators, MAUs, and fan coils).
Condition	4-Good
Quantity	~80,000 square feet
Unit Cost	\$20/square foot for ~\$1,600,000
Year in Service	Boiler (~2002), Other System Components ~2002
Expected Useful Life (EUL)	Boiler ~30 Years, Other System Components ~30 Years
Remaining Useful Life (RUL)	~10 years
Location	Entire Facility. See comments for further details.
Basis of Costing	RMS Means Data with Contingencies Added

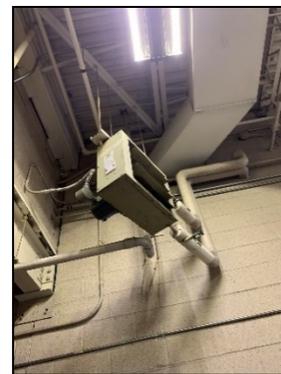
Figure 19: Hot-Water Unit Heater

There are many small, hot-water unit heaters located throughout the facility. These heaters appear to be locally controlled with a thermostat mounted on the unit.

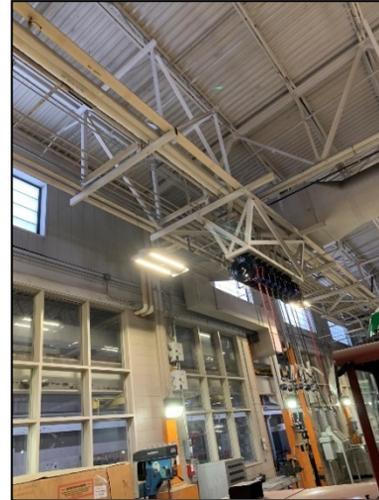
Figure 21: MAU on the Perimeter of the Garage

The MAUs provide tempered air to replace the air exhausted from the various exhaust systems. Some MAUs are hung from the ceiling at locations on the perimeter of the garage area. These units are ducted across the garage and to various rooms along the perimeter. MAUs are also mounted on the flat roof and provide MAU to the exterior spaces, outside of the garage area. An additional Fan Coil Unit is in the parts storage area.

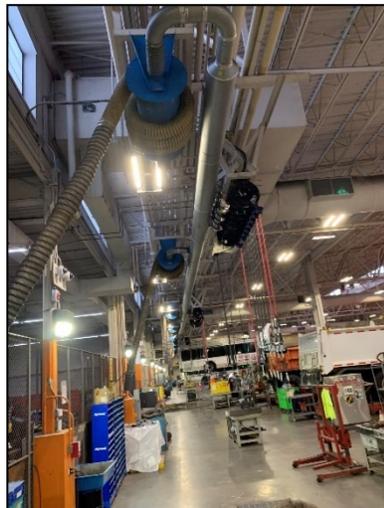
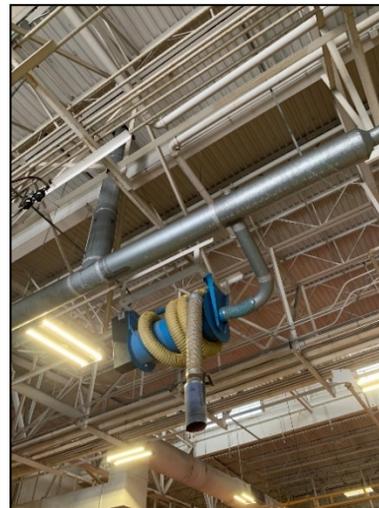
The garage is equipped with motor driven exhaust fans that have branch ducting with a rope-and-pulley system for localized exhaust. The local exhaust systems appear in good, working order. The fan drives for the exhaust systems are mounted on the roof. Some fans appear newer, and some appear to be original with the building.

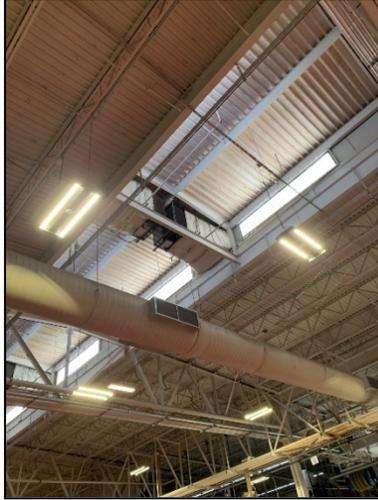
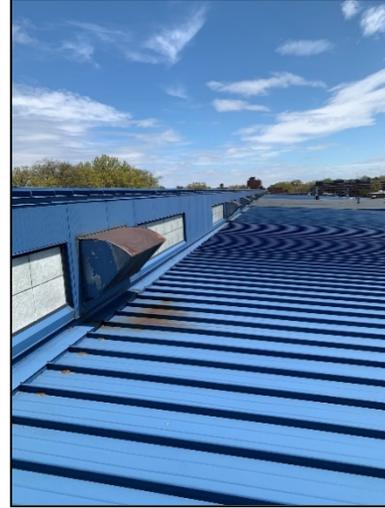
The main floor of the garage has exhaust fans mounted on both sides of the peak of the ceiling. These exhaust fans face one another and exhaust directly to the exterior. On the walls of the garage, there are control sensors that measure CO and NO₂ and control the fans.

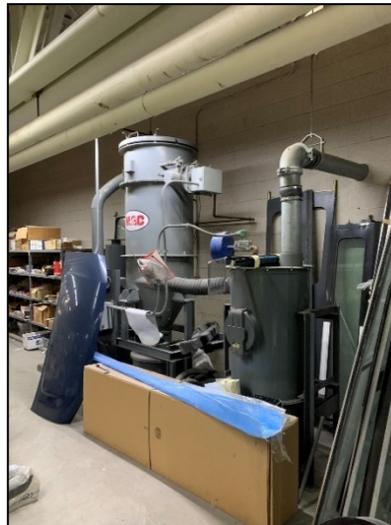
The Body Shop is equipped with a localized smoke exhaust. The machine appears in working order.

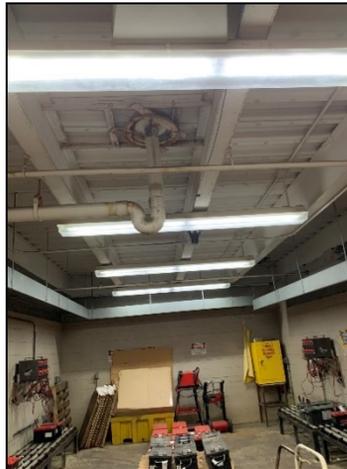
The battery storage room has makeup air to it, but there is not a control system in place to exhaust the room if there is a dangerous buildup of off gasses from the batteries.

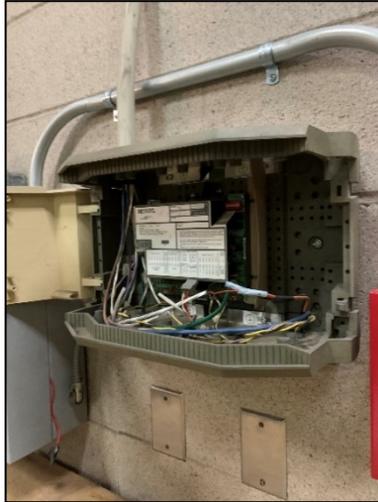
An abandoned in-place BMS controls system panel is in the parts storage room. The abandoned system is JCI MetaSys system. The working controls system panel is in the boiler room. The working BMS controls system is JCI Facility Explorer.

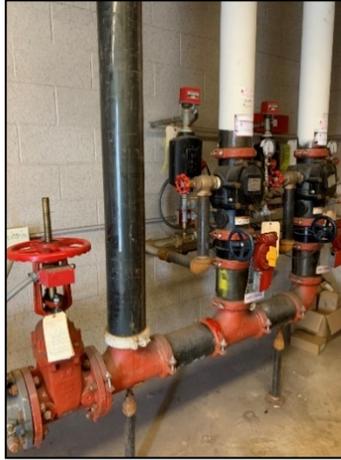
The Risers for the zones appear rather new. There are new flow switches and tamper switches in place. The riser check assemblies appear in good condition.

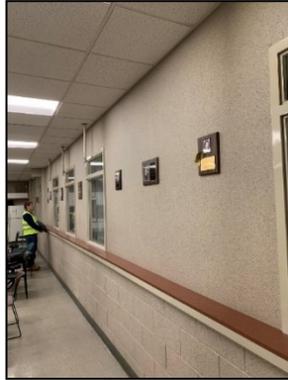
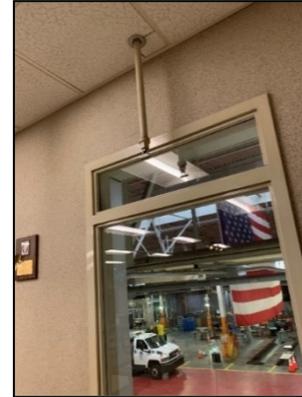
All sprinklers appear to be original to the building and appear in good, working order. Recessed sprinklers are in the office portion. Uprights and drops are in other areas. The mezzanine overlooking the garage floor was equipped with window sprinklers on both sides of the windows. The piping is steel, which is in fair condition.

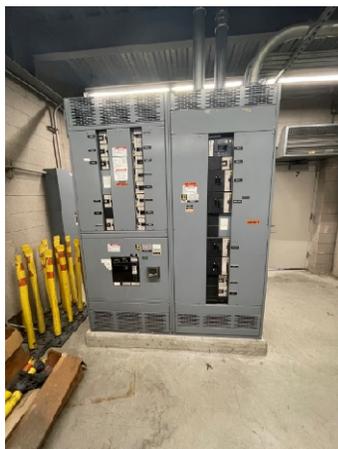
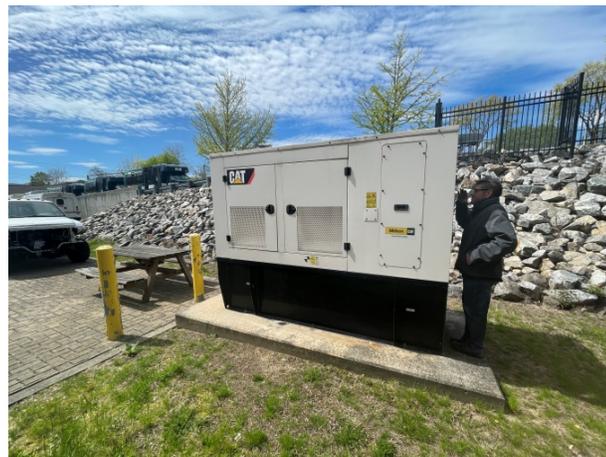
A 1,600A, 480V service installed approximately 10 years ago. The service is fed from the pad mounted transformer (North side of the building) and enters the main switchboard (*Figure 1*) located in the Electrical Room. Building is served by a backup generator (Figure 2). All distribution equipment appears to be in good condition.

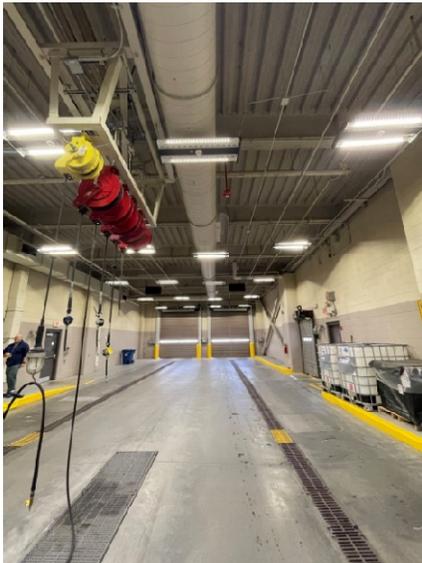
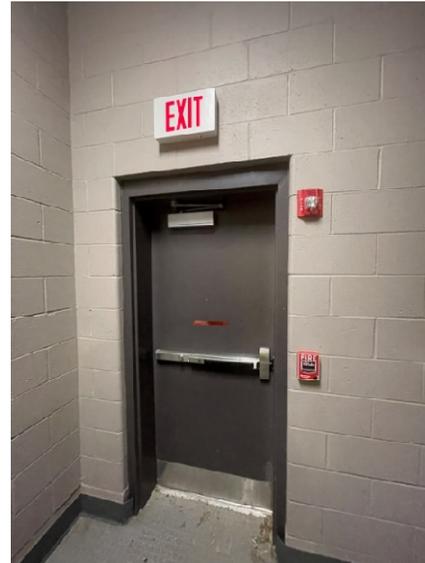
LED high-bay fixtures with integral occupancy sensors (*Figure 1*) are installed throughout the first floor garage space. All exit signs (*Figure 2*) throughout the space are illuminated and appear to be completely operational.

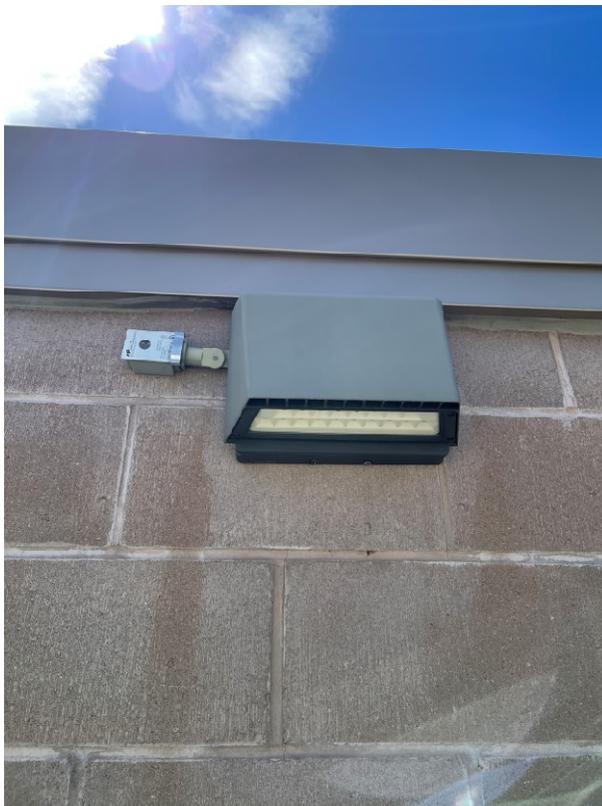
Figure 9: Exterior Wall packs

Wall packs (*Figure 9*) are installed along perimeter of building. Emergency wall packs (*Figure 10*) are located above doors for emergency egress lighting.

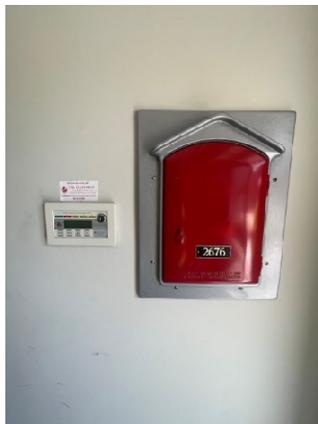
Figure 1: Gamewell Master Box

Fire alarm system consists of an addressable Fire Alarm Control Panel (Figure 2) (Notifier NFS-320) and associated devices manufactured by Notifier. Connection to local fire department is through a Gamewell Master Box (Figure 1). CO detection system is installed throughout the garage space (Figure 3). A fire suppression system is installed in the IT room (Figure 4). Fire Alarm system and associated devices and wiring appear to be in good condition.
