Transit Asset Management Plan

October 1, 2022 – September 30, 2026

RHODE ISLAND PUBLIC TRANSIT AUTHORITY

FINAL ASSESSMENT REPORT
August, 2022

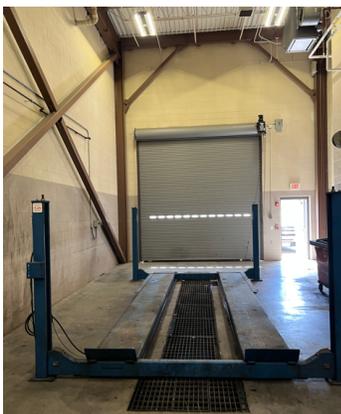
Coding / Field Name	Asset Description
System Name	Vehicle lifts
Condition	3
Quantity	5
Unit Cost	\$175,000
Year in Service	2009
Expected Useful Life	20 years
Remaining Useful Life	10 years, Estimated, Based on Date of Observation
Location	Building interior
Basis of Costing	Square Foot Costs with RSMeans Data 2022 – 43 rd Edition

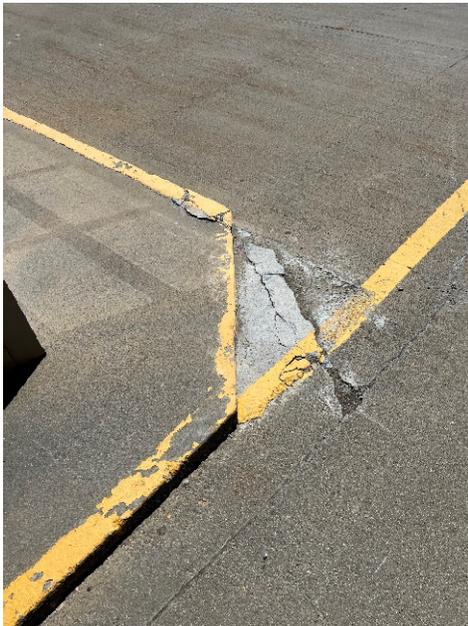
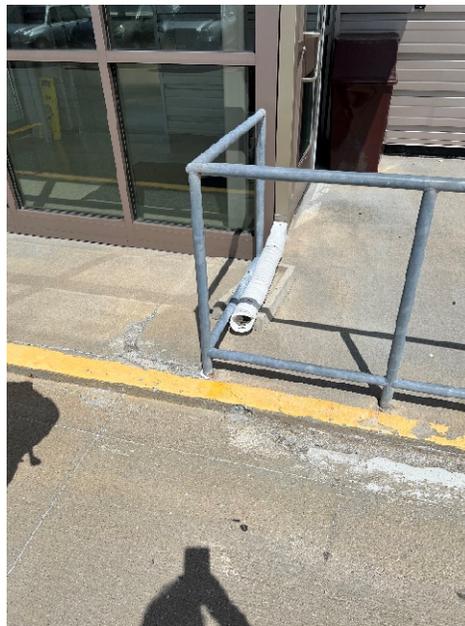
Coding / Field Name	Asset Description
System Name	Site work and parking lot
Condition	3
Quantity	~ 90,857.75 sq. ft.
Unit Cost	\$478,809.60
Year in Service	2009
Expected Useful Life	25 years
Remaining Useful Life	5 years, Estimated, Based on Date of Observation
Location	Building Exterior
Basis of Costing	Square Foot Costs with RSMeans Data 2022 – 43 rd Edition
